**CASE STUDIES 2 AND 1**

#### 4.2.2. Lock and Dam 24 (Case Study 2)

#### 4.2.1. Big Creek (Case Study 1)

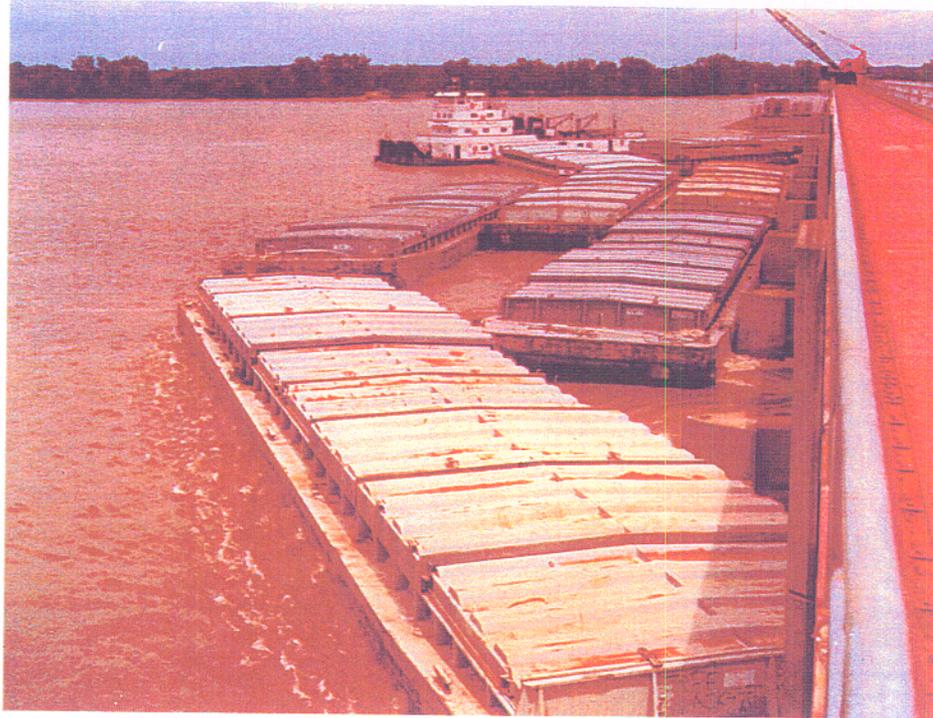
Severe outdraft at Lock and Dam 24 had existed since the dam was completed in 1940. ~~Downbound~~ *from upstream* flows approaching the Lock usually experienced these detrimental crosscurrent patterns between the upper end of the landwall and the lock chamber. These currents ~~had~~ pulled vessels toward the riverwall and gate openings in the dam. Numerous accidents and near catastrophic events have occurred from this recurring problem. Figure 2 shows the consequences of an outdraft induced accident at Lock and Dam 24.

**Figure 2: Barges in the Dam, Aftermath of an Outdraft Induced Accident at Lock and Dam 24**

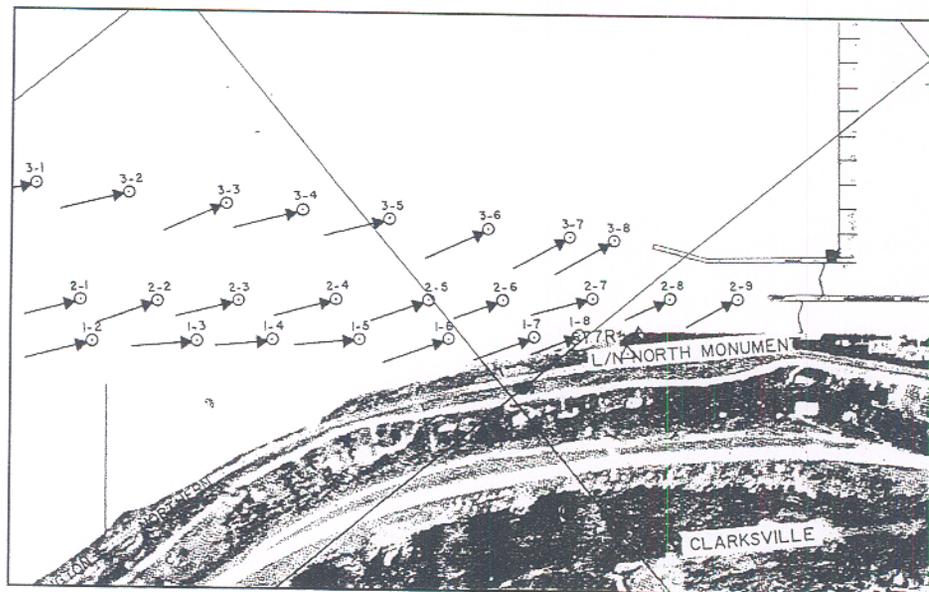
Figure 4 show velocity vectors surveyed upstream of the Lock during three consecutive days in April of 1982. Although the density or resolution of the data points was limited, the surveys showed that velocities near the lock chamber were directed toward the gate openings. The most severe skewed angles of velocity occurred just upstream of the riverwall. However, reliable velocity patterns that delineated the outdraft problem could not fully be determined from this data alone.

Figure 4: Velocity Vectors at Lock 24, Surveyed in April 1982.

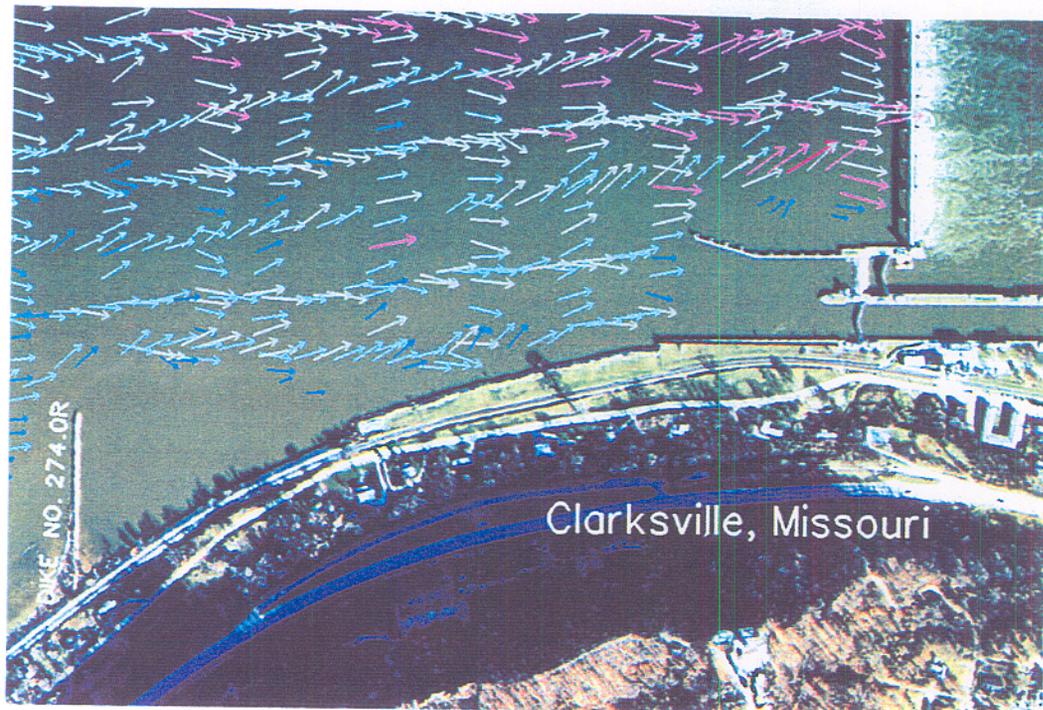
Figure 5 displays velocity vectors that were collected using an ADCP in March of 1997 during open river conditions. Since the resolution of the historical data was limited, this data further characterized the velocity patterns. The data indicated that currents deflected off the right descending bank near the apex of the rock bluff protrusion and

approximately 600 feet upstream of the end of the landwall. This discovery served a vital role in the eventual calibration of flow within the micro model.

**Figure 5: ADCP Velocity Vectors at Lock 24, Surveyed March 1997.**

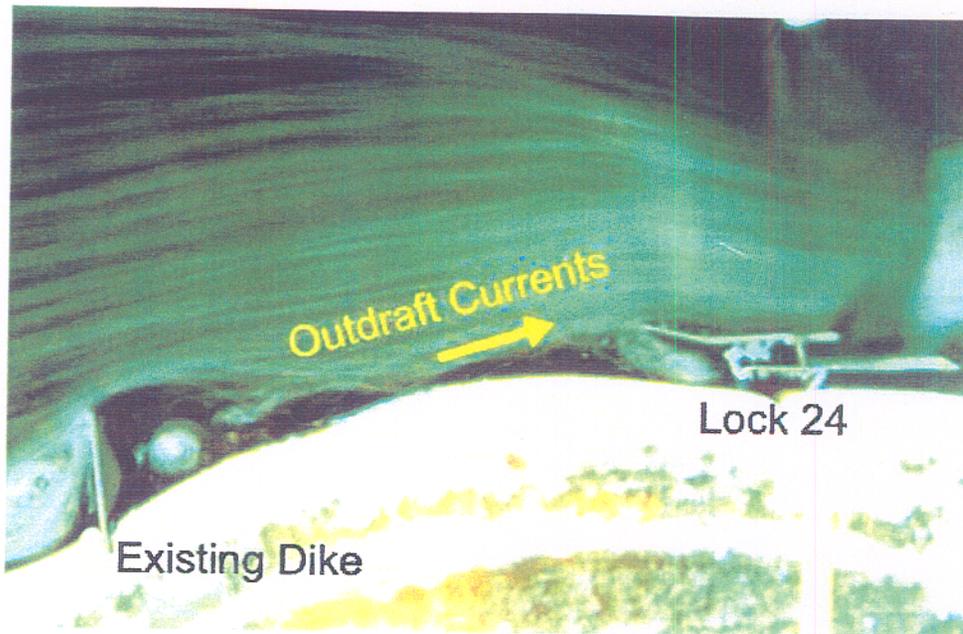
to those of the prototype. It was then determined that the flow patterns of the base test (Figure 7) were extremely similar to those shown in the prototype flow data.

**Figure 7: Micro Model Base Test Flow Visualization Showing Dangerous Outdraft Flow Patterns.**

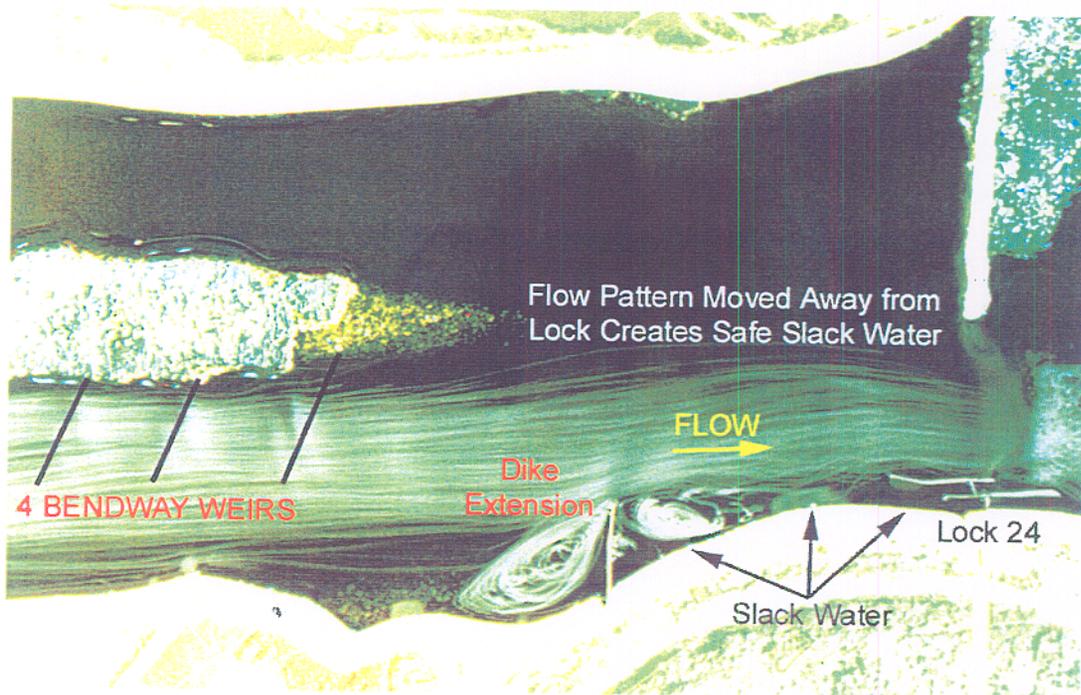
**Figure 8: Micro Model Flow Visualization of the Recommended Remedial Design.**

Using the model study test results as a guide, team representatives from the St. Louis District and river industry determined the most economical and practical solutions to the outdraft problem at the Lock. The team concluded that four bendway weirs upstream of the lock chamber off the left descending bank and a 200-foot extension of

the existing dike at Mile 274.0R would result in the best possible measure at reducing or eliminating the outdraft problem. The weirs were designed to push flow towards the existing rock dike, making the elongated structure more effective at creating an area of slack water between the dike and the lock chamber. The resultant bathymetry from the model indicated that the thalweg shifted toward the right descending bank near the dike extension. Flow visualization in the model indicated that this design would create increased slack water between the dike and the lock chamber which would reduce the outdraft flow patterns (Figure 8, flow visualization). These patterns would provide favorable flow conditions for both upbound and downbound tows entering and leaving the lock chamber.

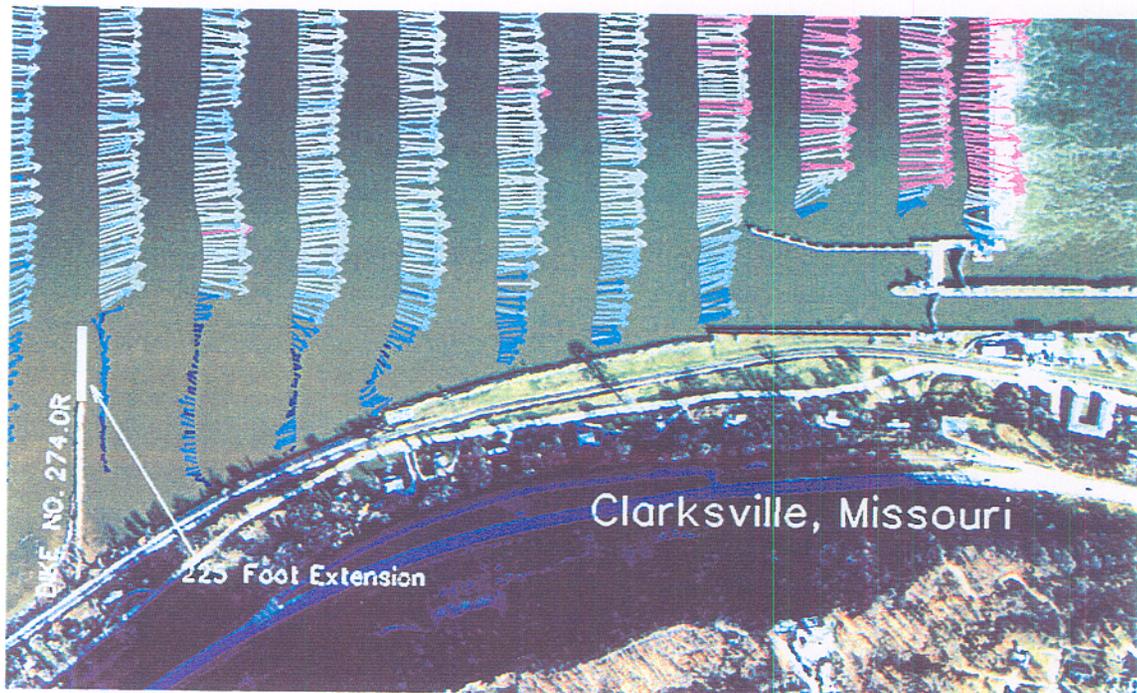
Figure 9: ADCP Velocity Vectors at Lock 24, Post Construction, 2000

The flow patterns discerned from the ADCP data collected in 2000 (Figure 9) clearly demonstrates distinctive similarities to those predicted by the micro model flow visualization of the recommended design (Figure 8). This ADCP data compared to the pre construction ADCP data (Figure 5) indicates that the dangerous flow patterns that had caused the outdraft problem have been dissipated. As also shown in the post construction data, the flow patterns in the model displayed a correction to the detrimental currents that had deflected off the right descending bank. The micro model also correctly predicted the position and size of the eddy downstream of the dike. Although these methods of recording flow patterns are different, the similarities between the ADCP velocity vectors and the time elapsed stream lines from the model are clearly shown in these Figures.

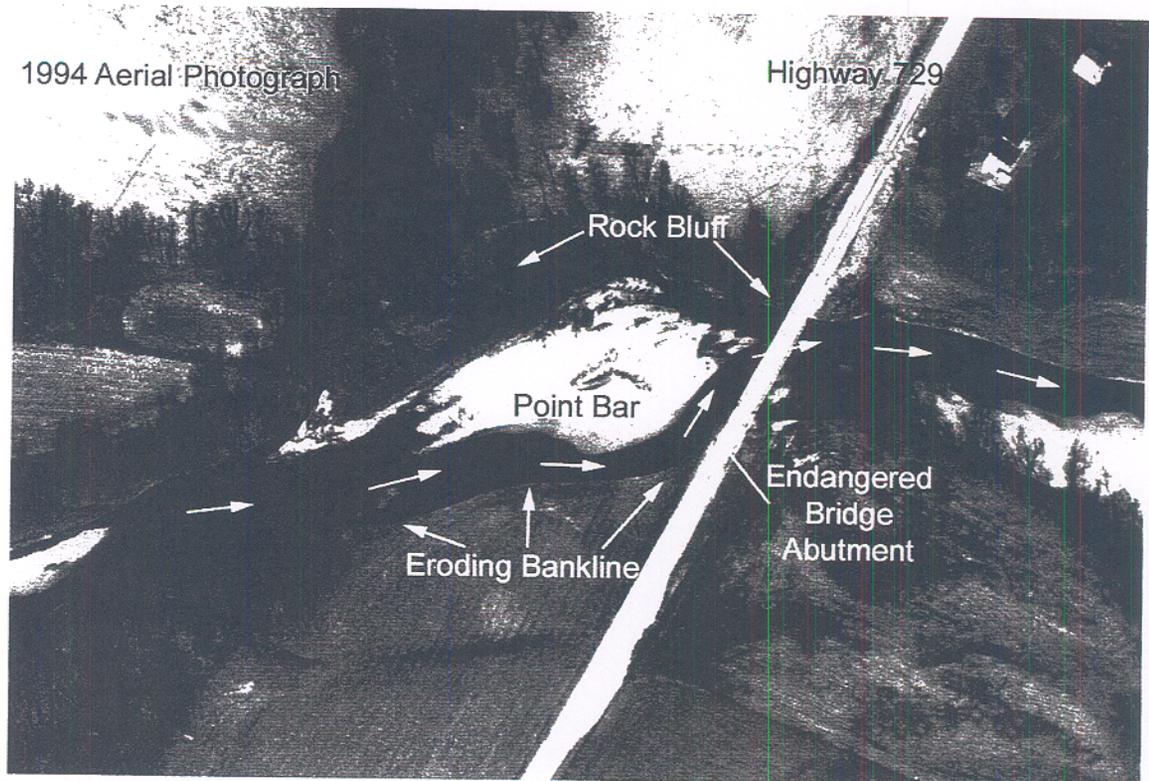
**Figure 1: 1994 Aerial Photograph of Big Creek at Lincoln County Highway 729.**

Figure 1 shows a complete overview of the study conditions. Conditions of the stream in the vicinity of the bridge crossing were described as follows:

- The right descending bank was actively eroding and did not contain any natural vegetation. This feature extended from the bridge abutment to a point 500 feet upstream of the bridge.

- The banks, 500 feet upstream of the bridge, were heavily wooded and stable.
- A large point bar was located along the left descending bank upstream of the bridge. The size and growth of the point bar was directly related to the migration of the right descending bank. This depositional area indicated that the majority of flow was concentrated along the right descending bank.

- The left descending bank immediately upstream of the bridge was a wooded, natural rock bluff line. This condition was evident to a point approximately 400 feet upstream of the bridge.

- The bridge crossing was severely misaligned with the channel thalweg.
- Downstream of the bridge, the right descending bank was heavily vegetated. A small point bar was located along this bank. The majority of flow was concentrated along the left descending bank.

- The left descending bank downstream of the bridge was vertical and devoid of vegetation. This condition was evident from the bridge to approximately 700 feet downstream to a small outcropping of trees.

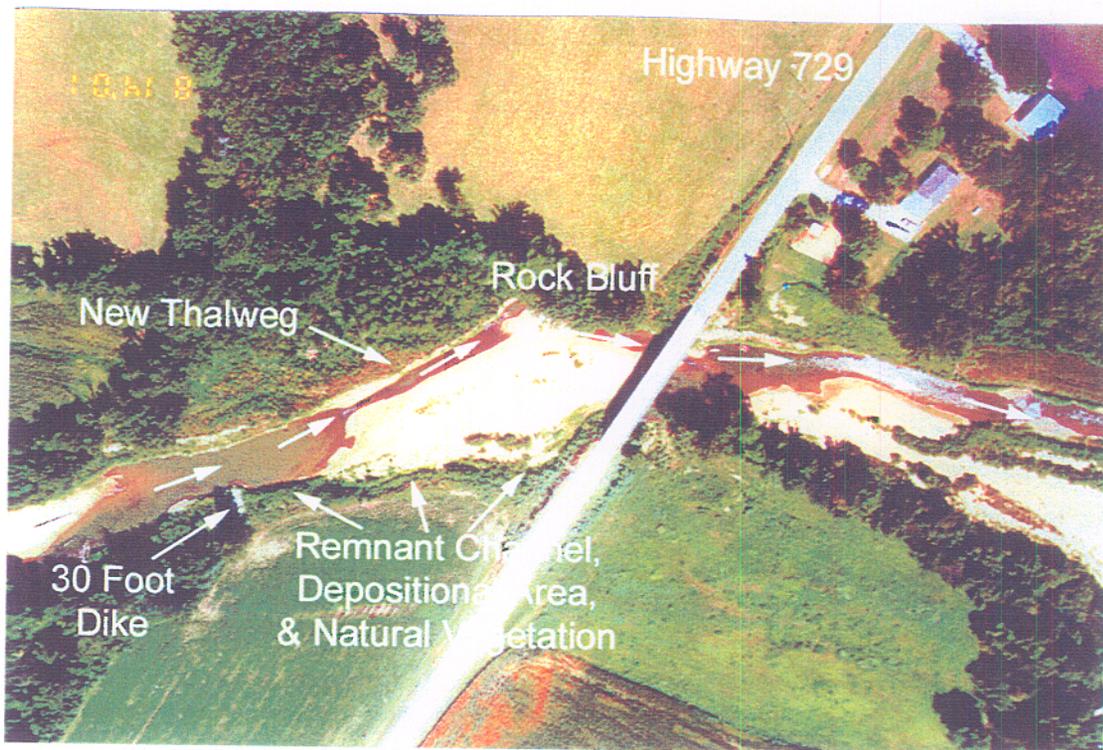
The recommended design was constructed in the summer of 1997. After the first high water event, the streambed demonstrated an began to react immediately. With the passing of each event, the bed configuration continued to develop. Figure 4-2 shows a 2001 aerial photograph of the reach (compare this photo with Figure 4-1). Figure 4-3 shows a photograph taken from the top of the bridge facing upstream before the construction of the dike. Figure 4-4 was taken from the same location 3 years after construction. The photos show a substantial shift of the thalweg from the right descending bank towards the left descending bank. The thalweg cut a new path through the depositional area, which isolated the remnants of the old point bar along the right descending bank. The right descending bank downstream of the dike has begun to naturally repair itself with vegetation. The area near the endangered bridge abutment has filled with sediment, which indicates that it is now a depositional area with slower velocities. Additional maintenance to the bank and bridge abutments after construction has not been required and only periodic monitoring of the streambed has been needed.

**Figure 2: 2001 Aerial Photograph showing Post Construction Response in the Stream**

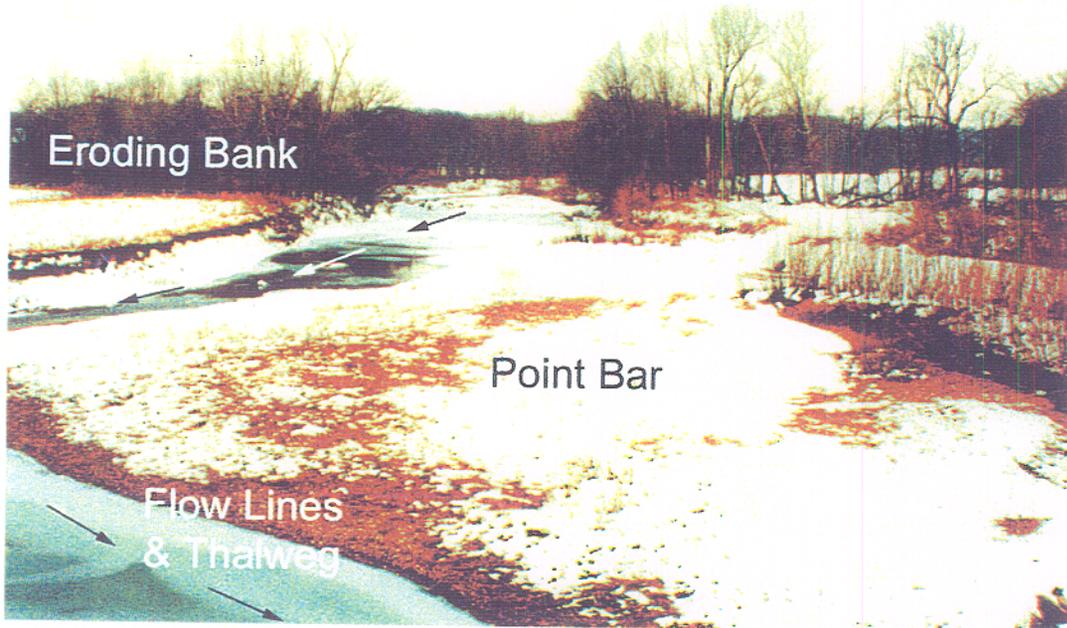
Figure 4-3: 1996 Photograph Looking Upstream from the Bridge Crossing.

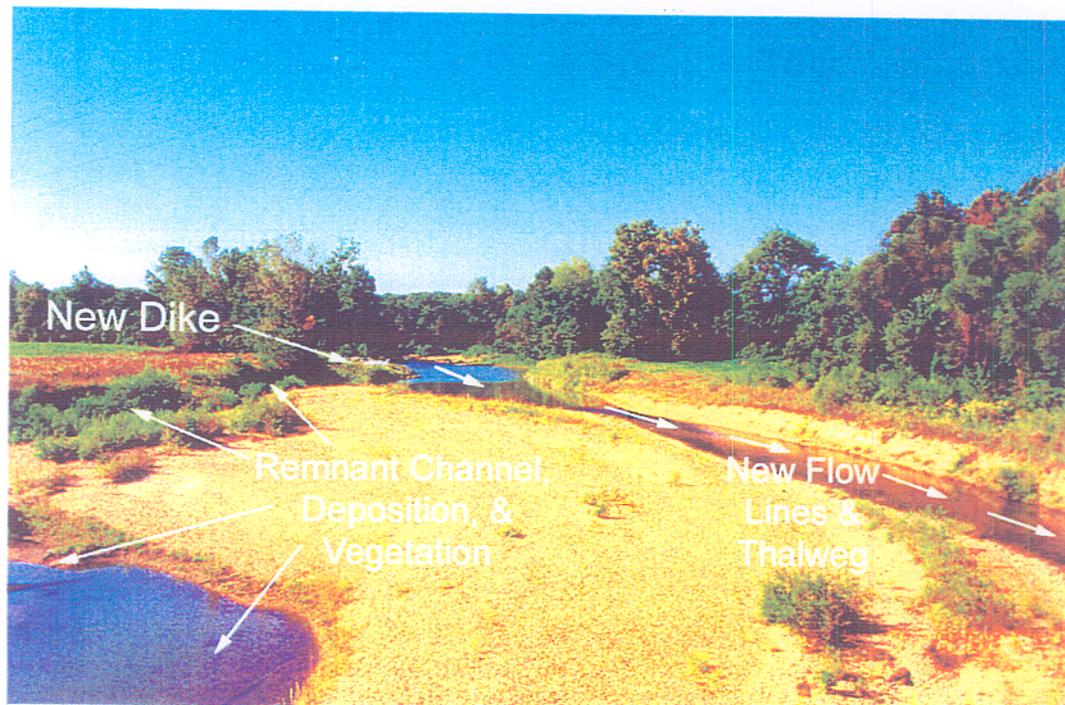
Figure 4-4: 2000 Post Construction Photograph with the Same View as Figure 4-3.
