Johnson Creek, DeSoto County, MS: Fluvial Geomorph Level I Channel Stability Assessment & Reconnaissance Report

Appendix C. Memphis Metropolitan Stormwater – North DeSoto Count Feasibility Study

Christopher P. Haring and David S. Biedenbarn

March 2021

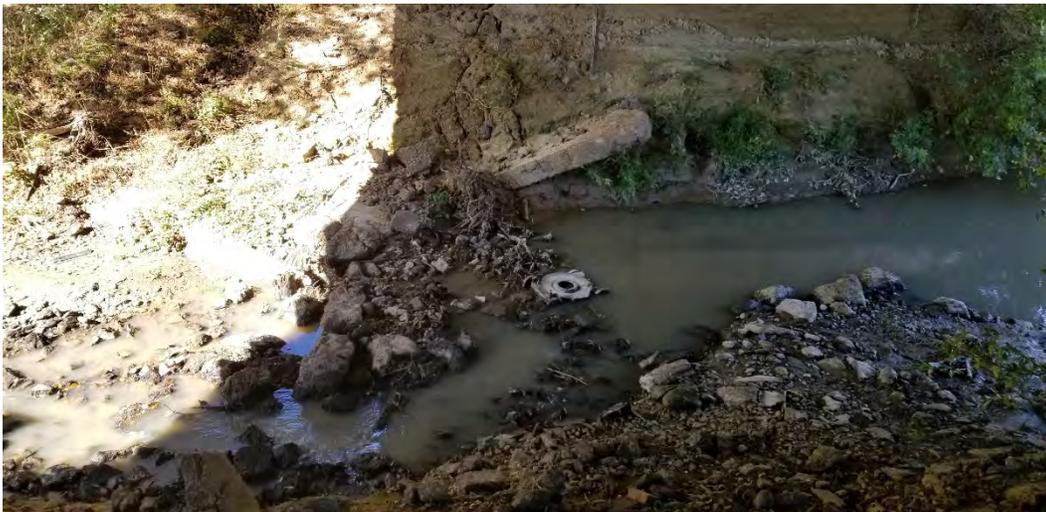
Figure 2. Johnson Creek at Austin Road Bridge showing minimal riprap protection under the bridge.

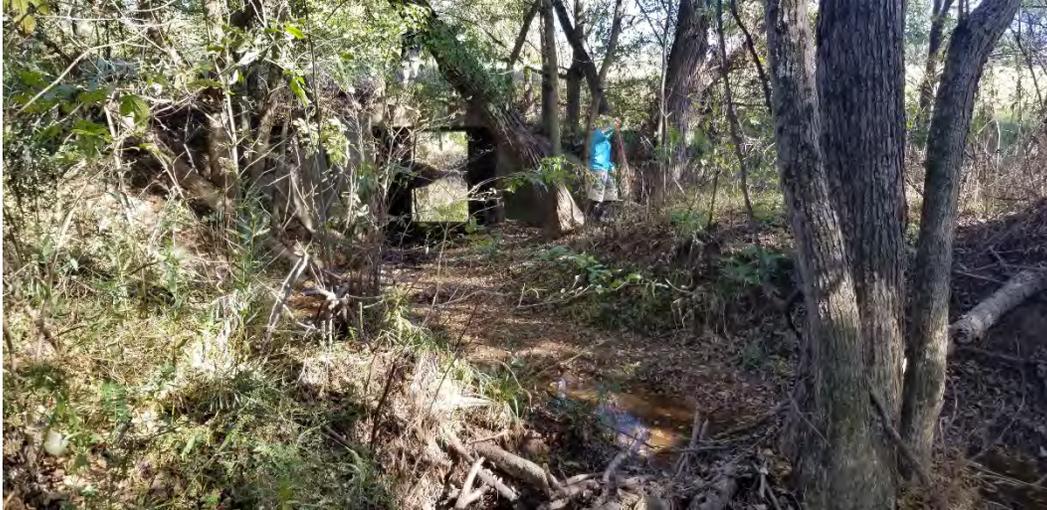
Figure 3. Johnson Creek at State Route 301 Culvert providing grade control.

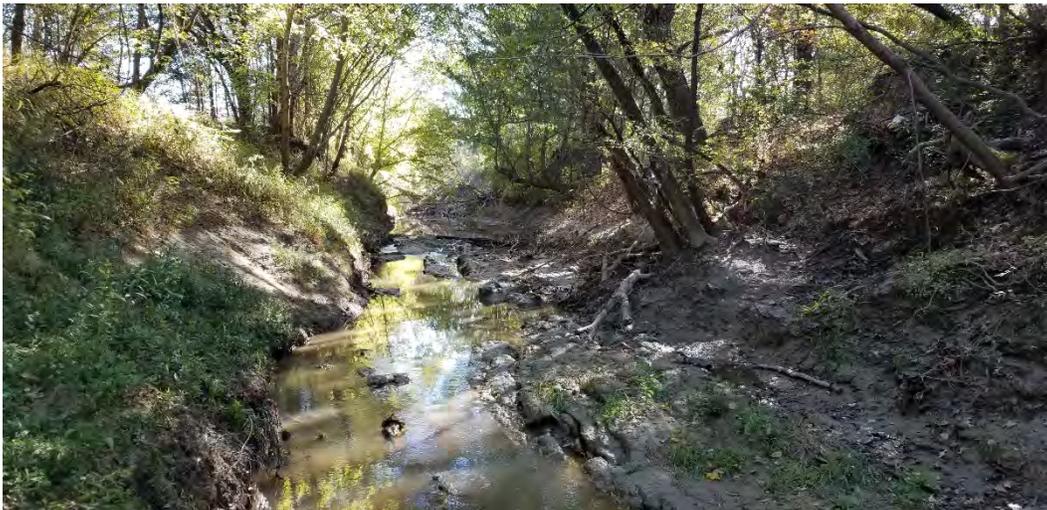
During the site visit on November 4, 2020, the channel sections in proximity to the Baldwin Road Bridge were investigated (Figures 4 and 5). Downstream of the bridge is where the channel slope changes from the low channel slope Mississippi River floodplain materials (Reach 1) to clay, silts and higher channel slope gravel deposits in the upland steeper sloped watershed areas (Reach 2 and 3). Figure 4 illustrates channel degradation that has eroded through some of the less erosion resistant clay bed.

Figure 4. Johnson Creek-Baldwin Road Bridge-looking upstream at degrading channel, trees sliding in on right bank

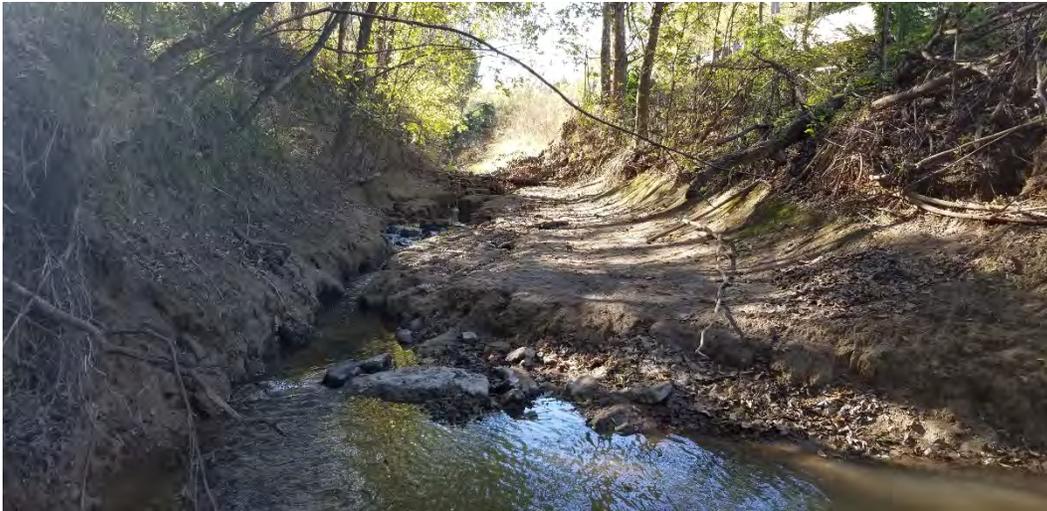
Vegetation is also sloughing in from the channel margins as the channel continues to degrade lowering the base level of the channel. Also illustrated (Figure 5) is the tributary channel that enters Johnson Creek on

Figure 5. Johnson Creek-Baldwin Road Bridge-looking upstream at channel degradation in a tributary immediately upstream of bridge

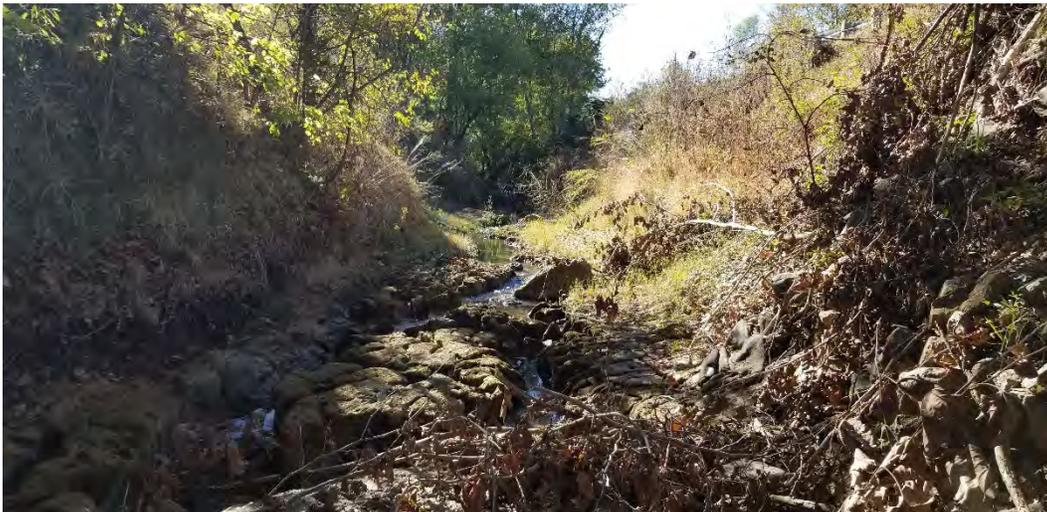
the left bank upstream of the bridge. The top of the degradation can be viewed approximately 100 feet upstream of the confluence with Johnson Creek (Figure 6). If the degradation continues upstream the base level continues to lower and the channel widens. Upstream of this location the tributary is no longer degrading and is relatively stable.

Figure 6. Johnson Creek-Baldwin Road Bridge-looking upstream at channel degradation in a tributary immediately upstream of bridge

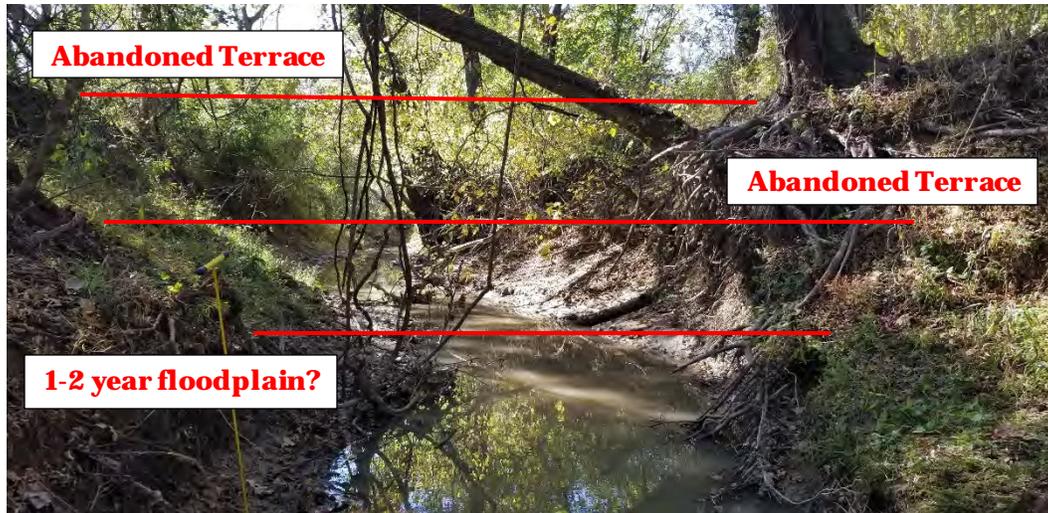
Figure 8. Johnson Creek Cross-section illustrating abandoned terraces and possible 1-2 year floodplain berm development.

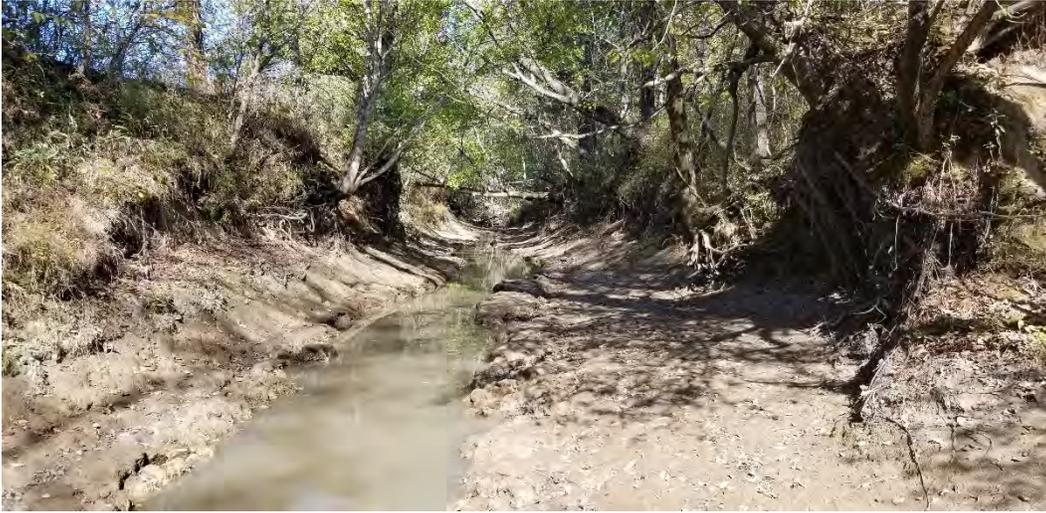
Figure 9. Johnson Creek upstream of Austin Road (Reach 2) showing clay bed with silty and clay loam banks.

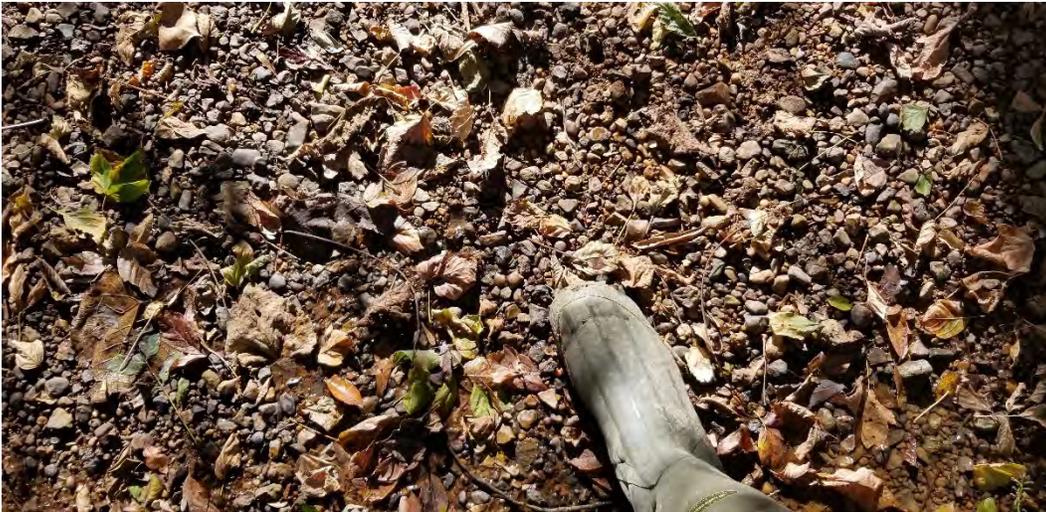
Figure 10. Johnson Creek upstream of State Route 301 culver with point bar material-small gravel to sand in Reach 3

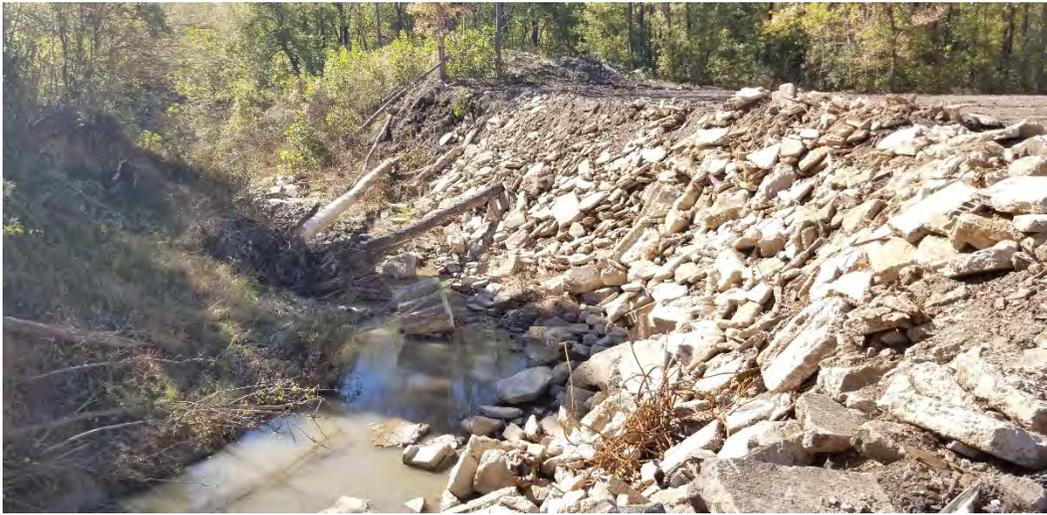
22). There is also a new subdivision that installed revetment materials at another location upstream just south of Odums Crossings Road (Orange Circle in Figures 21 and 22). Johnson Creek at the Odums Crossing subdivision has an extensive amount of concrete and other rubble that has been added to protect right bank erosion (Figure 23). There are also active nick points partially buried by concrete and a visible nick zone downstream of the concrete revetment (Figure 24).

Figure 23. Johnson Creek Reach 2: Concrete bank revetment at Odums Crossings Subdivision

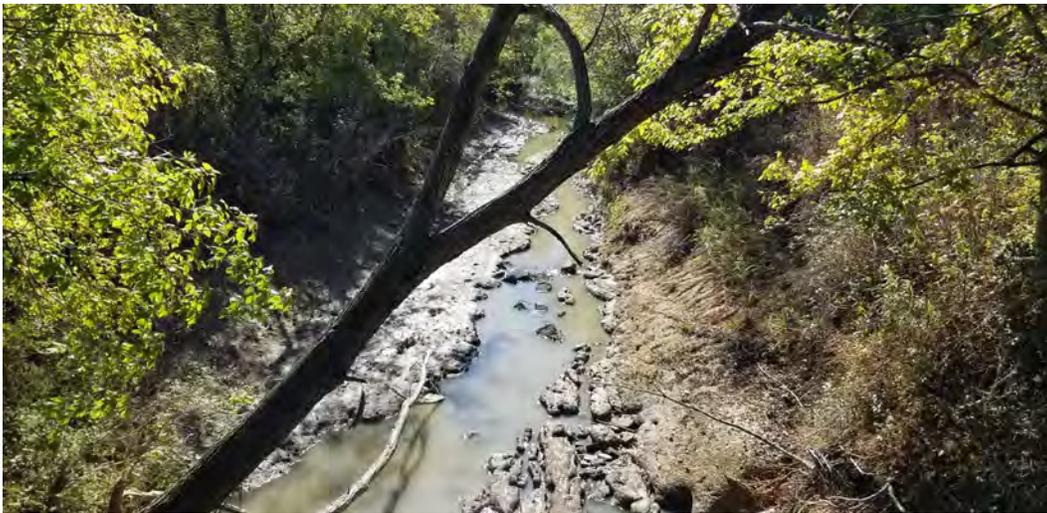
Figure 24. Johnson Creek Reach 2 nick zone located at Odums Crossings Subdivision

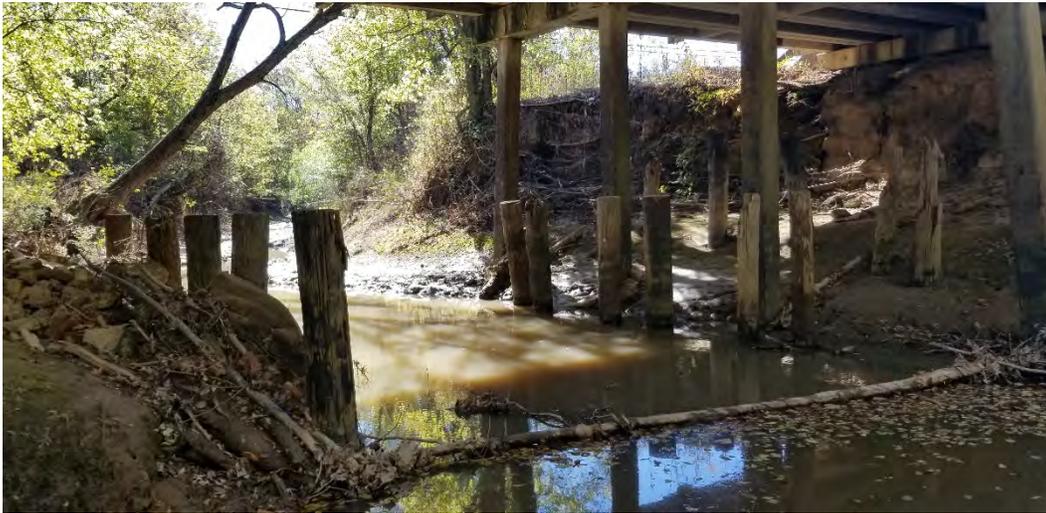
Figure 32. Johnson Creek Reach 3: Limited riprap and concrete bank revetment at the Austin Road Bridge.

- Austin Road Bridge appears to be providing very limited protection with debris present in the channel bottom and margins.
- Limited grade control is provided in the reach by the Highway 301 Road Bridge and the Church Road Culverts. There are no distinct differences between channel stability upstream of Highway 301 and downstream. The Church Road Culverts show signs of channel degradation at the downstream concrete aprons and should be monitored for further degradation and potential undermining.

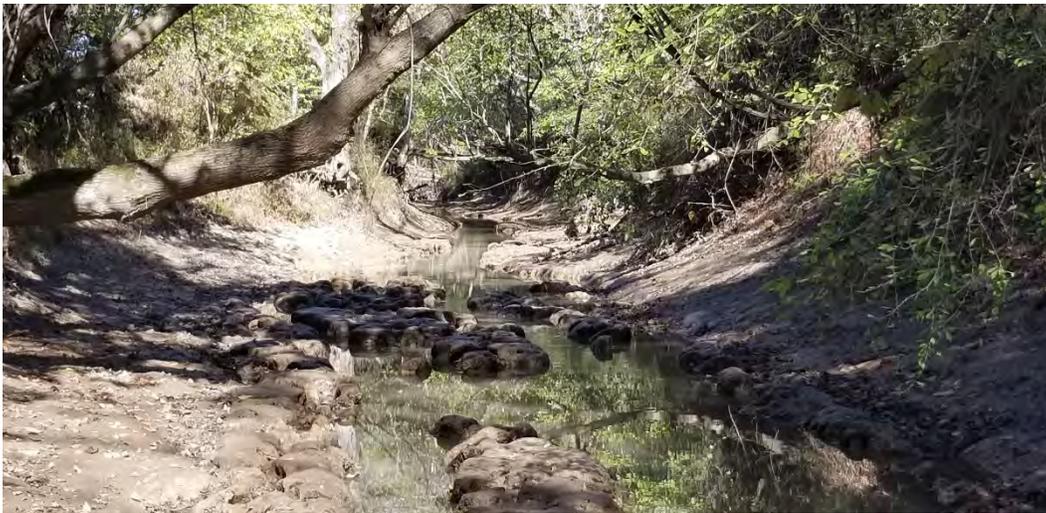
Figure 33. Johnson Creek Reach 3 nick zone located upstream of Austin Road Bridge

- Based on the field site visit, there is conclusive evidence of bed degradation upstream of the Austin Road Bridge. Reach 2 has a degradational trend (CEM II & III) but does have some cohesive, limited erosion resistant clay bed and lower banks that may be

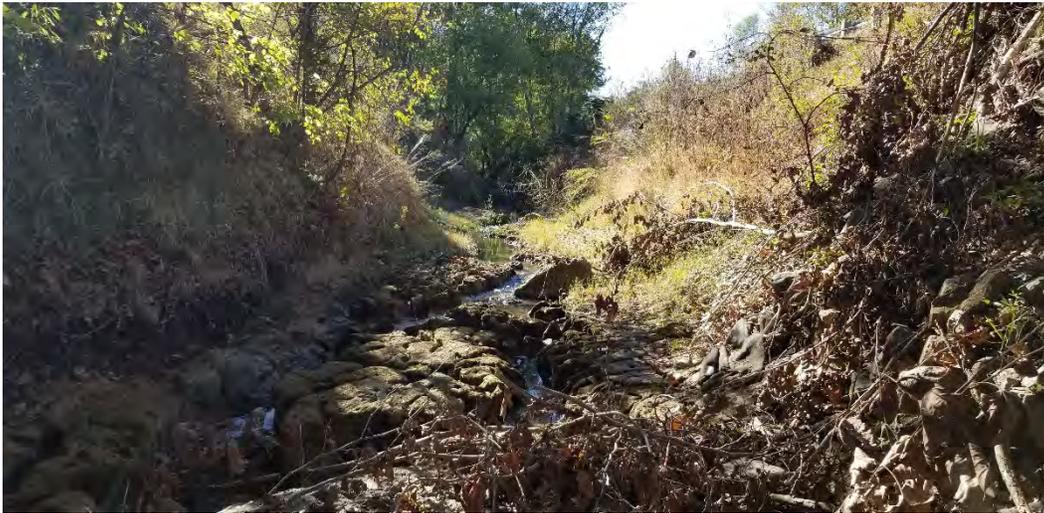
- Based on the field site visit, there is conclusive evidence of bed degradation upstream of the Baldwin Road Bridge. Based on the profile information there is likely more degradation that will work upstream into the bridge area causing further channel instability. The mid and upper Reach 2 is in a CEM Stage II-III. The section has a degradational trend (CEM II & III) but does have some cohesive, limited erosion resistant clay bed and lower banks that may be effectively locking the channel in place in certain areas within the reach. Some form of grade stabilization is required before bank stabilization should be attempted.

Figure 41. Johnson Creek upstream of Baldwin Road Bridge illustrating tributary erosion.

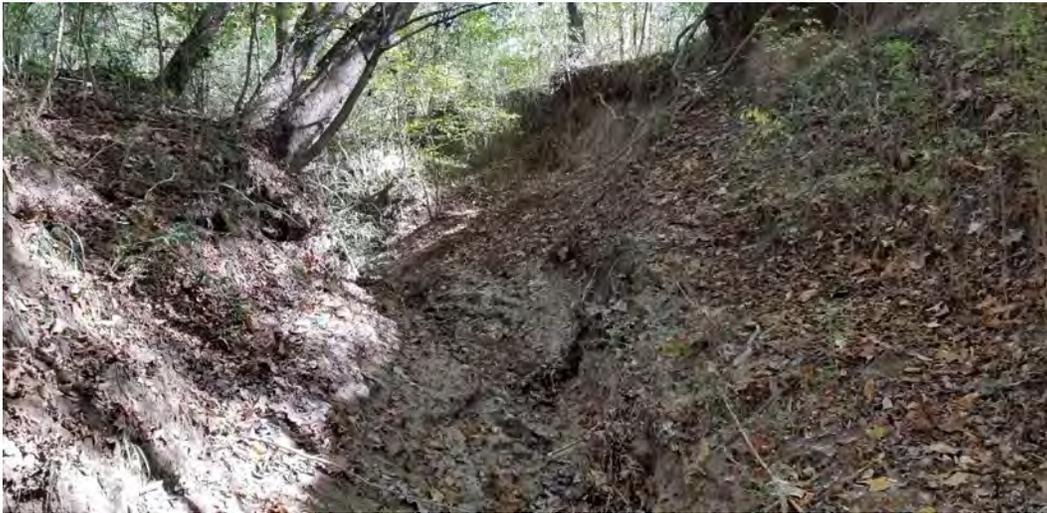
- There is widespread tributary and small drainage channel instability along the margins, adjacent to the stream channel form the continued degradation of the main Johnson Creek channel (Figure 42). As the channel continues to degrade the tributaries and drainage ditches will adjust to a new base level and erode deeper and widen out as par to the continued channel evolution process. As part of the Johnson Creek restoration and stabilization plan, additional analysis is required to treat the areas throughout the watershed.

Figure 42. Johnson Creek upstream of Austin Road Bridge illustrating gully formation from agricultural field runoff.

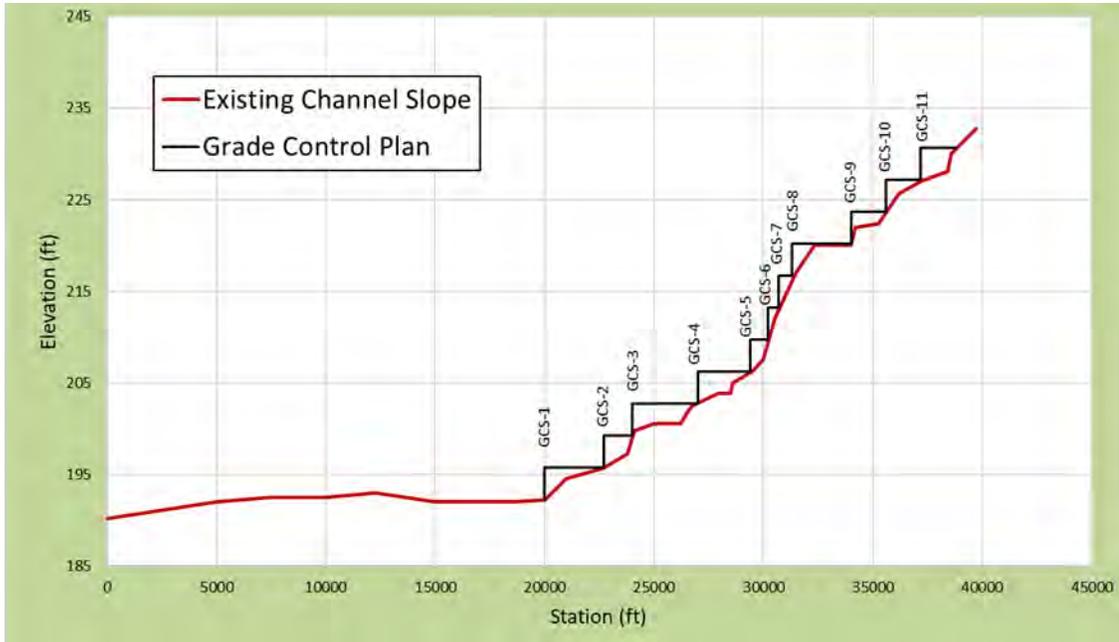
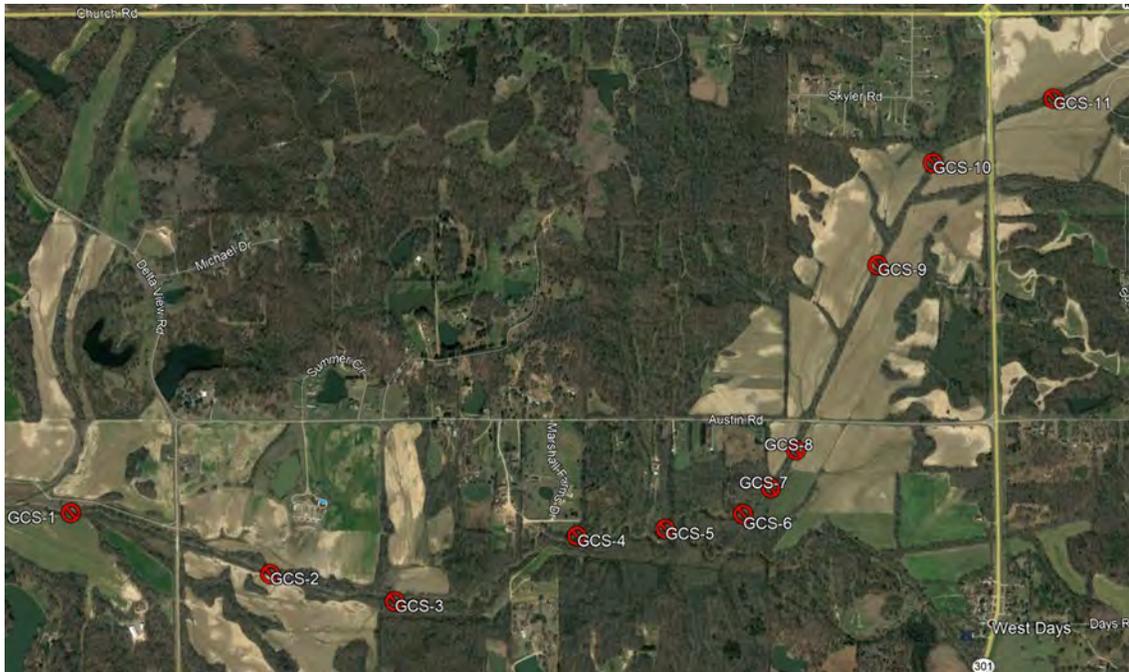
Figure 46. Grade Control Plan for Johnson Creek-Reach 2 Profile Plot

Figure 47. Grade Control Plan for Johnson Creek-Reach 2 Planview Map

of sloping rock grade control structures is recommended. For this plan it was simply assumed that each structure would have a 3.5-foot drop with a flat pool upstream which would provide a tailwater for the next upstream structure. Figures 46 and 47 show the tentative locations of these 11 proposed structures proposed. Again, it must be emphasized that this is a conservative assessment and that the final locations, heights and number of structures could vary considerable after a more thorough analysis.

A total of 11 new grade control structures and approximately 6,300 feet of bank stabilization are recommended (Table 1). In addition, a woody riparian zone of approximately 6,000 feet is proposed. Grade control structures described in this report are sloping loose rock riprap structures, and bank stabilization structures will be assumed to longitudinal stone toe protection with tiebacks.
