## **Draft: Nolehoe Creek, DeSoto County, MS: Fluvial Geomorph Level I Channel Stability Assessment & Reconnaissance Report**

Appendix C. Memphis Metropolitan Stormwater – North DeSoto Count Feasibility Study

Christopher P. Haring and David S. Biedenbarn

March 2021

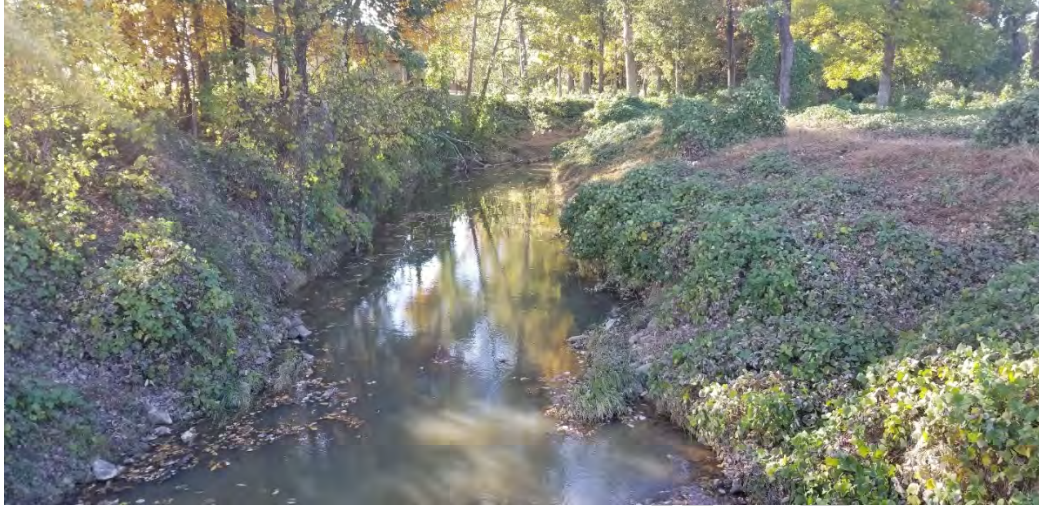
**Figure 3. Nolehoe Creek-Malone Street culvert-looking upstream at stable channel**

The culverts at Malone and Pleasant Hill Roads have helped stabilize the stream system in those locations by providing bed control to a trending degradational channel system.

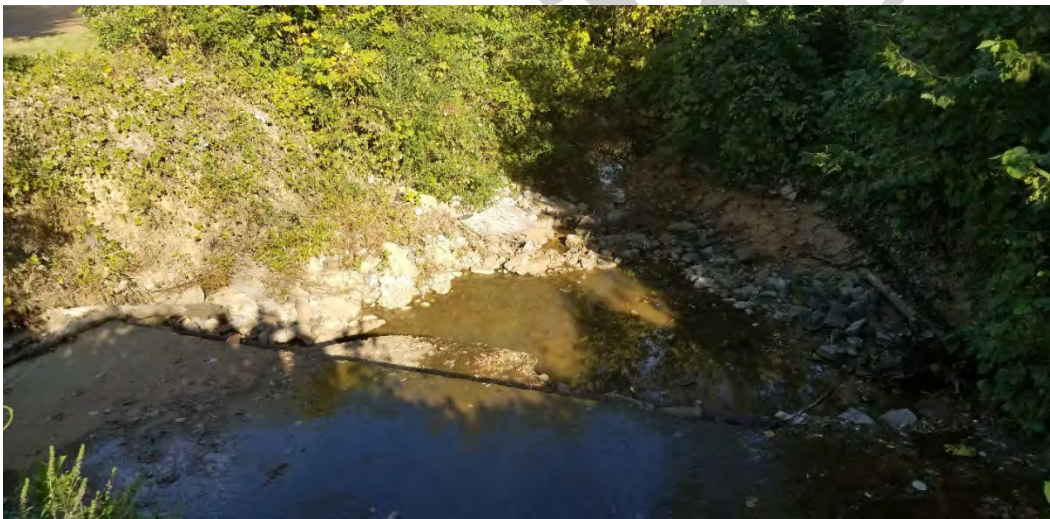
**Figure 4. Nolehoe Creek-Malone Street culvert-looking downstream at channel degradation**

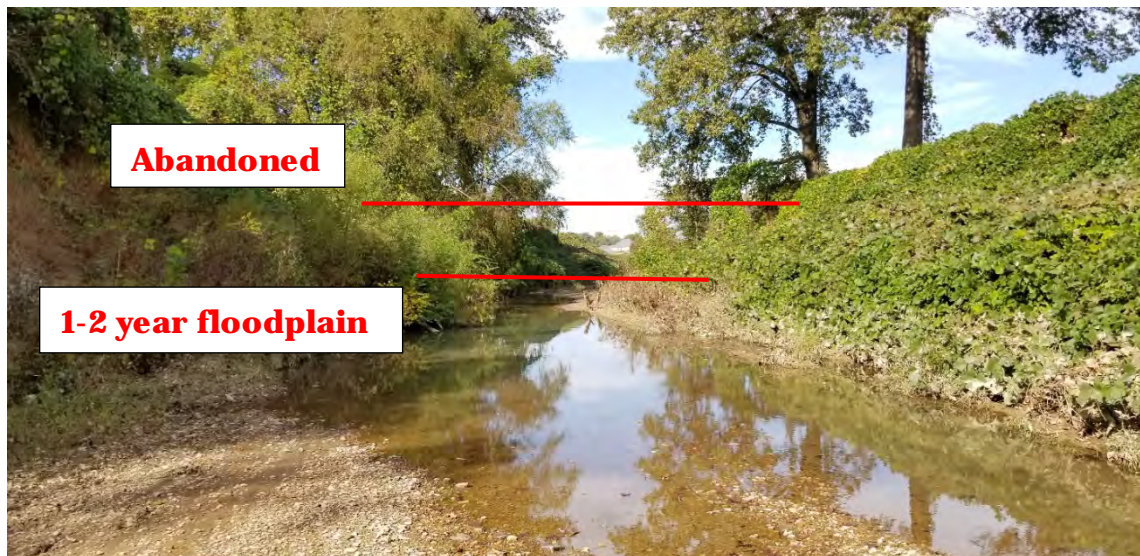
roadways, utilities. The changes impact soil infiltration and runoff rates changing the characteristic delivery of sediment and hydrologic discharge regimes throughout the watershed. If not mitigated, the changes typically lead to a process of channel bed incision followed by widening and floodplain re-development. The process is outlined in the CEM diagram in Figure 5 and the multiple floodplain terraces defined in Figure 6 provide evidence for the process.

Figure 6. Nolehoe Creek Cross-section facing upstream approximately 1,800 ft from Camp Creek confluence

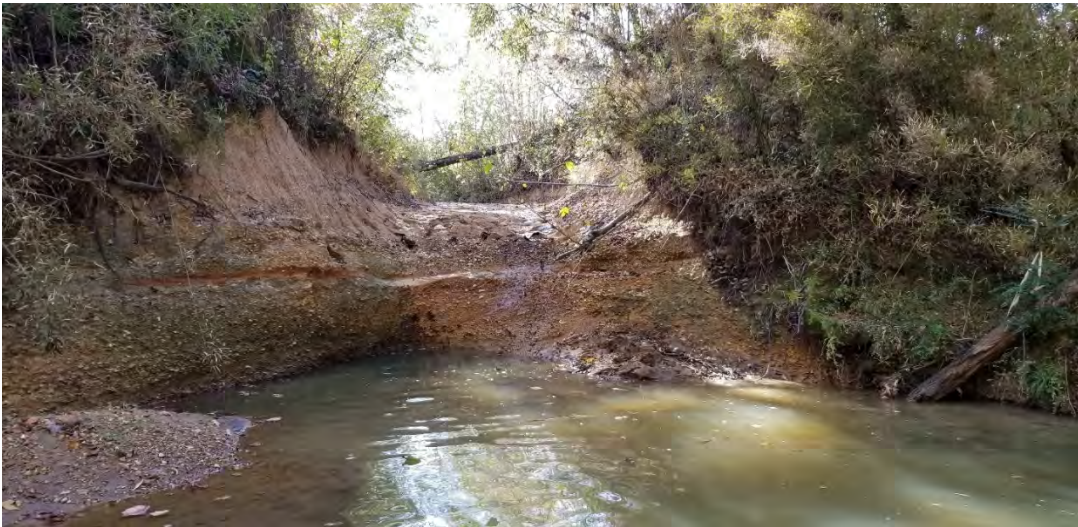
Figure 10. Nolehoe Nolehoe Creek right bank tributary outlet approximately 1,000 ft upstream of Pleasant Hill Road

Figures 7, 9, and 10 had largely interbedded gravel deposits with a compact hard clay matrix. The deposits were especially erosion resistant (Figures 9 and 10) located in Reach 2 where there was a blacktop looking unit directly over a hard-red clay.

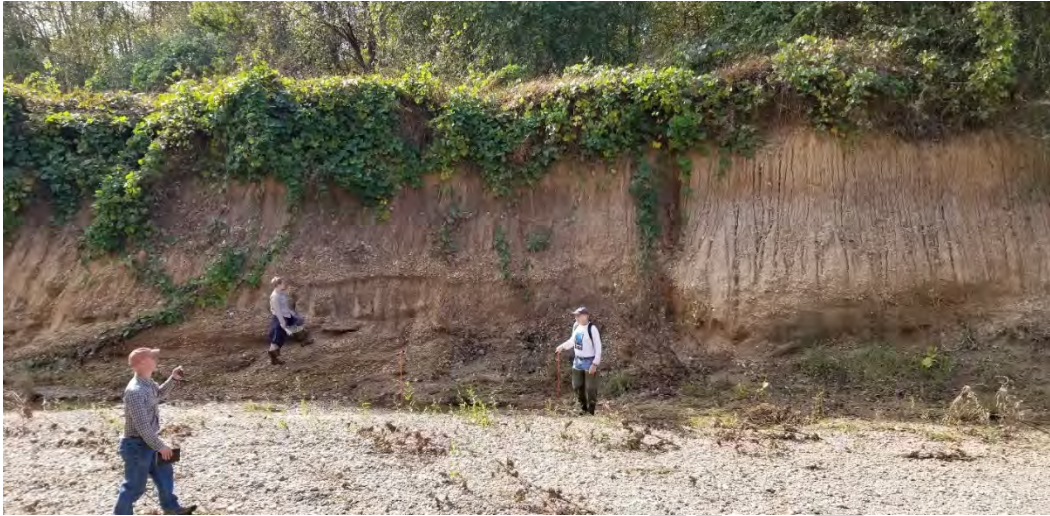
Figure 29. Nolehoe Creek right bank erosion site with large point bar
