Horn Lake Creek Stabilization Plan

Appendix C. Memphis Metropolitan Stormwater – North DeSoto Count Feasibility Study

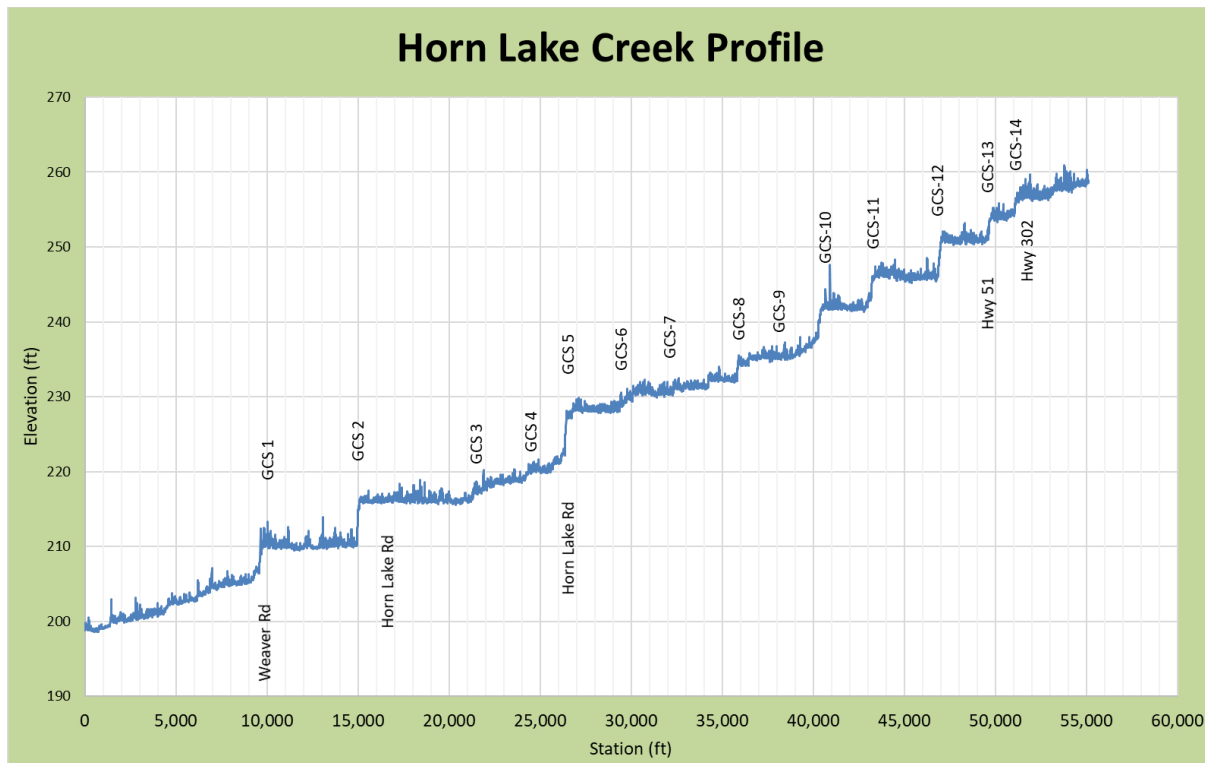
Figure 1. Horn Lake Creek LiDAR Profile with grade control locations

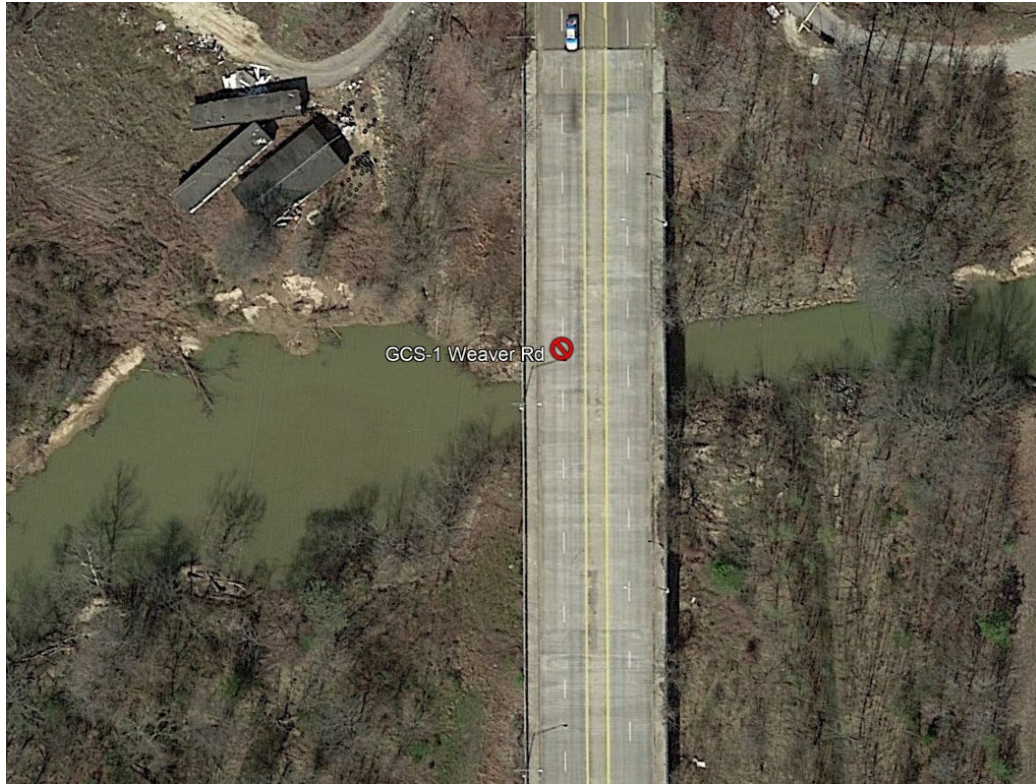
GCS-1 (Weaver Rd). Google Earth imagery indicates that there is a riprap structure through the bridge section (Figure 2). As shown in Figure 1, there is about a 4 to 6 foot drop through this structure. Although no field investigation was conducted here, it appears that a large scour hole has developed downstream of the structure (Figure 2). Consideration should be given to providing protection of this scour hole. Although no direct observations are available for the riprap structure itself, it is likely, based on inspections of similar structures in the system that repairs would be needed.

Figure 2. GCS-1 at Weaver Road

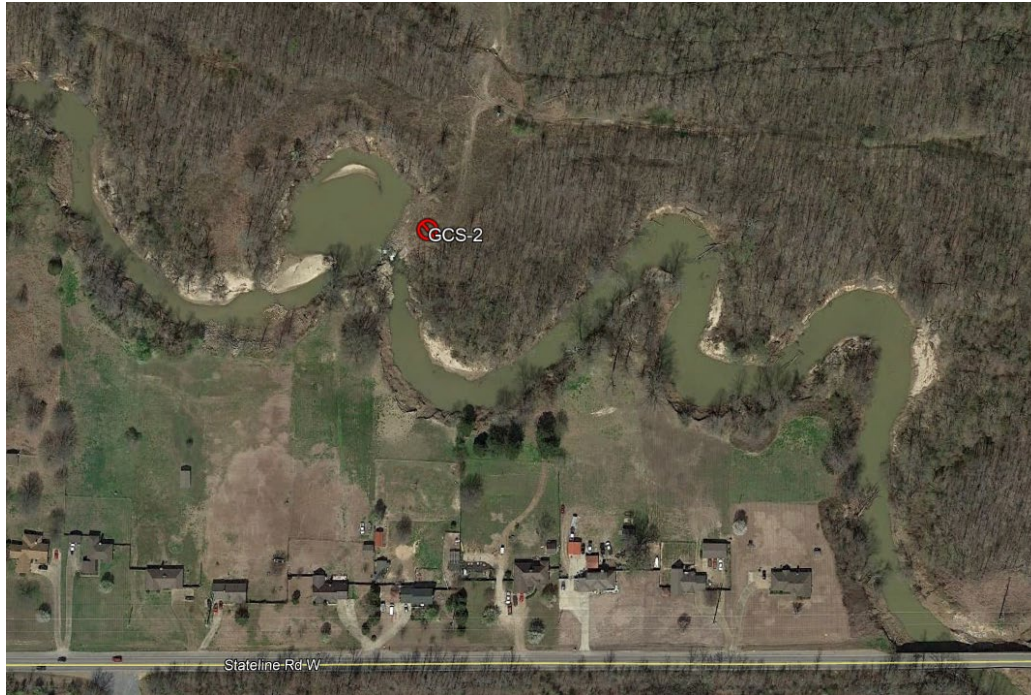
GCS-2 (Downstream of Stateline Rd). There is an existing riprap structure about 2,000 feet downstream of the Stateline Road. According to Figure 1, there is about 6 to 7 feet of drop at this structure. Unfortunately, there is severe erosion both upstream and downstream that is threatening to flank this structure (Figure 3). Failure of this structure would significantly destabilize the upstream channel system. Therefore, this structure needs to be repaired or probably replaced entirely. For this assessment it will be assumed that the structure should be replaced with a new structure. The final location of the proposed grade control structure is not known at this time, but, regardless of the location, it is likely that several of the actively migrating meander bends in this reach will need to be stabilized as part of the rehabilitation effort. Approximately 2,000 feet of bank stabilization is estimated for this site.

Figure 3. GCS-2 downstream of Stateline Road.

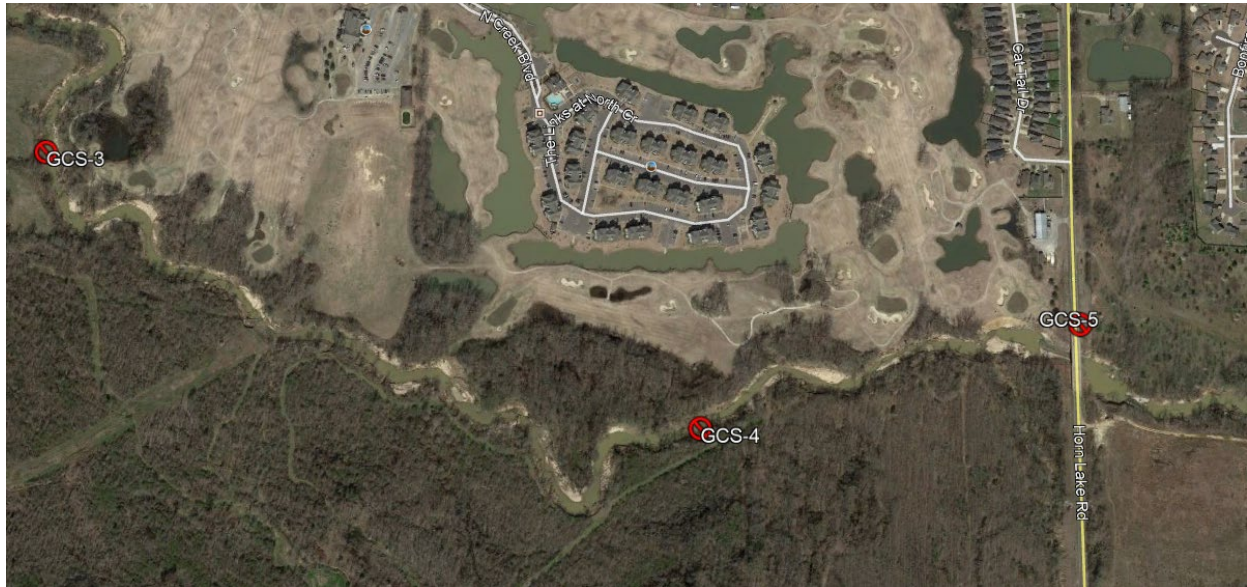
GCS-3, 4, and 5. There is a sloping riprap grade control structure under the Horn Lake Rd bridge with a huge scour hole downstream. This will be designated GCS-5. While there is some riprap along this scour hole, this structure need to be extended by about 150 to 200 feet downstream. Additional stone may also be needed along the sloping rock structure itself.

There is also another sloping rock type structure about 200 feet upstream of the bridge. There is a huge unprotected scour hole downstream of this structure. This scour hole need to be stabilized to ensure the integrity of the road. The existing sloping rock structure also appears to be in danger of being flanked. Therefore, this structure needs to be repaired, or replaced. For this assessment it will be assumed that the structure should be replaced with a new structure, which will be called GCS-5a. Additionally, about 800 feet of bank stabilization may be required upstream of the structure to ensure its integrity.

According to Google Earth imagery, there are no existing structures between GCS-2 and GCS-5. However, according to the Lidar survey there does appear to be a somewhat oversteepened zones in this reach which could be degradational. Inspection of Google Earth imagery revealed that there are numerous areas with significant bank instability. For this reason, two additional grade control structures (GCS-3 and GCS-4) are recommended in order to provide stability for this reach, and to help protect GCS-6. The drop heights at these two structures will likely be in the 3 foot range. A more detailed field and geomorphic assessment will be required to site GCS-3 and GCS-4, but approximate locations of these structures, as well as for GCS-5 are shown in Figure 3. Approximately 3,000 feet of bank stabilization may be required as part of the GCS-3 and GCS-4 efforts.

Figure 3. GCS- 3, 4, and 5

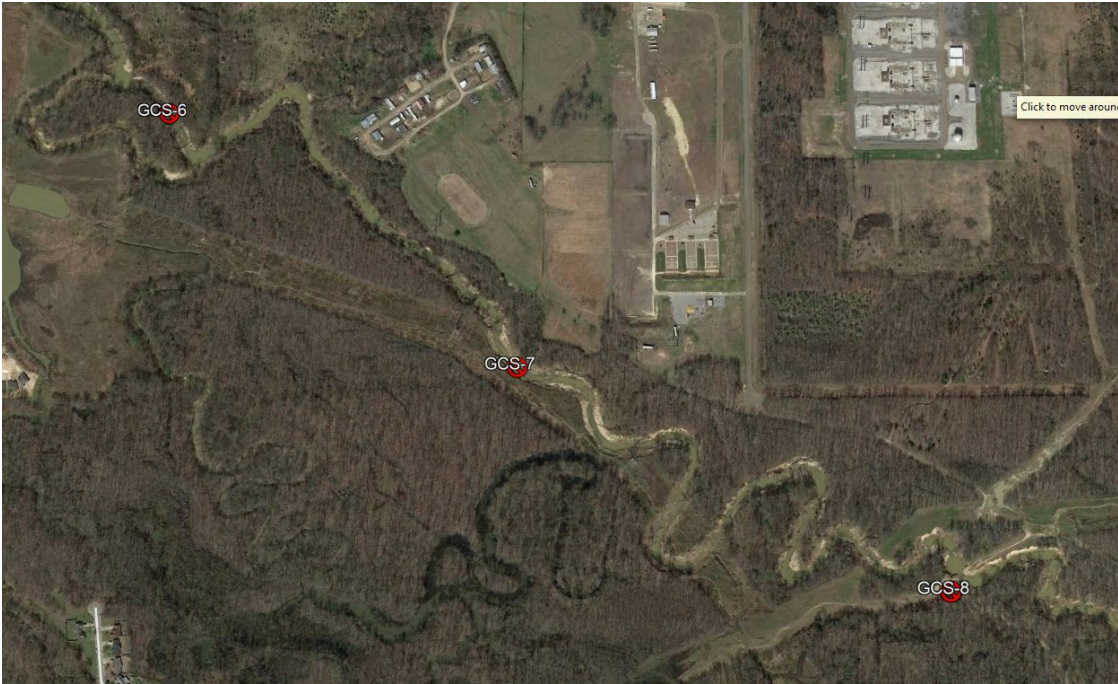
GCS-6, 7 and 8. There is an existing rock structure at the GCS-8 site that is holding about 2 to 3 feet of grade. It is not clear as to the exact function of this structure, but it may be a low water crossing built by locals. There is considerable bank erosion both upstream and downstream of this structure that needs to be stabilized in order to prevent the total loss of this structure. This structure needs to be rehabilitated, or more likely completely replaced with an engineered grade control structure. For this assessment it will be assumed that the structure should be replaced with a new structure. Approximately 2,200 feet of bank stabilization will be required to protect this structure.

According to Google Earth imagery, there are no existing structures between GCS-5 and GCS-8. However, according to the Lidar survey there does appear to be some oversteepened zones in this reach which could be degradational. Additionally, close inspection of Google Earth imagery revealed what appeared to be clay outcrops in this reach. For this reason, two additional grade control structures (GCS-6 and GCS-7) are recommended in order to provide stability for this reach, and to help protect GCS-8. The drop heights at these two structures will likely be in the 3 foot range. A more detailed field and geomorphic assessment will be required to site GCS-6 and GCS-7, but approximate locations of these structures, as well as for GCS-8 are shown in Figure 4. Approximately 3,000 feet of bank stabilization may be required as part of the GCS-6 and GCS-7 efforts.

Figure 4. Approximate locations of GCS- 6, 7, and 8.

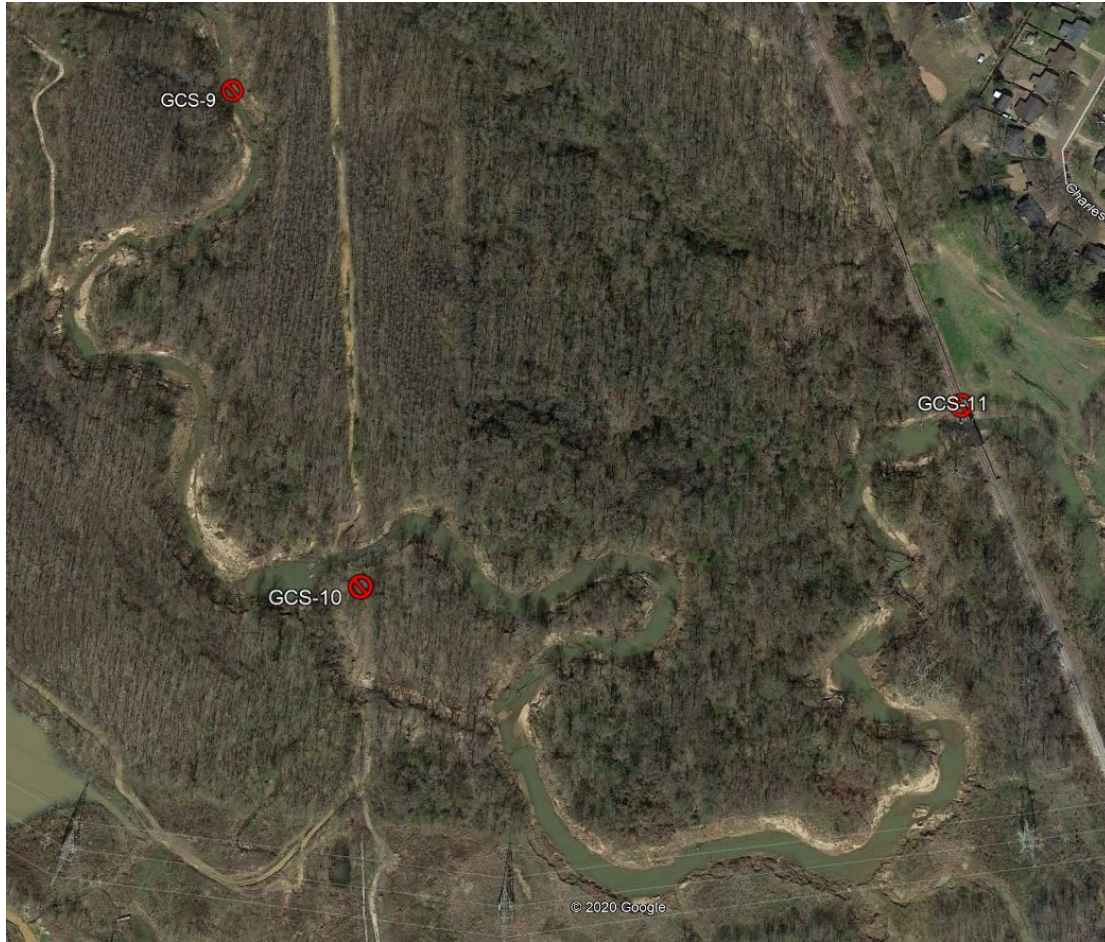
GCS-9, and 10. There is an existing rock structure at GCS-10. According to the Lidar profile, there is approximately 4 to 5 feet of drop at this structure. The purpose of this structure is not known, but it appears to be crossing location. There is considerable erosion both upstream and downstream of this structure and there is some potential for this structure to be flanked. For this reason, this structure needs rehabilitated or possible replaced. For this assessment it will be assumed that the structure should be replaced with a new structure. Approximately 2,500 feet of bank stabilization will be required at this site.

Immediately downstream of GCS-10, there appears to be a very steep zone on the Lidar profile, and what appeared to be clay was observed in the bed on Google Earth imagery. For this reason, an additional structure is proposed downstream at GCS-9. The drop height for this structure will likely be in the 3 foot range. The exact location for GCS-9 will require additional studies, but the approximate location is shown in Figure 5, along with GCS-10. Approximately 1,200 feet of bank stabilization will be required in the vicinity of GCS-9.

GCS-11. GCS-11 is located at a railroad crossing about 3,000 feet upstream of GCS-10. (Figure 5). There appears to be a 4 to 5 feet of drop at this structure (Figure 1). Although this site was not inspected as part of the field investigations, it is assumed that some rehabilitation and reinforcement of this structure will be required. An estimated 1,000 feet of bank stabilization may also be required here to protect the integrity of the structure.

Figure 5. Approximate locations of GCS-9, 10, and 11.

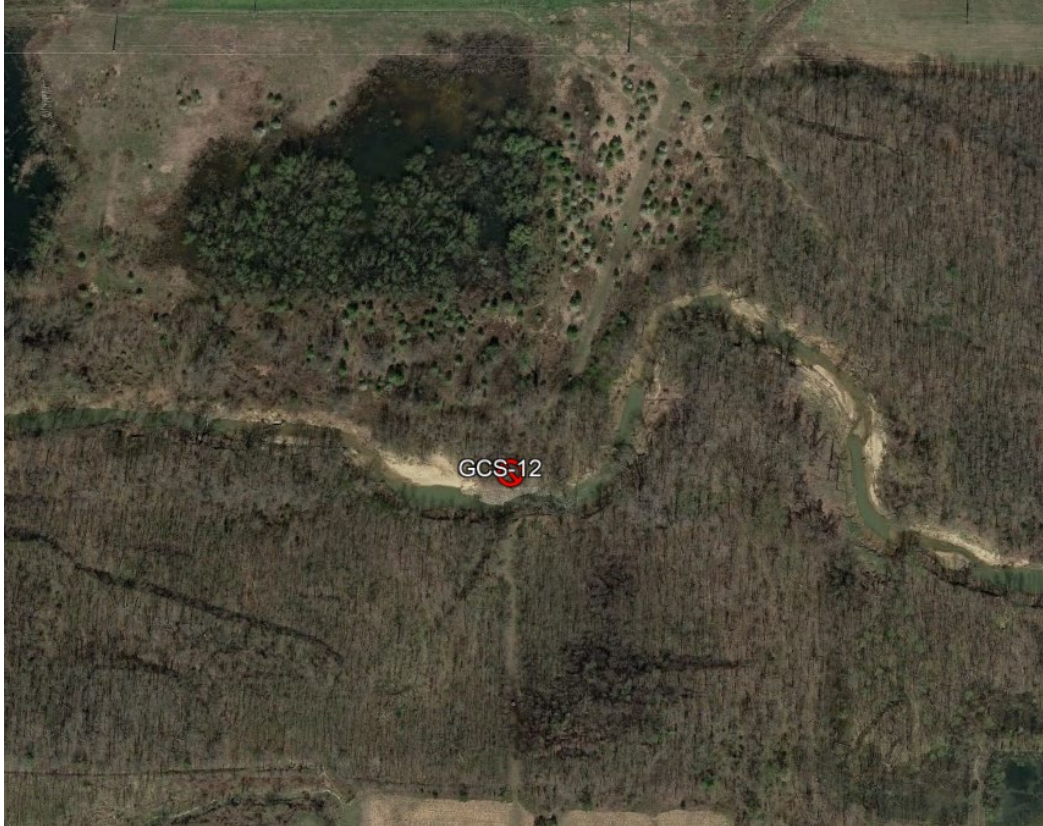
Figure 6. GCS-12

GCS-12. There is an existing rock structure at this site (Figure 6). The purpose of this structure is not known, but may be some sort of low water crossing. This structure appears to be in danger of failing, and there is bank erosion both upstream and downstream of the structure. This structure will need to be rehabilitated or more likely replaced. For this assessment it will be assumed that the structure should be replaced with a new structure. An estimated 1,500 feet of bank stabilization may also be required here.

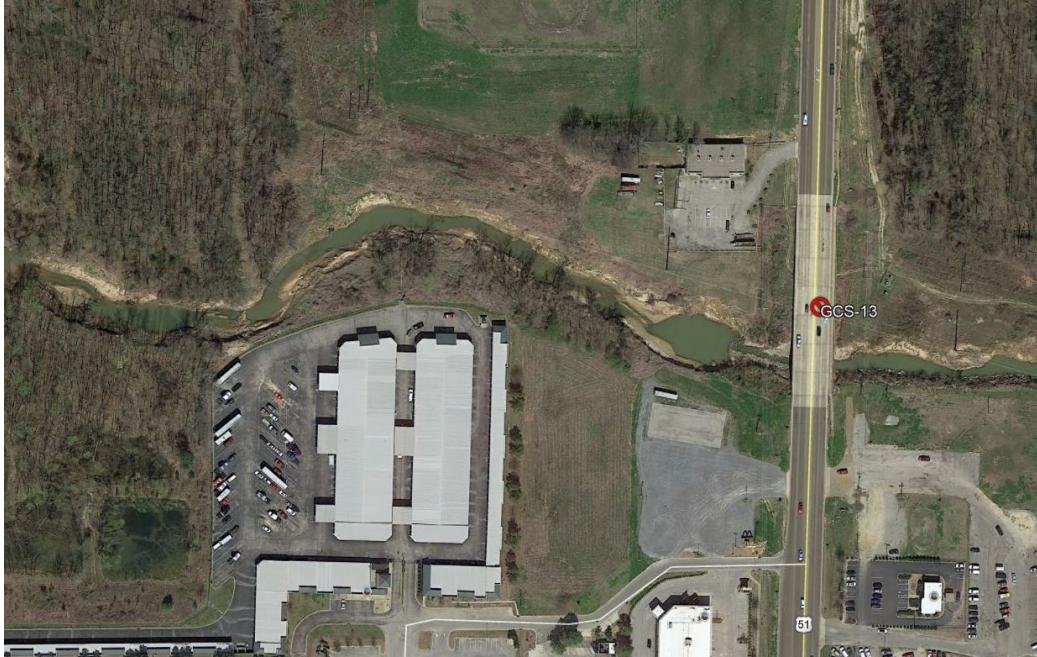
Figure 7. GCS-13.

GCS-13. There is an existing sloping rock structure at the Hwy 51 bridge with a drop of about 4 feet (Figure 7). There is a large scour hole downstream of the structure that has recently been protected with a longitudinal stone toe and tiebacks. This structure appears to be relatively stable at this time, but a more detailed inspection of the structure may reveal the need for some additional repair work. Additionally, there are some bank erosion sites in this area, including some erosion that appears to be endangering some commercial buildings. that may require stabilization. An estimate of 1,000 feet of bank stabilization will be required.

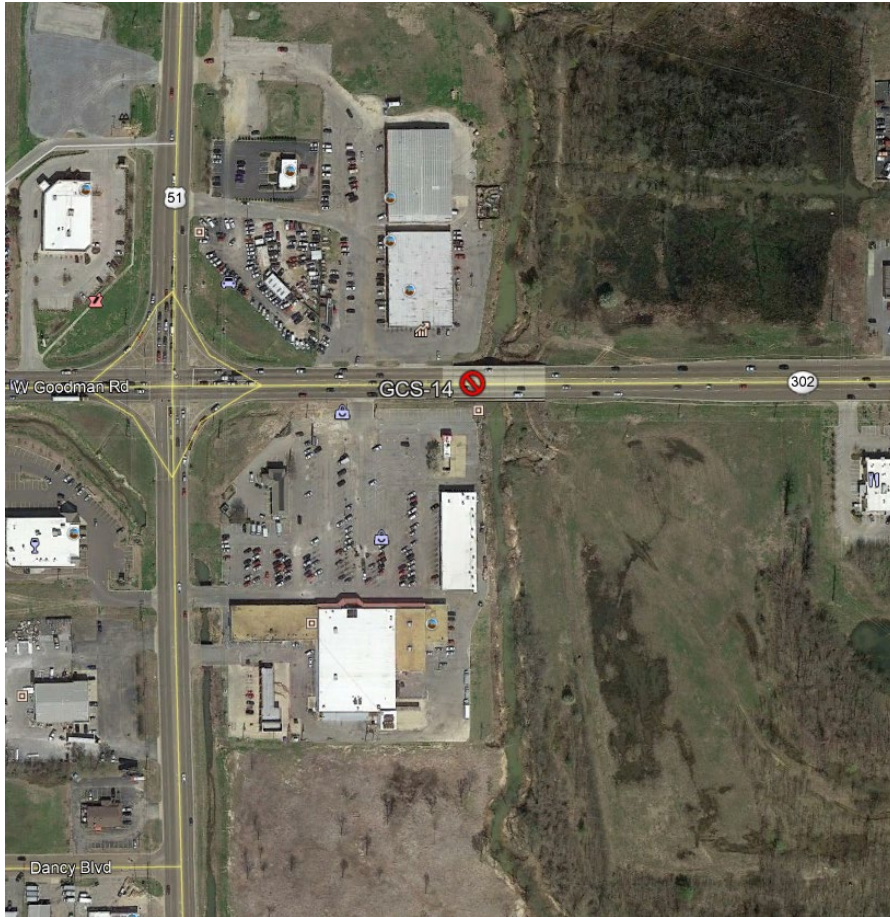
Figure 8. GCS-14.

GCS-14. There is an existing sloping rock structure at the Hwy 302 bridge with a drop of about 4 feet (Figure 8). Since there was no visual inspection at this site, the integrity of the structure is not known, but it is assumed that some repair will be needed. Additionally, there is a large scour hole downstream of the structure that will need to be stabilized. There also appears to be some bank erosion along the stream both upstream and downstream of the bridge that may be endangering numerous commercial buildings. Approximately 1,500 feet of bank stabilization may be required here in addition to the repairs at the structure.
