Draft: Nolehoe Creek, DeSoto County, MS: Fluvial Geomorph Level I Channel Stability Assessment & Reconnaissance Report

Appendix C. Memphis Metropolitan Stormwater – North DeSoto Count Feasibility Study

Christopher P. Haring and David S. Biedenbarn

March 2021

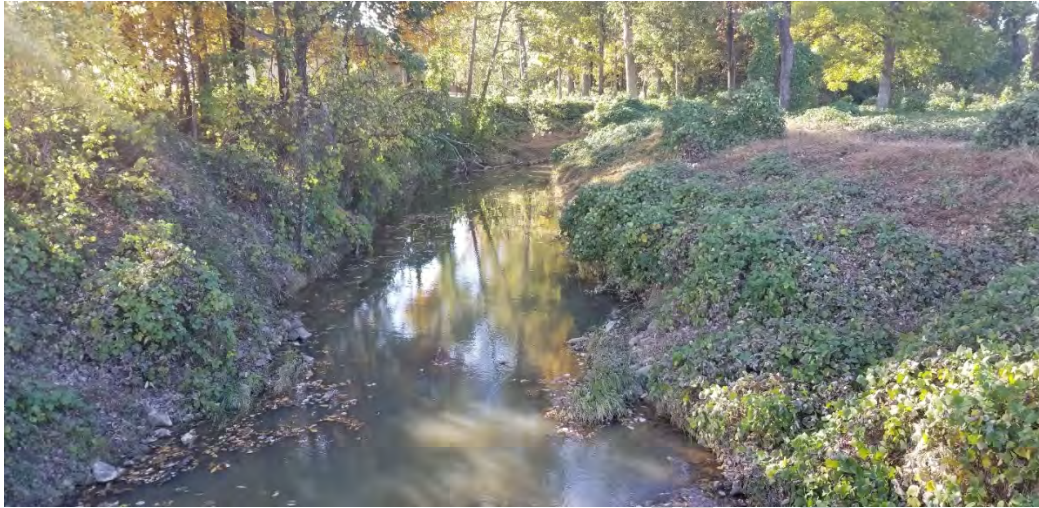
Figure 3. Nolehoe Creek-Malone Street culvert-looking upstream at stable channel

The culverts at Malone and Pleasant Hill Roads have helped stabilize the stream system in those locations by providing bed control to a trending degradational channel system.

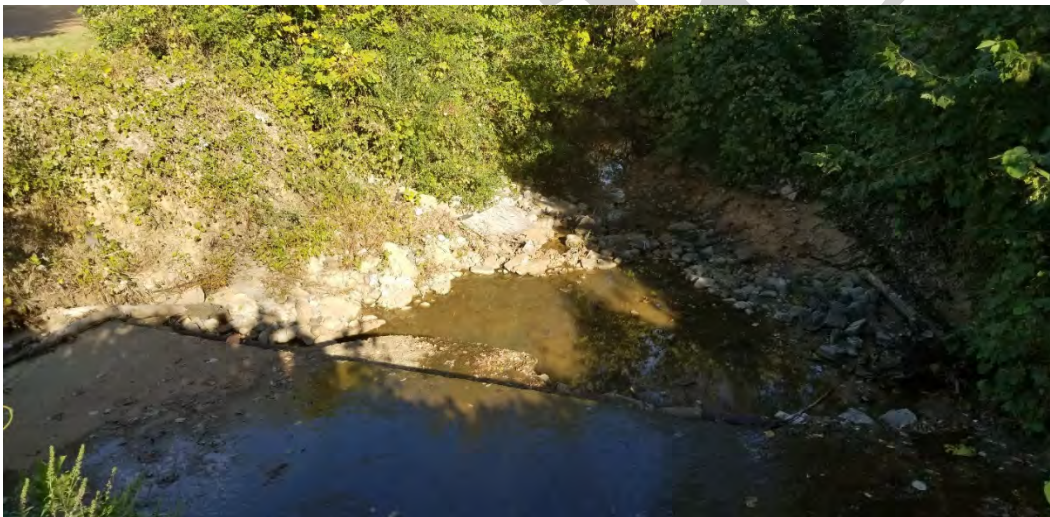
Figure 4. Nolehoe Creek-Malone Street culvert-looking downstream at channel degradation

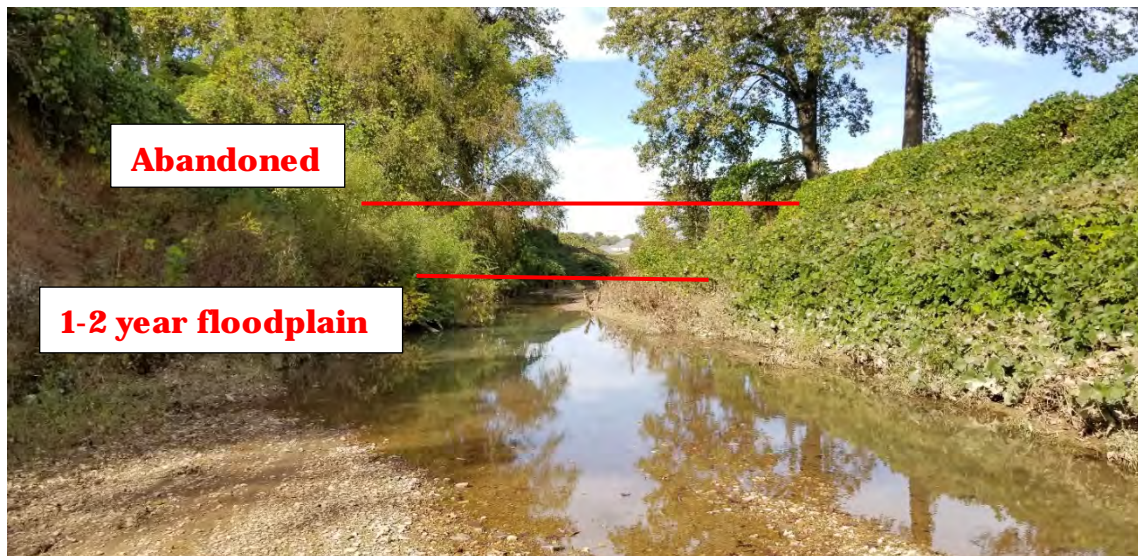
Figure 6. Nolehoe Creek Cross-section facing upstream approximately 1,800 ft from Camp Creek confluence

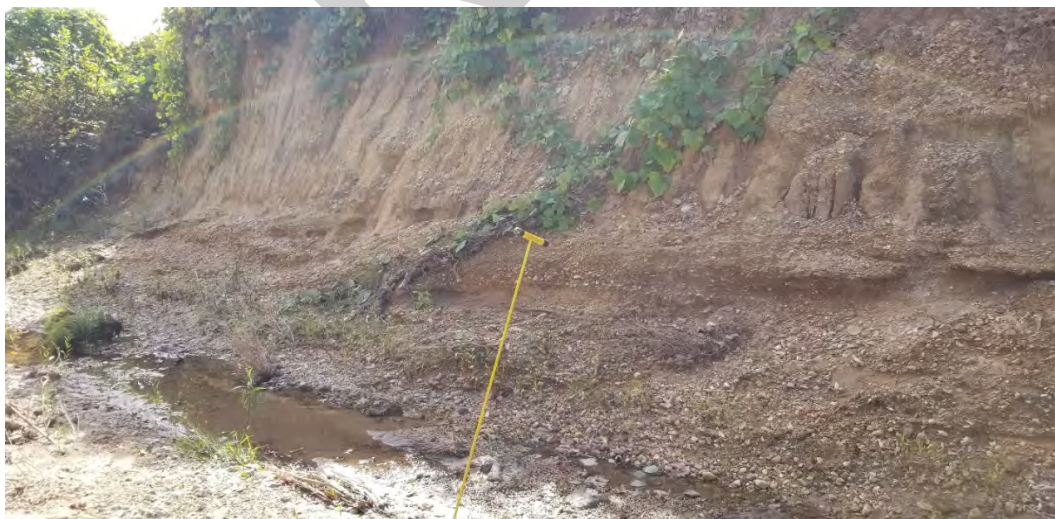
Figure 7. Nolehoe Nolehoe Creek Cross-section facing downstream approximately 1,800 ft from Camp Creek confluence

Figures 7, 9, and 10 had largely interbedded gravel deposits with a compact hard clay matrix. The deposits were especially erosion resistant (Figures 9 and 10) located in Reach 2 where there was a blacktop looking unit directly over a hard-red clay.

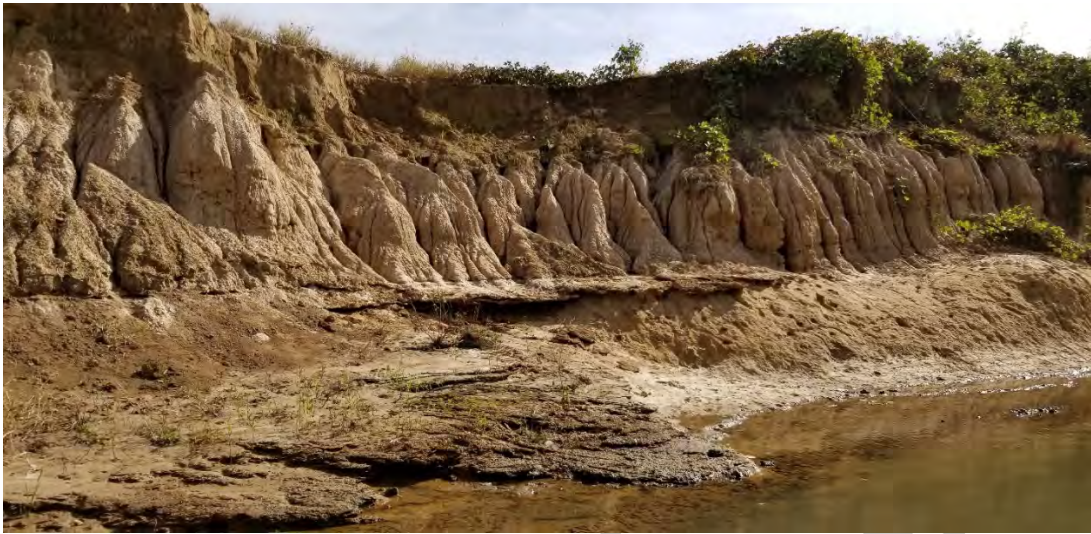
Figure 8. Nolehoe Nolehoe Creek left bank approximately 700 ft from Camp Creek confluence

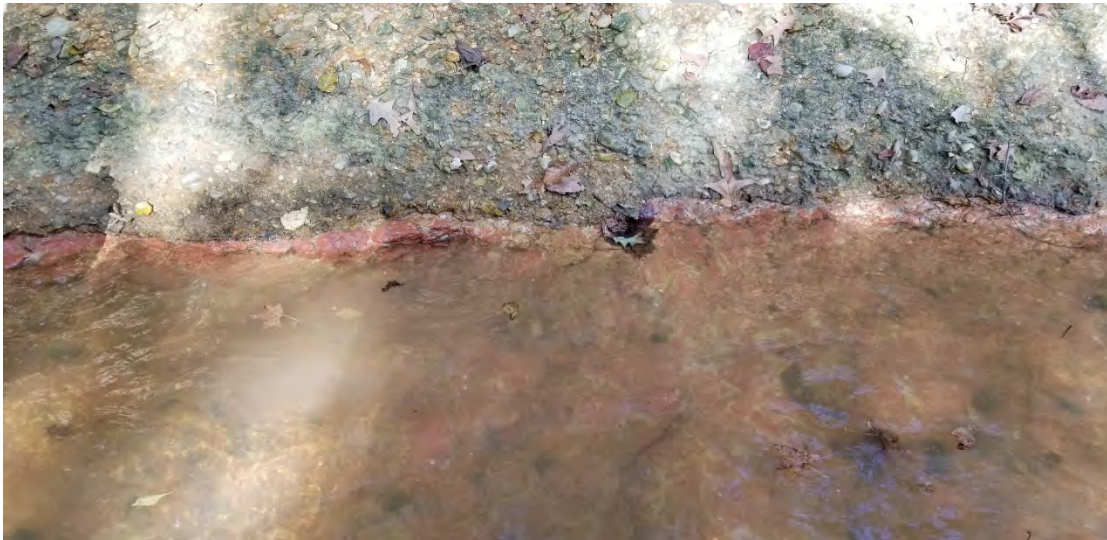
Figure 9. Nolehoe Nolehoe Creek left bank approximately 1,000 ft upstream of Pleasant Hill Road

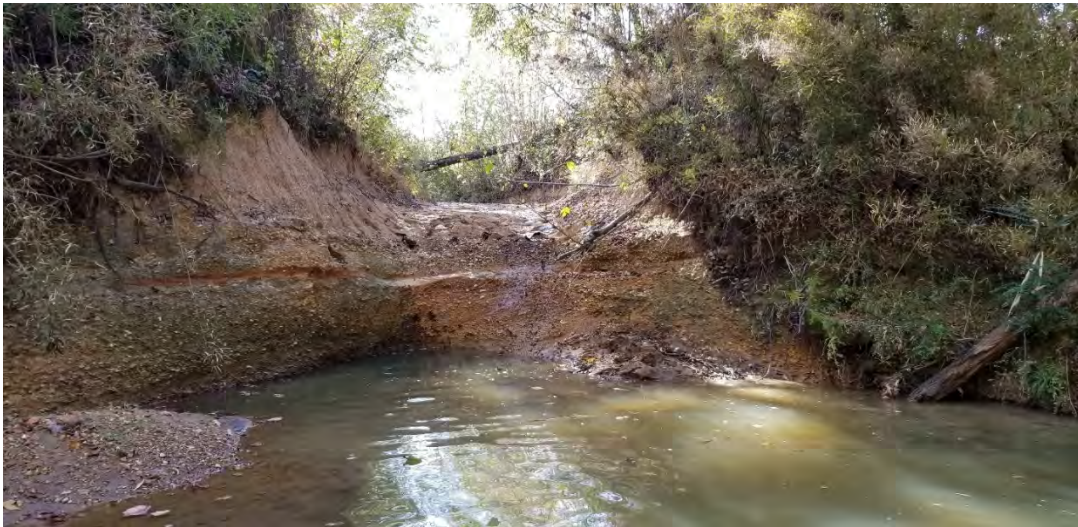
Figure 10. Nolehoe Creek right bank tributary outlet approximately 1,000 ft upstream of Pleasant Hill Road

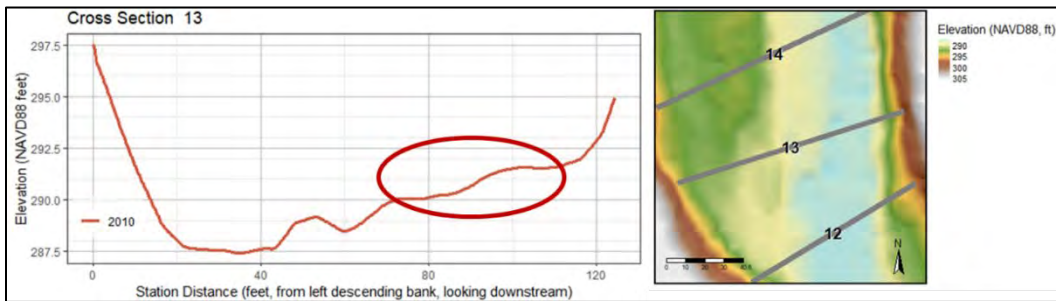
Figure 16. Cross-section 13, illustrating right-bank floodplain berm building in lower Reach 1.

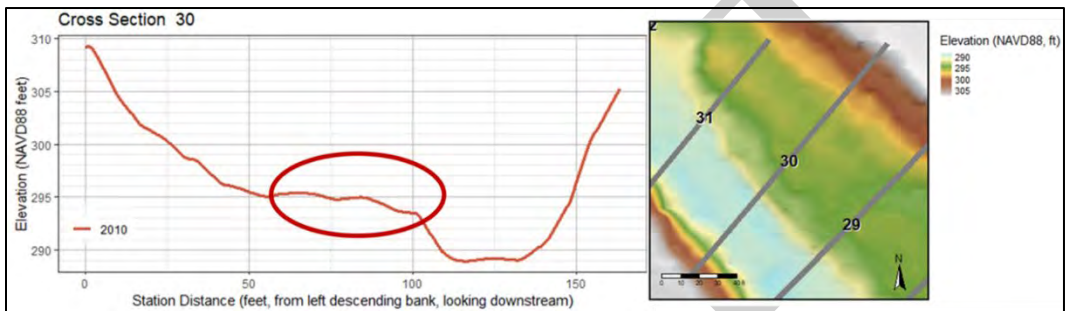
Figure 17. Cross-section 30, illustrating left-bank floodplain berm building.

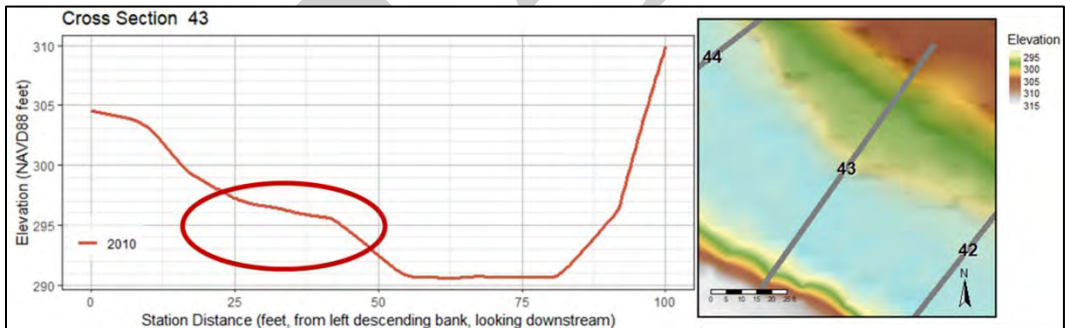
Figure 18. Cross-section 43, illustrating left-bank floodplain berm building.

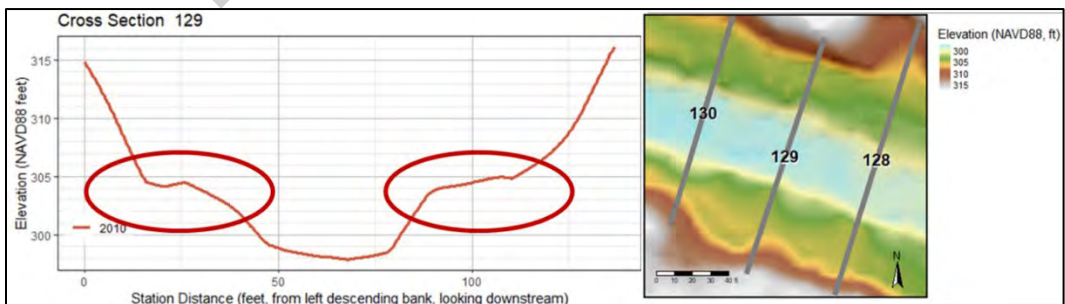
Figure 19. Cross-section 129, illustrating left and right floodplain berm development.

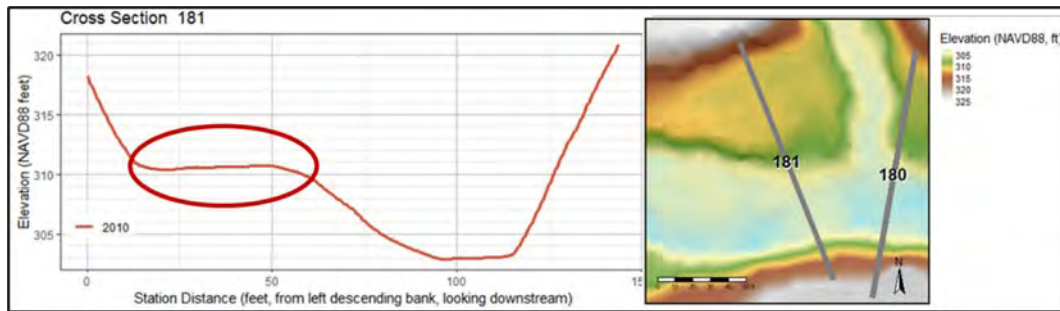
Figure 20. Cross-section 181, illustrating left bank floodplain berm upstream of tributary

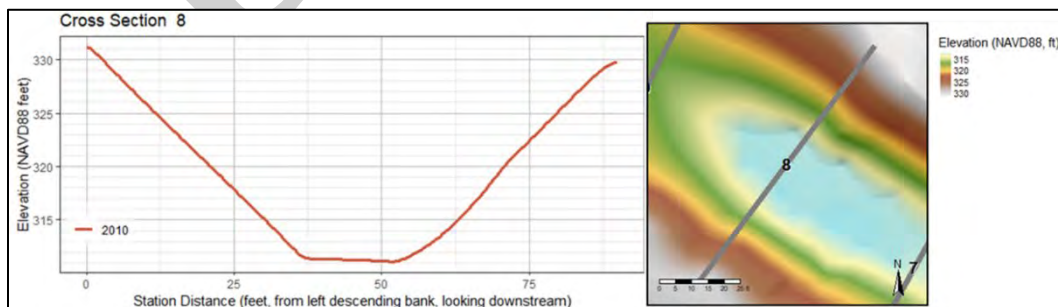
Figure 23. Cross-section 8, illustrating lack of floodplain berm building in lower Reach 2.

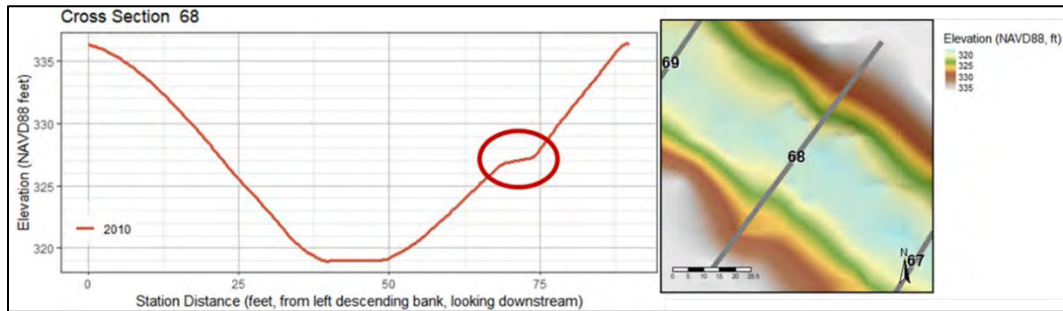
Figure 24. Cross-section 68, illustrating minor left-bank floodplain berm building.

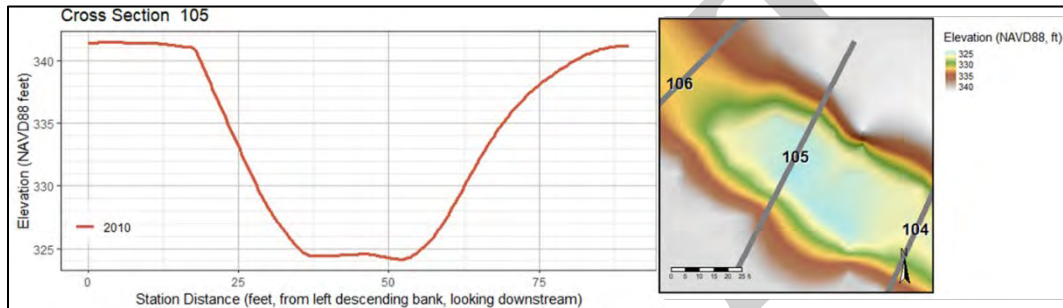
Figure 25. Cross-section 105, illustrating lack of floodplain berm building in lower Reach 2.

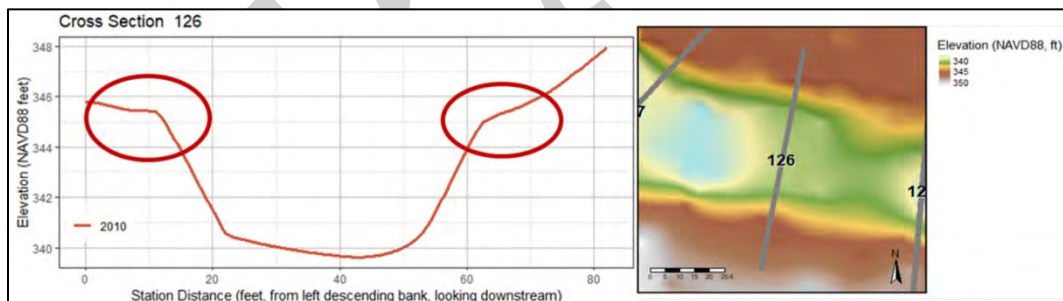
Figure 26. Cross-section 126, illustrating left and right floodplain berm development immediately upstream of Malone Road Culvert.

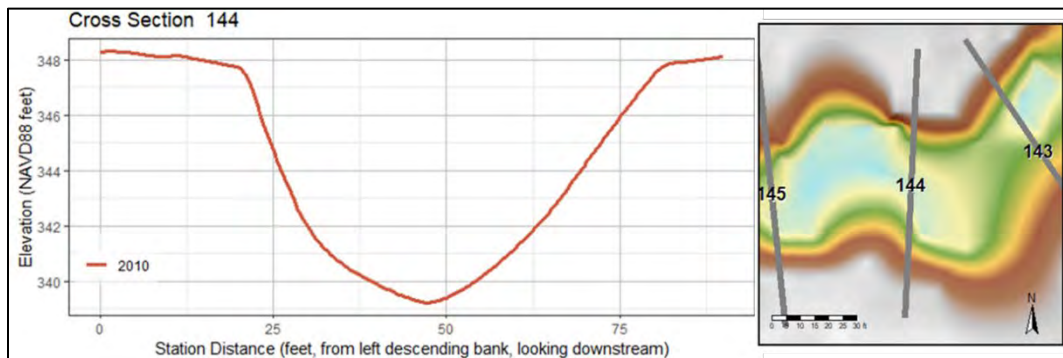
Figure 27. Cross-section 144, illustrating no active floodplain berm building.

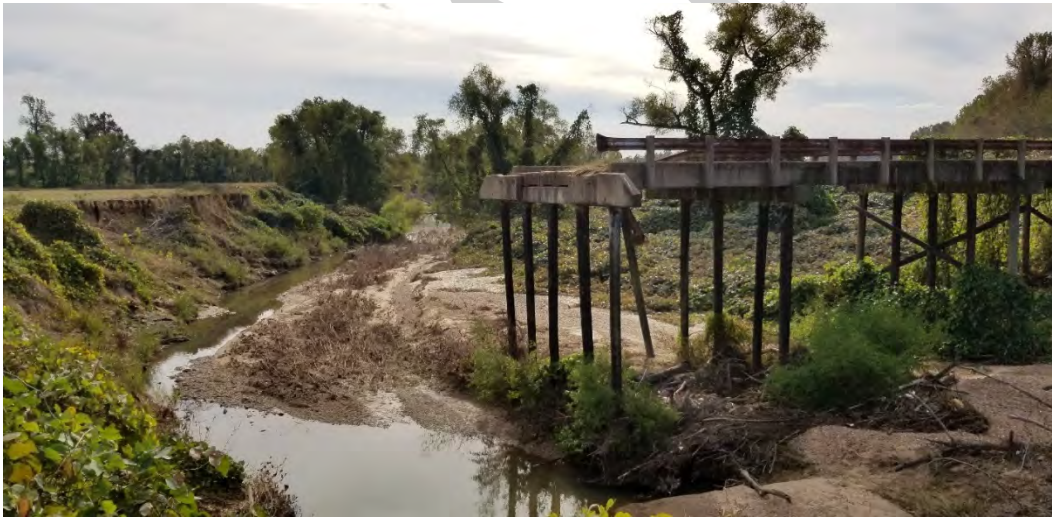
- Reach 1 appears to be stabilizing from a trend of degradation. Based on the field site visit, there is conclusive evidence of past bed degradation at the Sandridge Road Bridge (Figure 28) with localized areas of bank erosion (Figure 29) where the channel is still adjusting, or possible planform issues are causing accelerated erosion. The section is likely in a late CEM Stage IV.

Figure 28. Nolehoe Creek-Sand Ridge Road Bridge failure site (left bank)

Reach 1 appears to have widespread local bank instability along the entire reach. It is difficult to state with certainty whether this is systematic instability associated with a degradational regime, or if it is local instability associated with alternate bars and locally shifting alignments. For Reach 1, we feel that the most effective way to achieve the project goals to minimize channel degradation, channel erosion, and sedimentation is through the construction of a series of grade control structures. The location of the proposed six grade control structures for Reach 1 are shown in Figures 32 and 33. It must be emphasized that the locations of these structures is preliminary and that final locations, and structure grades may change based on more detailed investigations. These structures would not only stabilize the channel grade against any future degradation but would also improve the local bank stability in this reach.

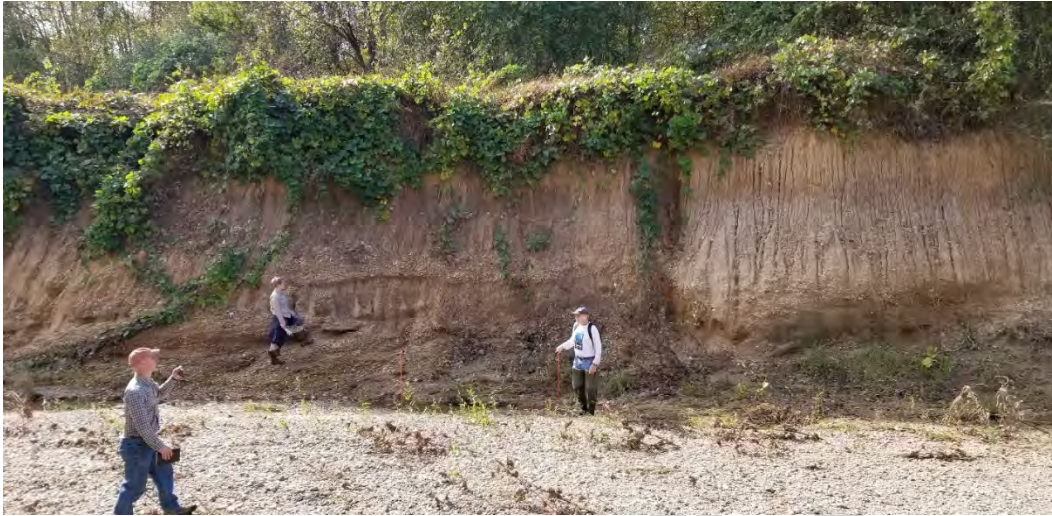
Figure 29. Nolehoe Creek right bank erosion site with large point bar

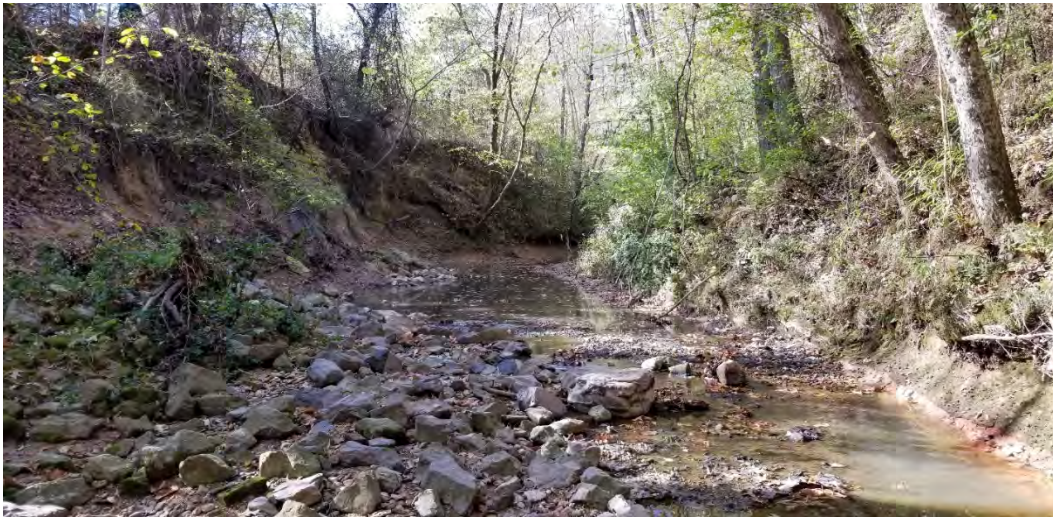
- The lower section of Reach 2 has non-alluvial channel characteristics. Based on the field site visit, there is conclusive evidence of past bed degradation and (Figure 30) localized bank erosion. The section has a very slow degradational trend (CEM II & III) because of the presence of a cohesive, erosion resistant clay bed and lower banks that have effectively locked the channel in place.
- Grade control is provided in the reach by the Pleasant Hill (Figure 31) and Malone Road Culverts. There is a marked channel change from relatively unstable conditions downstream to stable immediately upstream of the Malone Street Culvert.

Figure 30. Nolehoe Creek section approximately 1200 ft upstream of Pleasant Hill Road

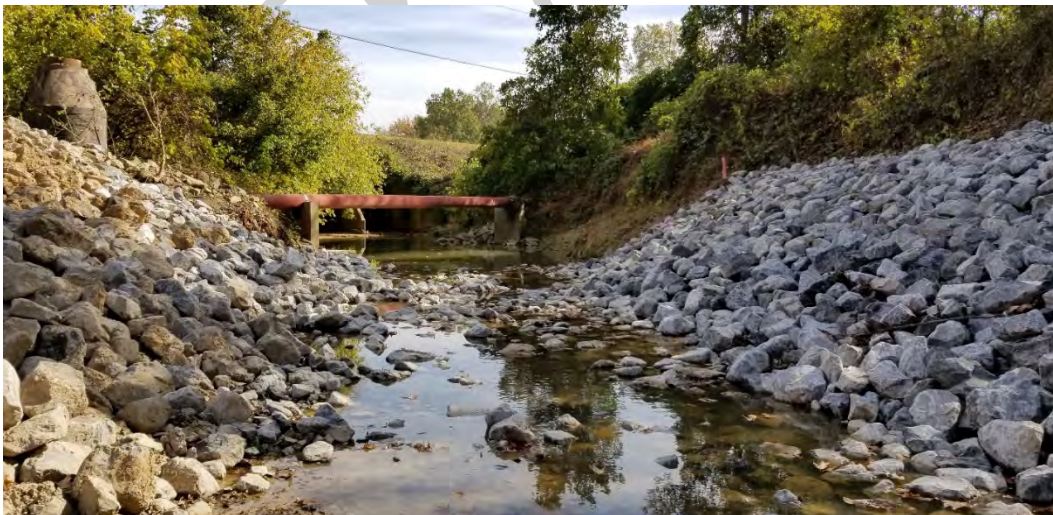
Figure 31. Nolehoe Creek riprap structure immediately upstream of Pleasant Hill Road Culvert

- Grade control is provided in the reach by the Pleasant Hill (Figure 31) and Malone Road Culverts. There is a marked channel change from relatively unstable conditions downstream to stable immediately upstream of the Malone Street Culvert.
