Johnson Creek, DeSoto County, MS: FluvialGeomorph Level I Channel Stability Assessment & Reconnaissance Report

Appendix C. Memphis Metropolitan Stormwater – North DeSoto Count Feasibility Study

Christopher P. Haring and David S. Biedenbarn

March 2021

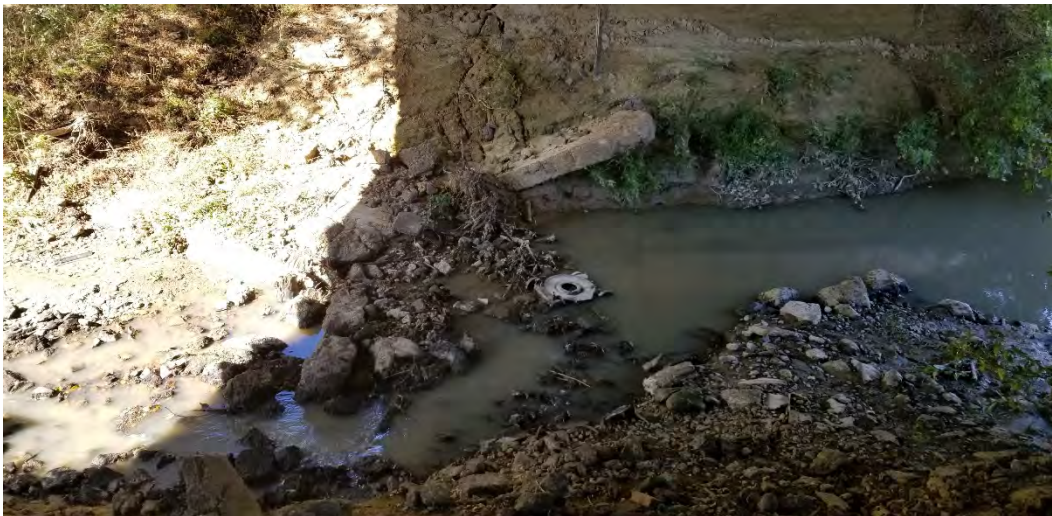
Figure 2. Johnson Creek at Austin Road Bridge showing minimal riprap protection under the bridge.

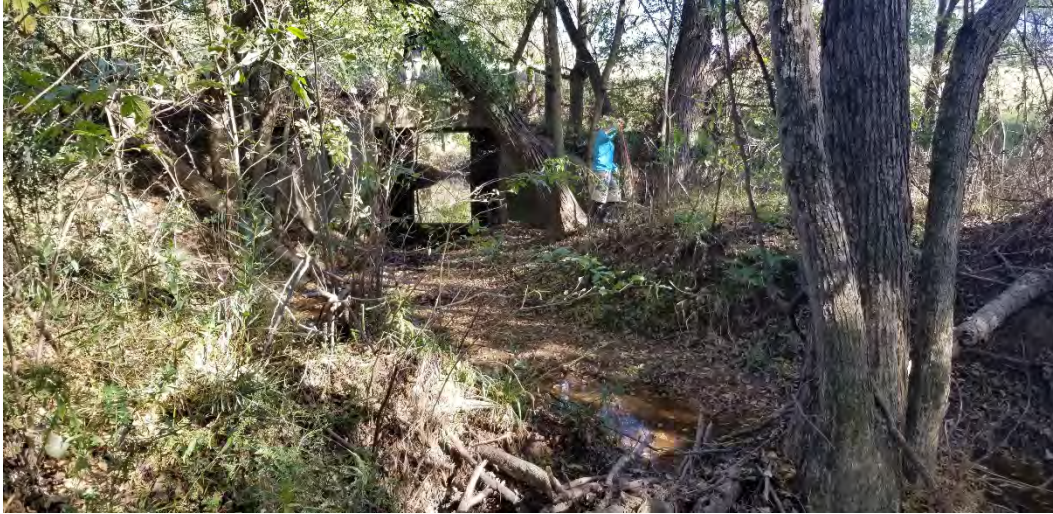
Figure 3. Johnson Creek at State Route 301 Culvert providing grade control.

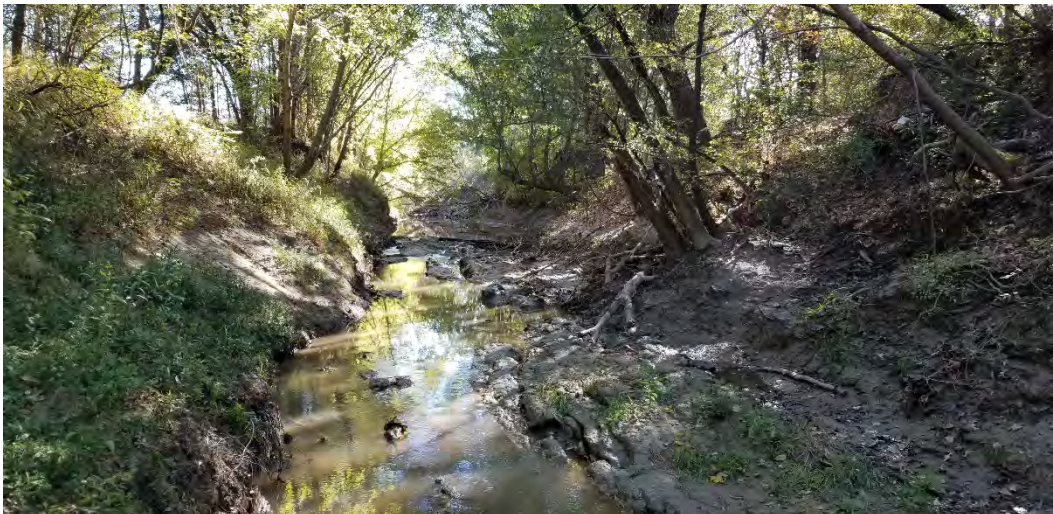
During the site visit on November 4, 2020, the channel sections in proximity to the Baldwin Road Bridge were investigated (Figures 4 and 5). Downstream of the bridge is where the channel slope changes from the low channel slope Mississippi River floodplain materials (Reach 1) to clay, silts and higher channel slope gravel deposits in the upland steeper sloped watershed areas (Reach 2 and 3). Figure 4 illustrates channel degradation that has eroded through some of the less erosion resistant clay bed.

Figure 4. Johnson Creek-Baldwin Road Bridge-looking upstream at degrading channel, trees sliding in on right bank

Vegetation is also sloughing in from the channel margins as the channel continues to degrade lowering the base level of the channel. Also illustrated (Figure 5) is the tributary channel that enters Johnson Creek on

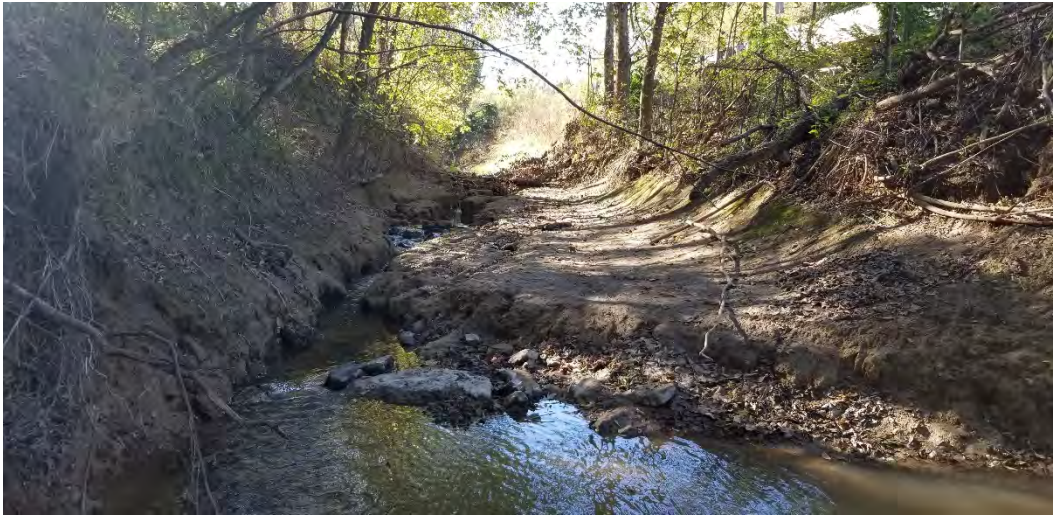
the left bank upstream of the bridge. The top of the degradation can be viewed approximately 100 feet upstream of the confluence with Johnson Creek (Figure 6). If the degradation continues upstream the base level continues to lower and the channel widens. Upstream of this location the tributary is no longer degrading and is relatively stable.

Figure 5. Johnson Creek-Baldwin Road Bridge-looking upstream at channel degradation in a tributary immediately upstream of bridge

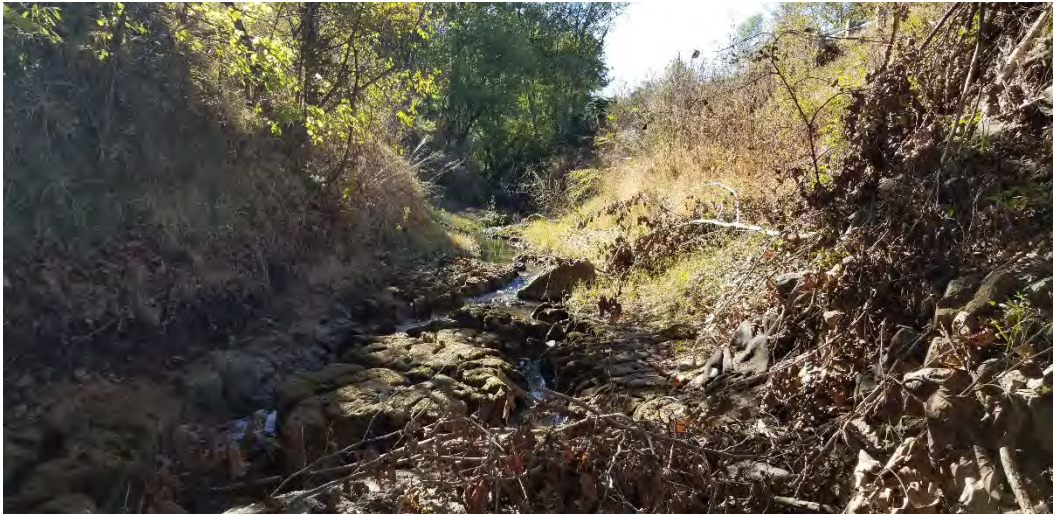
Figure 6. Johnson Creek-Baldwin Road Bridge-looking upstream at channel degradation in a tributary immediately upstream of bridge

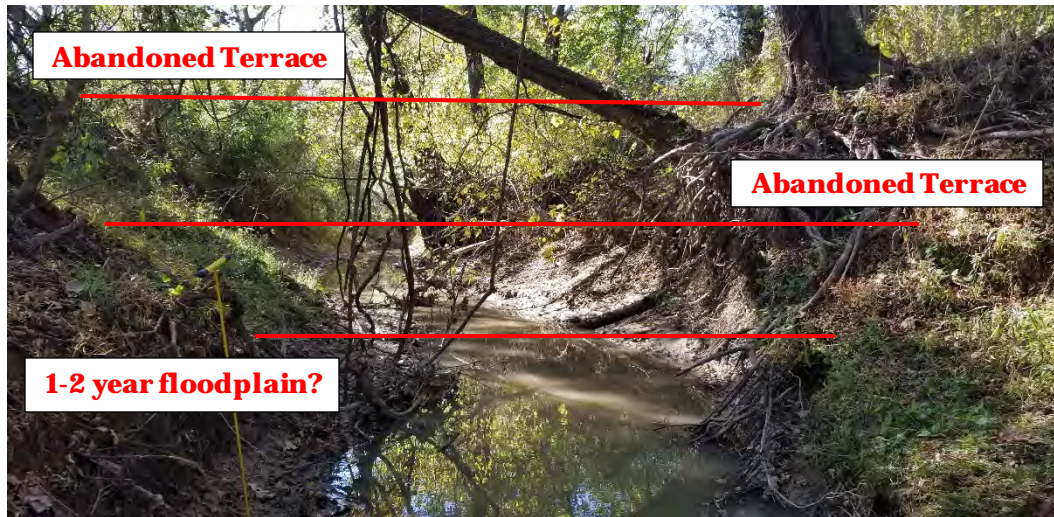
degradation leads to a process of channel bed incision followed by widening and floodplain re-development. The process is outlined in the CEM diagram in Figure 7 and the multiple floodplain terraces defined in Figure 8 provide evidence for the process.

Figure 8. Johnson Creek Cross-section illustrating abandoned terraces and possible 1-2year floodplain berm development.

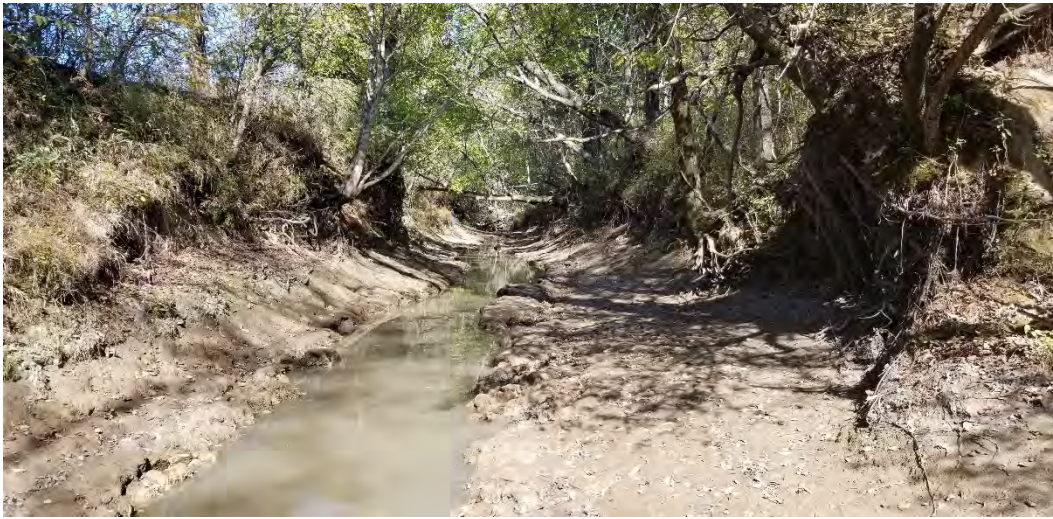
Figure 9. Johnson Creek upstream of Austin Road (Reach 2) showing clay bed with silty and clay loam banks.

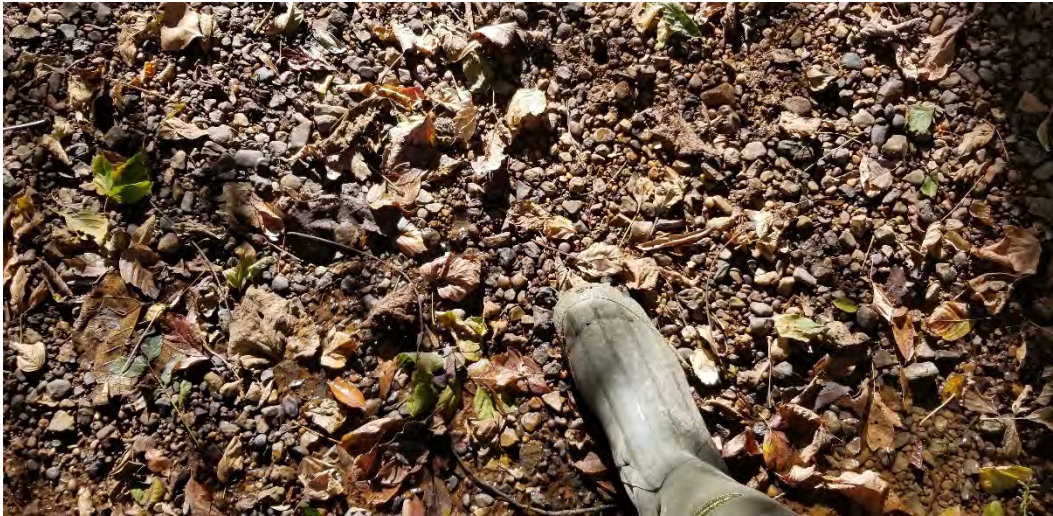
Figure 10. Johnson Creek upstream of State Route 301 culver with point bar material-small gravel to sand in Reach 3

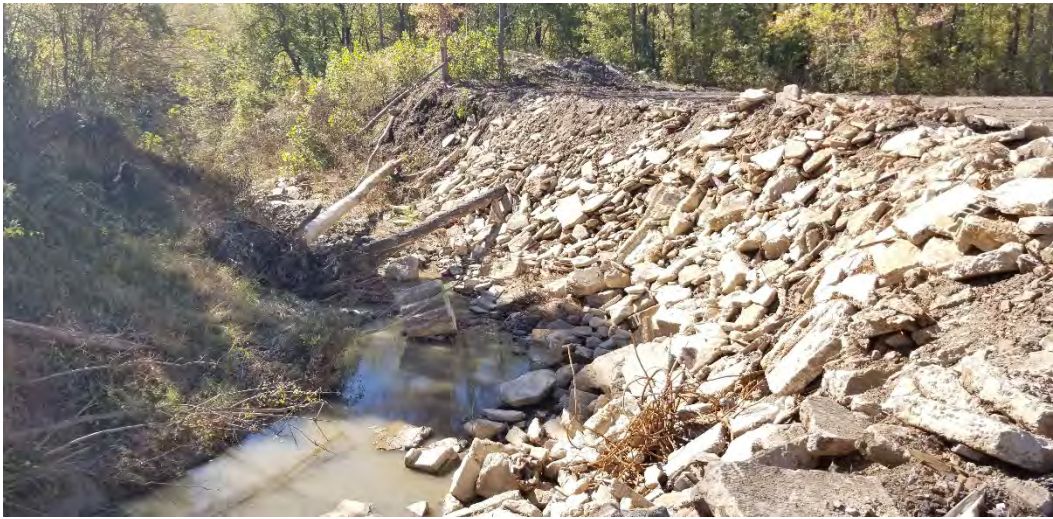
22). There is also a new subdivision that installed revetment materials at another location upstream just south of Odums Crossings Road (Orange Circle in Figures 21 and 22). Johnson Creek at the Odums Crossing subdivision has an extensive amount of concrete and other rubble that has been added to protect right bank erosion (Figure 23). There are also active nick points partially buried by concrete and a visible nick zone downstream of the concrete revetment (Figure 24).

Figure 23. Johnson Creek Reach 2: Concrete bank revetment at Odums Crossings Subdivision

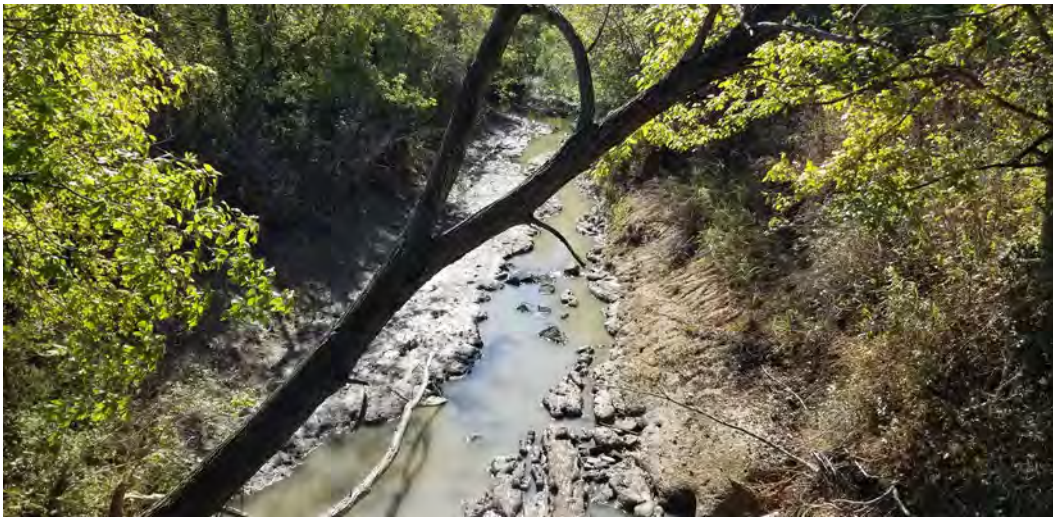
Figure 24. Johnson Creek Reach 2 nick zone located at Odums Crossings Subdivision

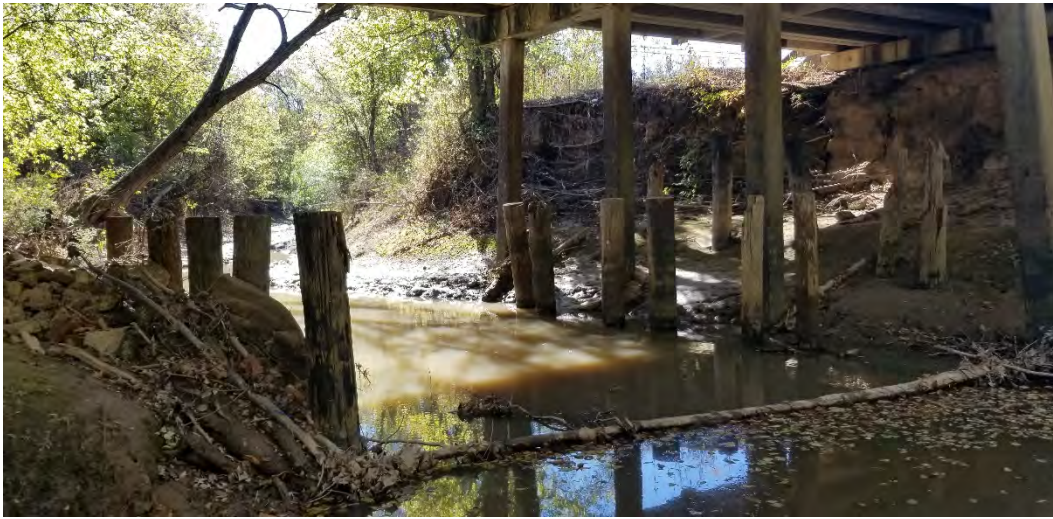
Figure 32. Johnson Creek Reach 3: Limited riprap and concrete bank revetment at the Austin Road Bridge.

- Austin Road Bridge appears to be providing very limited protection with debris present in the channel bottom and margins.
- Limited grade control is provided in the reach by the Highway 301 Road Bridge and the Church Road Culverts. There are no distinct differences between channel stability upstream of Highway 301 and downstream. The Church Road Culverts show signs of channel degradation at the downstream concrete aprons and should be monitored for further degradation and potential undermining.

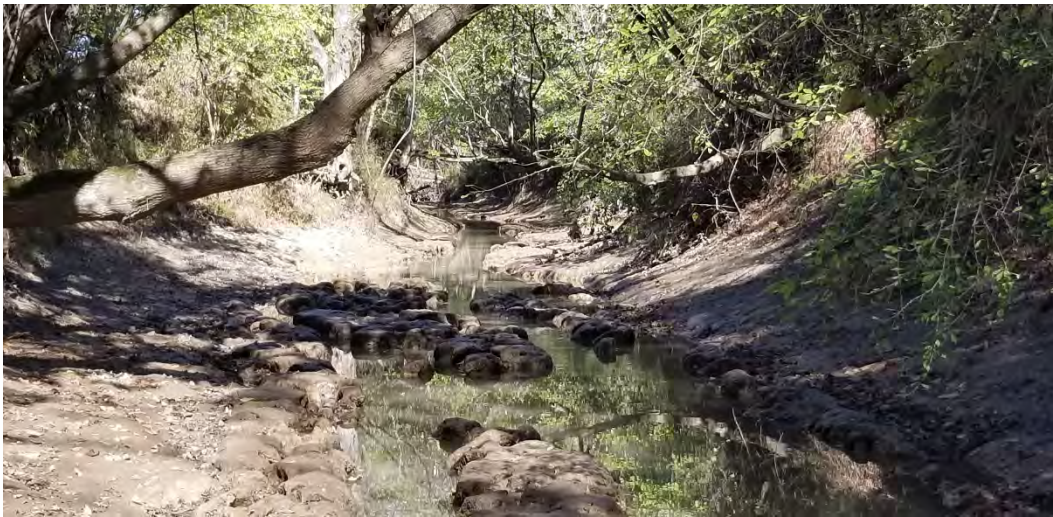
Figure 33. Johnson Creek Reach 3 nick zone located upstream of Austin Road Bridge

- Based on the field site visit, there is conclusive evidence of bed degradation upstream of the Austin Road Bridge. Reach 2 has a degradational trend (CEM II & III) but does have some cohesive, limited erosion resistant clay bed and lower banks that may be

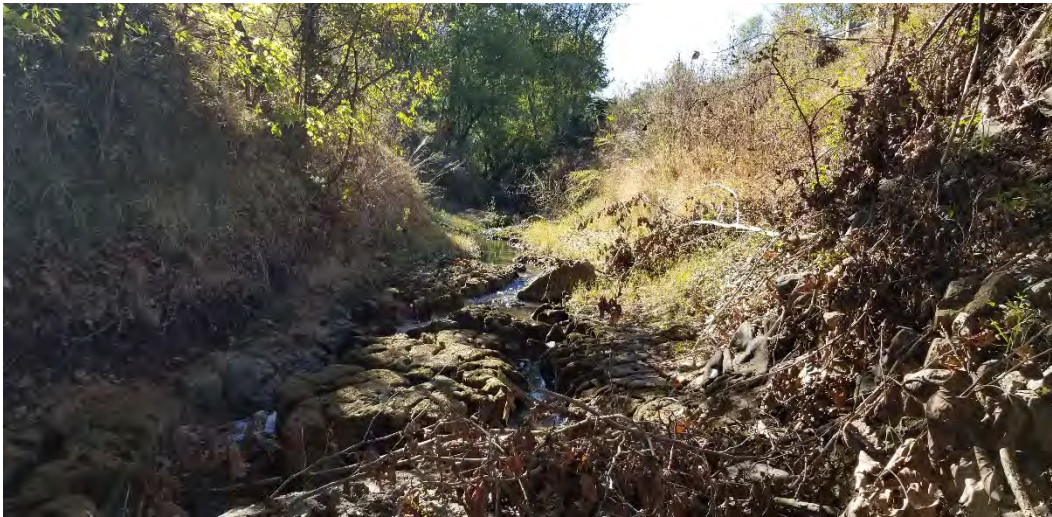
- Based on the field site visit, there is conclusive evidence of bed degradation upstream of the Baldwin Road Bridge. Based on the profile information there is likely more degradation that will work upstream into the bridge area causing further channel instability. The mid and upper Reach 2 is in a CEM Stage II-III. The section has a degradational trend (CEM II & III) but does have some cohesive, limited erosion resistant clay bed and lower banks that may be effectively locking the channel in place in certain areas within the reach. Some form of grade stabilization is required before bank stabilization should be attempted.

Figure 41. Johnson Creek upstream of Baldwin Road Bridge illustrating tributary erosion.

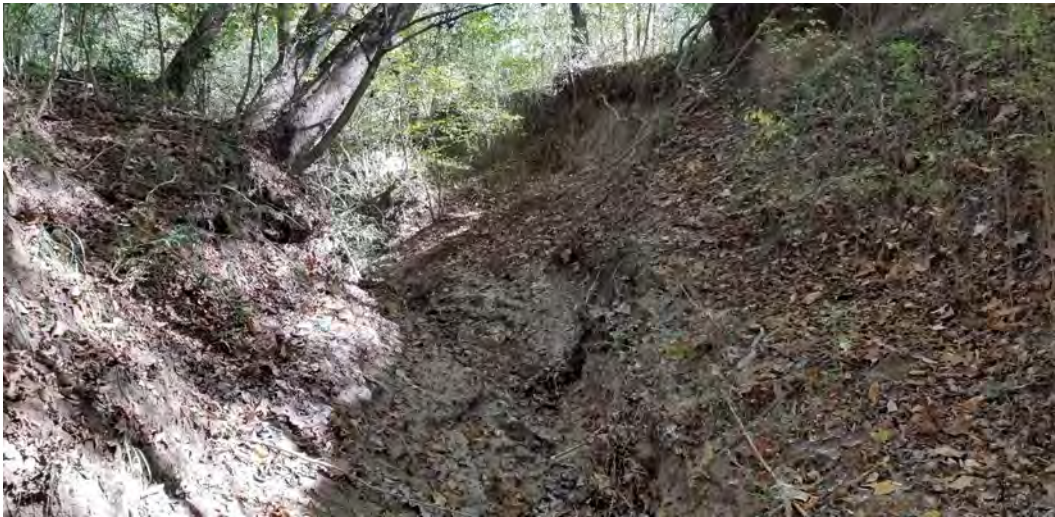
- There is widespread tributary and small drainage channel instability along the margins, adjacent to the stream channel form the continued degradation of the main Johnson Creek channel (Figure 42). As the channel continues to degrade the tributaries and drainage ditches will adjust to a new base level and erode deeper and widen out as par to the continued channel evolution process. As part of the Johnson Creek restoration and stabilization plan, additional analysis is required to treat the areas throughout the watershed.

Figure 42. Johnson Creek upstream of Austin Road Bridge illustrating gully formation from agricultural field runoff.
