## **Horn Lake Creek Stabilization Plan**

### **Appendix C. Memphis Metropolitan Stormwater – North DeSoto Count Feasibility Study**

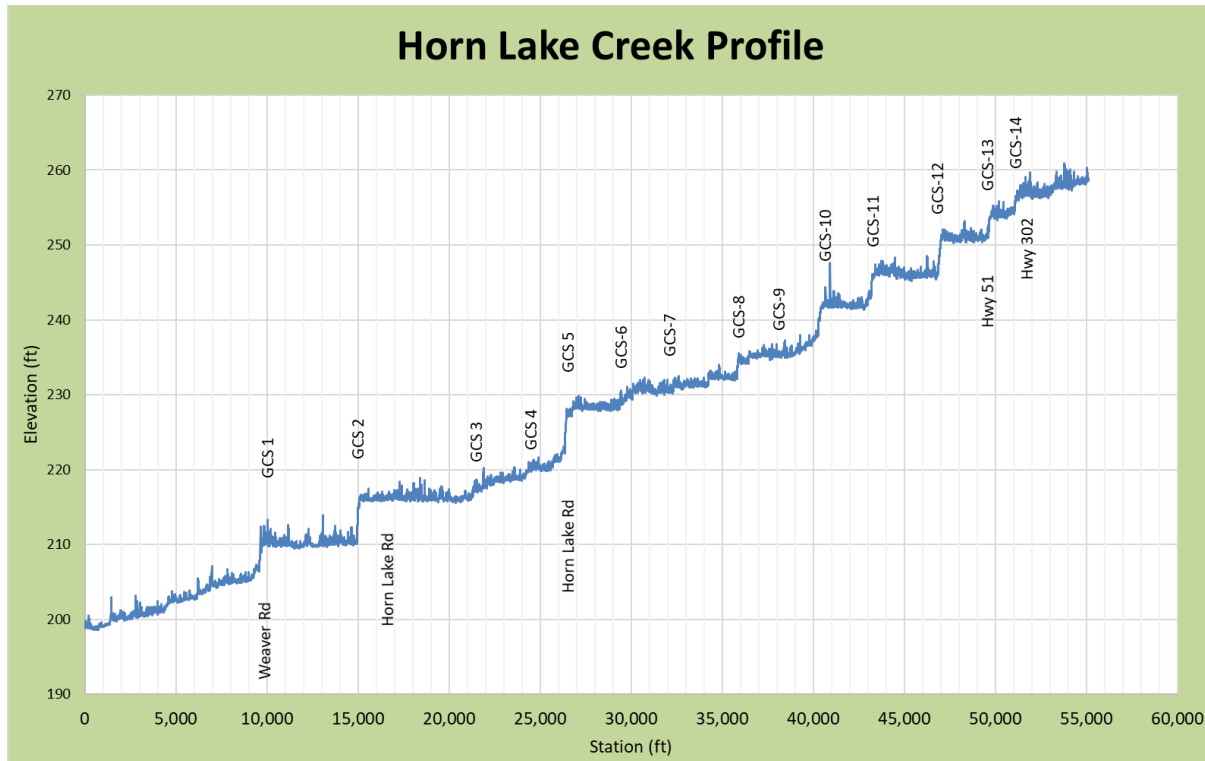
Figure 1. Horn Lake Creek LiDAR Profile with grade control locations

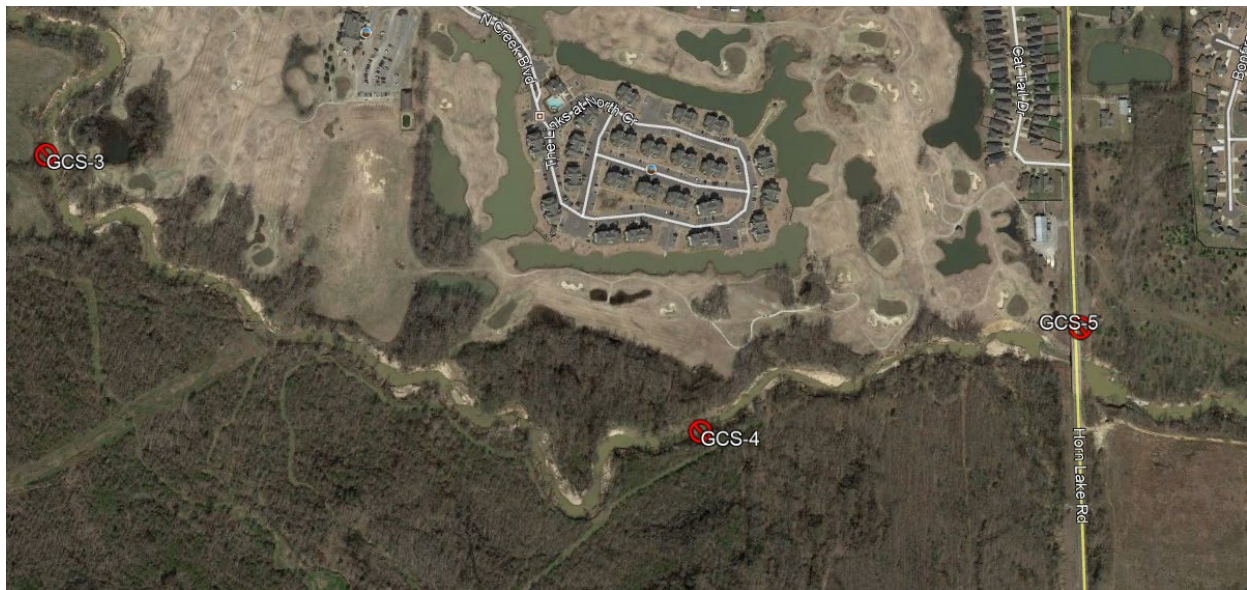
**GCS-3, 4, and 5.** There is a sloping riprap grade control structure under the Horn Lake Rd bridge with a huge scour hole downstream. This will be designated GCS-5. While there is some riprap along this scour hole, this structure need to be extended by about 150 to 200 feet downstream. Additional stone may also be needed along the sloping rock structure itself.

There is also another sloping rock type structure about 200 feet upstream of the bridge. There is a huge unprotected scour hole downstream of this structure. This scour hole need to be stabilized to ensure the integrity of the road. The existing sloping rock structure also appears to be in danger of being flanked. Therefore, this structure needs to be repaired, or replaced. For this assessment it will be assumed that the structure should be replaced with a new structure, which will be called GCS-5a. Additionally, about 800 feet of bank stabilization may be required upstream of the structure to ensure its integrity.

According to Google Earth imagery, there are no existing structures between GCS-2 and GCS-5. However, according to the Lidar survey there does appear to be a somewhat oversteepened zones in this reach which could be degradational. Inspection of Google Earth imagery revealed that there are numerous areas with significant bank instability. For this reason, two additional grade control structures (GCS-3 and GCS-4) are recommended in order to provide stability for this reach, and to help protect GCS-6. The drop heights at these two structures will likely be in the 3 foot range. A more detailed field and geomorphic assessment will be required to site GCS-3 and GCS-4, but approximate locations of these structures, as well as for GCS-5 are shown in Figure 3. Approximately 3,000 feet of bank stabilization may be required as part of the GCS-3 and GCS-4 efforts.

Figure 3. GCS- 3, 4, and 5

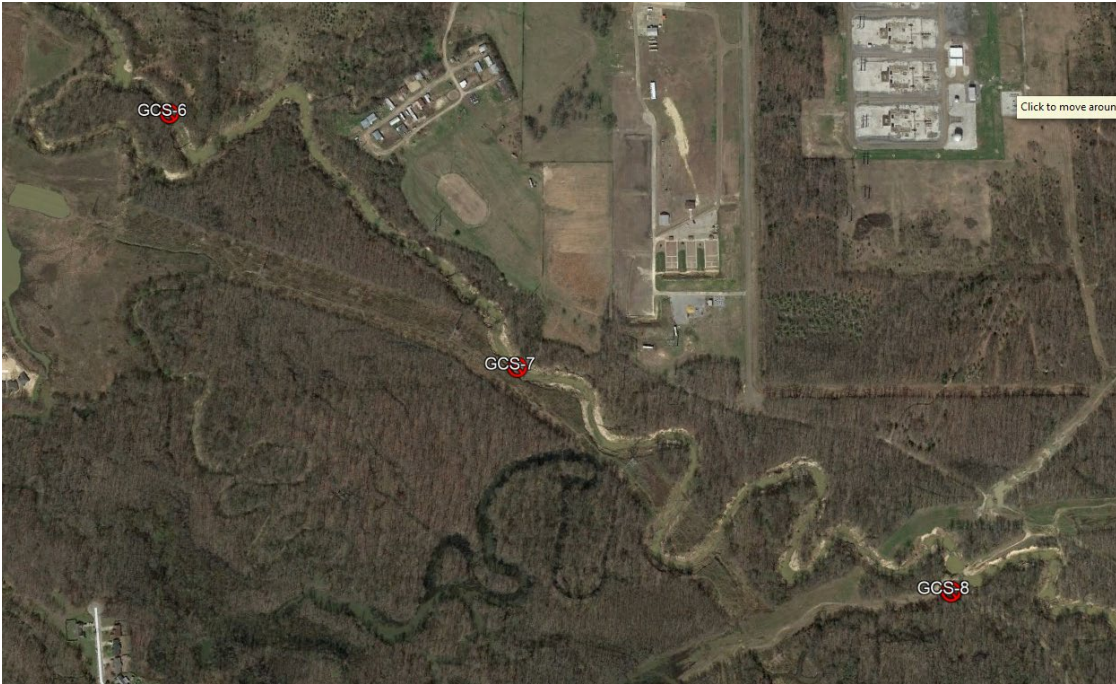
**GCS-6, 7 and 8.** There is an existing rock structure at the GCS-8 site that is holding about 2 to 3 feet of grade. It is not clear as to the exact function of this structure, but it may be a low water crossing built by locals. There is considerable bank erosion both upstream and downstream of this structure that needs to be stabilized in order to prevent the total loss of this structure. This structure needs to be rehabilitated, or more likely completely replaced with an engineered grade control structure. For this assessment it will be assumed that the structure should be replaced with a new structure. Approximately 2,200 feet of bank stabilization will be required to protect this structure.

According to Google Earth imagery, there are no existing structures between GCS-5 and GCS-8. However, according to the Lidar survey there does appear to be some oversteepened zones in this reach which could be degradational. Additionally, close inspection of Google Earth imagery revealed what appeared to be clay outcrops in this reach. For this reason, two additional grade control structures (GCS-6 and GCS-7) are recommended in order to provide stability for this reach, and to help protect GCS-8. The drop heights at these two structures will likely be in the 3 foot range. A more detailed field and geomorphic assessment will be required to site GCS-6 and GCS-7, but approximate locations of these structures, as well as for GCS-8 are shown in Figure 4. Approximately 3,000 feet of bank stabilization may be required as part of the GCS-6 and GCS-7 efforts.

Figure 4. Approximate locations of GCS- 6, 7, and 8.

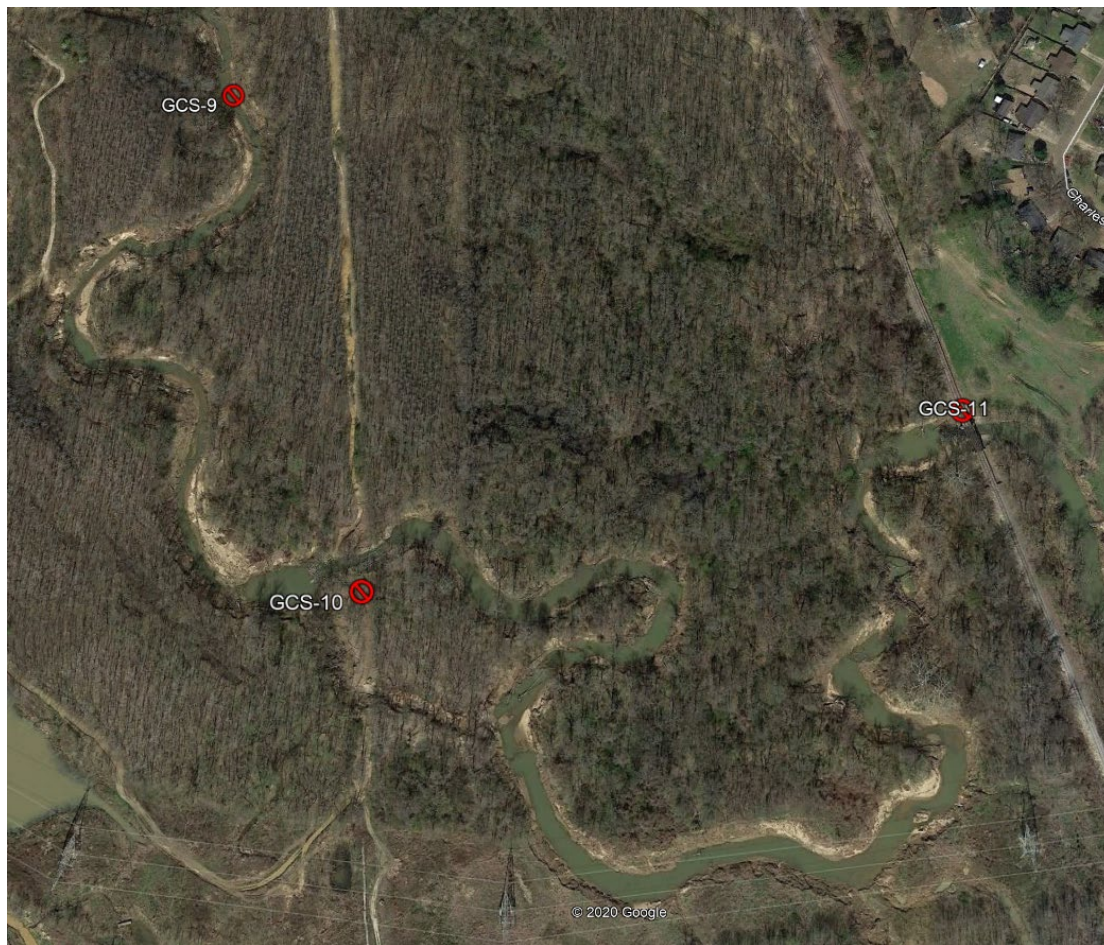
**GCS-9, and 10.** There is an existing rock structure at GCS-10. According to the Lidar profile, there is approximately 4 to 5 feet of drop at this structure. The purpose of this structure is not known, but it appears to be crossing location. There is considerable erosion both upstream and downstream of this structure and there is some potential for this structure to be flanked. For this reason, this structure needs rehabilitated or possible replaced. For this assessment it will be assumed that the structure should be replaced with a new structure. Approximately 2,500 feet of bank stabilization will be required at this site.

Immediately downstream of GCS-10, there appears to be a very steep zone on the Lidar profile, and what appeared to be clay was observed in the bed on Google Earth imagery. For this reason, an additional structure is proposed downstream at GCS-9. The drop height for this structure will likely be in the 3 foot range. The exact location for GCS-9 will require additional studies, but the approximate location is shown in Figure 5, along with GCS-10. Approximately 1,200 feet of bank stabilization will be required in the vicinity of GCS-9.

**GCS-11.** GCS-11 is located at a railroad crossing about 3,000 feet upstream of GCS-10. (Figure 5). There appears to be a 4 to 5 feet of drop at this structure (Figure 1). Although this site was not inspected as part of the field investigations, it is assumed that some rehabilitation and reinforcement of this structure will be required. An estimated 1,000 feet of bank stabilization may also be required here to protect the integrity of the structure.

Figure 5. Approximate locations of GCS-9, 10, and 11.

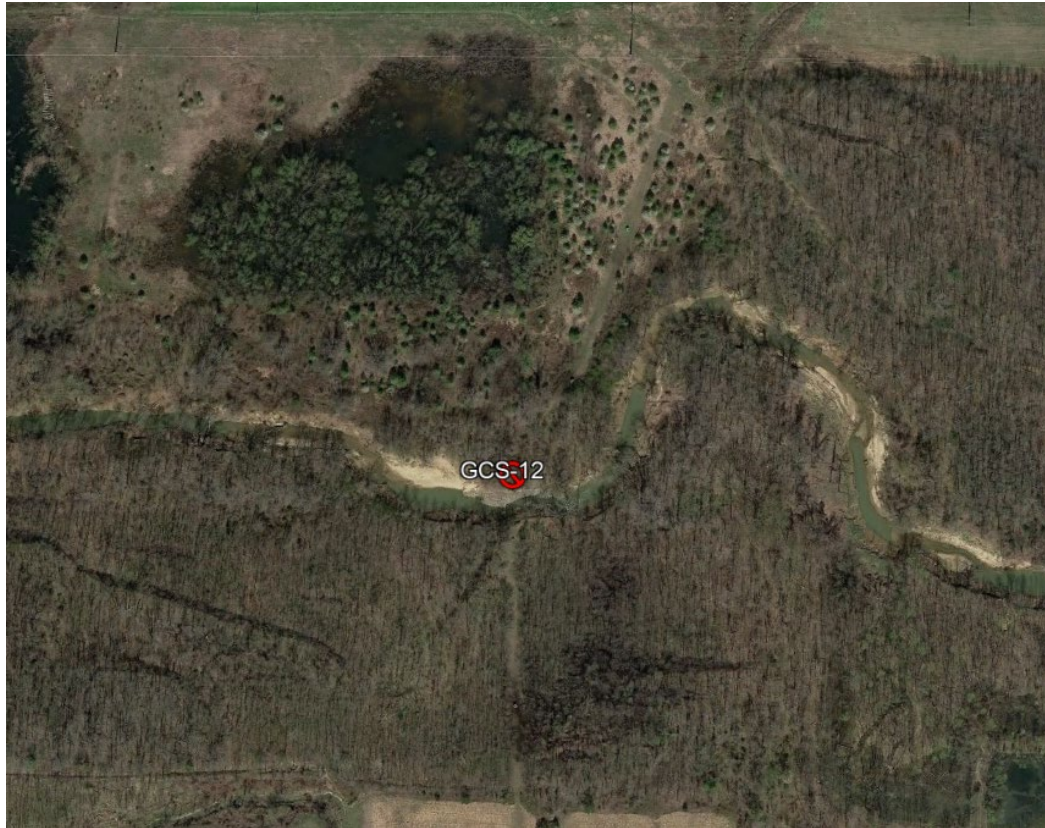
Figure 6. GCS-12

**GCS-12.** There is an existing rock structure at this site (Figure 6). The purpose of this structure is not known, but may be some sort of low water crossing. This structure appears to be in danger of failing, and there is bank erosion both upstream and downstream of the structure. This structure will need to be rehabilitated or more likely replaced. For this assessment it will be assumed that the structure should be replaced with a new structure. An estimated 1,500 feet of bank stabilization may also be required here.

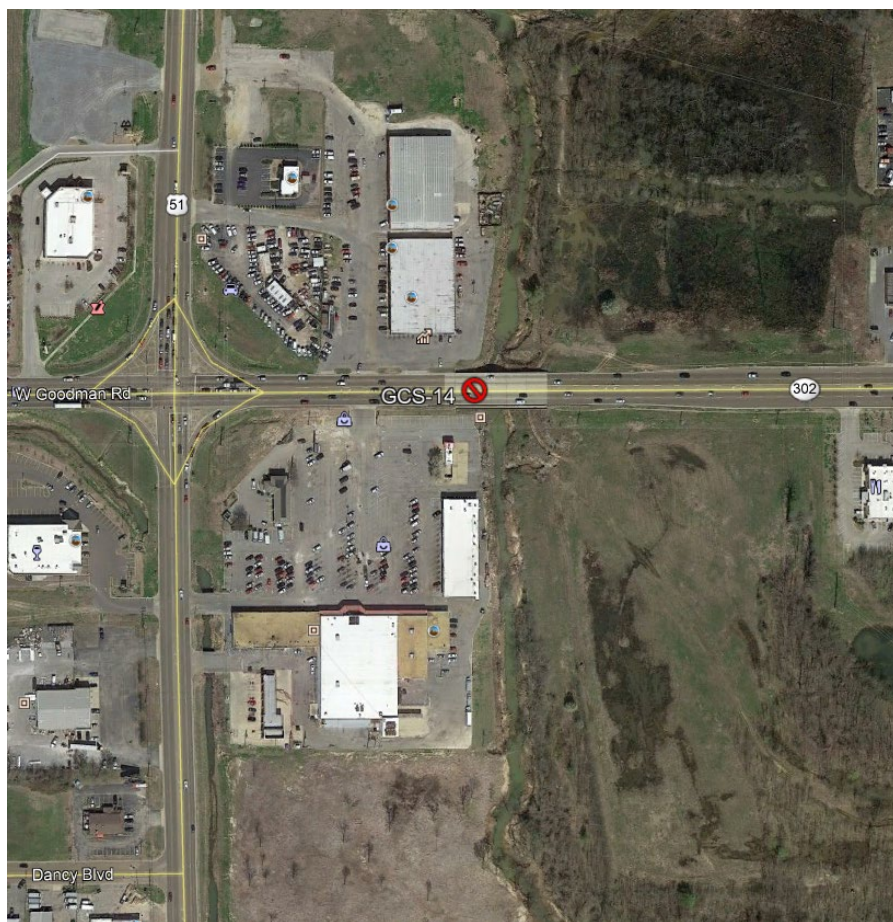
Figure 8. GCS-14.

**GCS-14.** There is an existing sloping rock structure at the Hwy 302 bridge with a drop of about 4 feet (Figure 8). Since there was no visual inspection at this site, the integrity of the structure is not known, but it is assumed that some repair will be needed. Additionally, there is a large scour hole downstream of the structure that will need to be stabilized. There also appears to be some bank erosion along the stream both upstream and downstream of the bridge that may be endangering numerous commercial buildings. Approximately 1,500 feet of bank stabilization may be required here in addition to the repairs at the structure.
