**REBUTTAL TO MAYNORD'S ESTES
PARK PAPER**

MVS COMPARISON OF MICROMODEL FLOW VISUALIZATION AND ACOUSTIC DOPPLER CURRENT PROFILER (ADCP) TO GPS FLOAT SURVEY, VICKSBURG FRONT

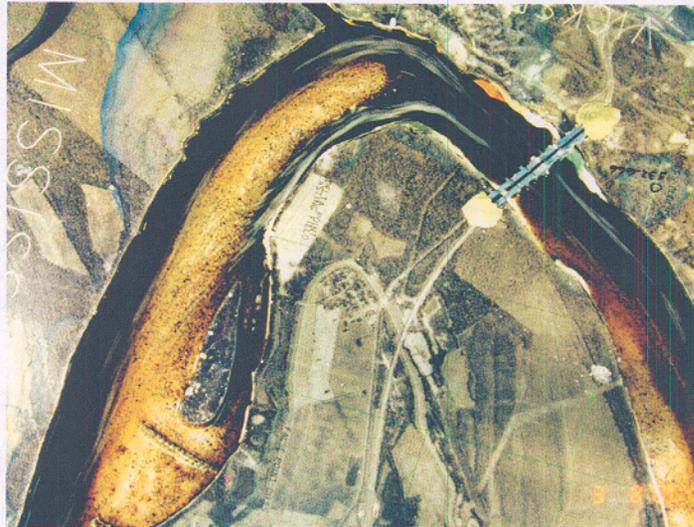
Figure 1, Flow Visualization, Vicksburg Front Micromodel, High Flow

The flow visualization used in the Vicksburg Front Micromodel study employed time exposure photography. The camera settings were setup to capture streaks of hundreds of floating particles seeded on the surface of the water in the Micromodel. The end result showed the general trend of water flow in the model at the surface. Figures 1 and 2 illustrate flow visualization used in the Vicksburg Front Micromodel study. The process does not represent the same physical phenomena as the GPS float survey conducted of the prototype for the following reasons:

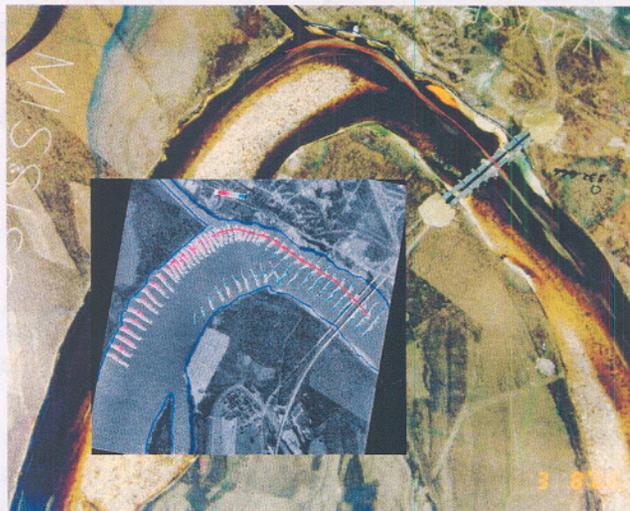
Figure 2 Flow Visualization, Vicksburg Front Micromodel, Low Flow Pathline Comparison with ADCP

2. The confetti introduced in the Micromodel represented an instantaneous snapshot of hundreds of floaters throughout the study reach viewed in the photo frame, whereas the floaters introduced in the prototype represented a relatively small amount of floaters (under 20 according to the survey) placed in the water not as a snapshot but as individual float pathlines or tracks established over a relatively long data collection period of 5 days. For the purposes of the Vicksburg Front Micromodel Study, the seeding resolution was actually reduced somewhat in order to better define critical flow. In this manner, the main concentration of flow was visualized along the thalweg and matched up exceptionally well with the ADCP data (Figure 2). In both the Micromodel and the

ADCP, the direction of the main current was directed off the rock protrusion near Mile 436.5 L and directed toward the right descending side of the navigation spans of the bridges.

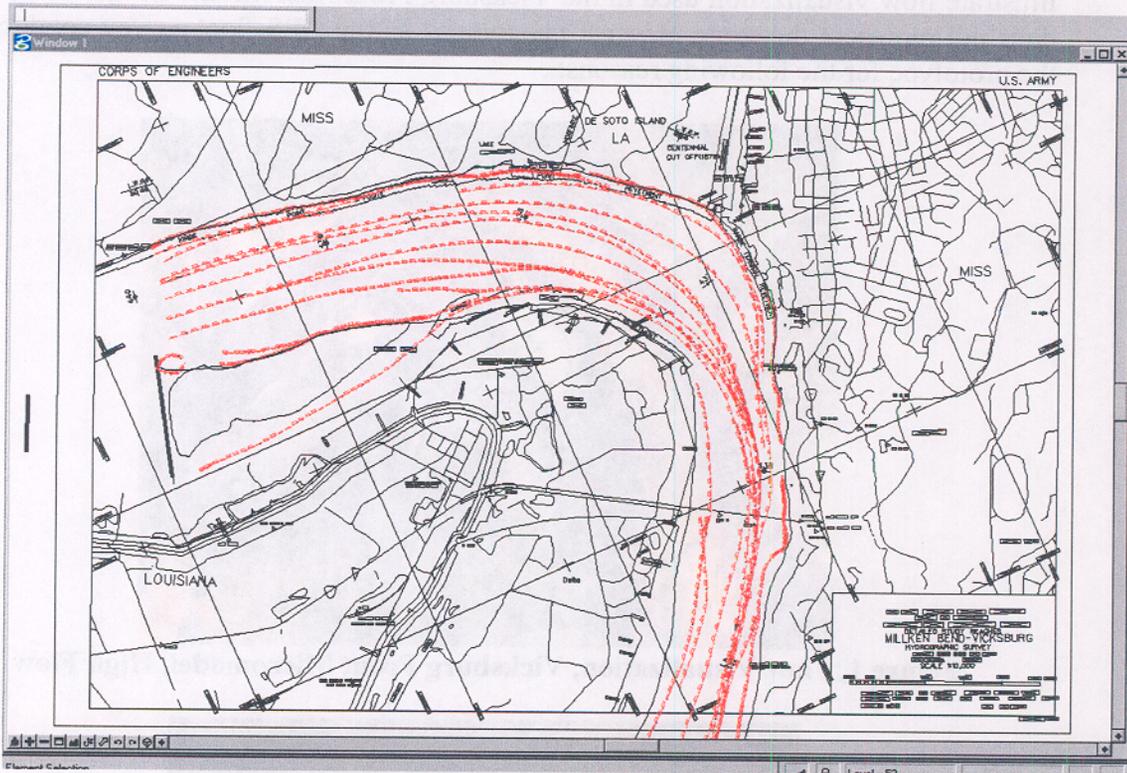
Figure 3. GPS Float Survey at Vicksburg Front

Figure 3 is a map showing the GPS float survey. The seeding of floats in the GPS float survey of the prototype conducted by contractor for ERDS in Vicksburg Front did not represent individual floating particles captured throughout the reach under study. Instead, a comparatively small amount of floaters were introduced at the upper end of the study reach and at few other selected locations downstream and then the single paths tracked along the river.

3. In the time exposure methodology used in the Micromodel, because of the high resolution of floaters, streaks were parallel and did not cross path lines. In this manner, relative flow distribution was captured, as observed in Vicksburg Front Micromodel study. In the GPS float survey of the prototype, because of the poor resolution established by the low seeding, pathlines were not parallel and crossed at numerous areas of the survey, including Mile 439.2 near the left descending bank, two areas near Mile 437.8 near the right descending bank in the side channel, one area at Mile 437 near the right descending side of the channel, an area in the left descending side of the main channel at Mile 437.4, an area off the right descending bank at Mile 436.6, and multiple pathlines crossing in the main channel near Mile 435.4. In addition, many floats that were placed in their respective starting positions in close proximity with each other deviated in their directional pathlines enormously.

As an example, two floats near the middle of the channel near Mile 439.3 were at the same relative point, yet the float pathlines that developed were not parallel and veered off from each other by as much as 500 feet. Another example was observed at the upper end of the reach in the main channel near Mile 439.8. Two floats in this location were placed within 80 feet of each other approximately 900 feet off the left descending bank, yet veered off from each other by as much as 720 feet near Mile 437. These two examples illustrate a great discrepancy in the direction of flow and would also influence the true recording of flow magnitude.

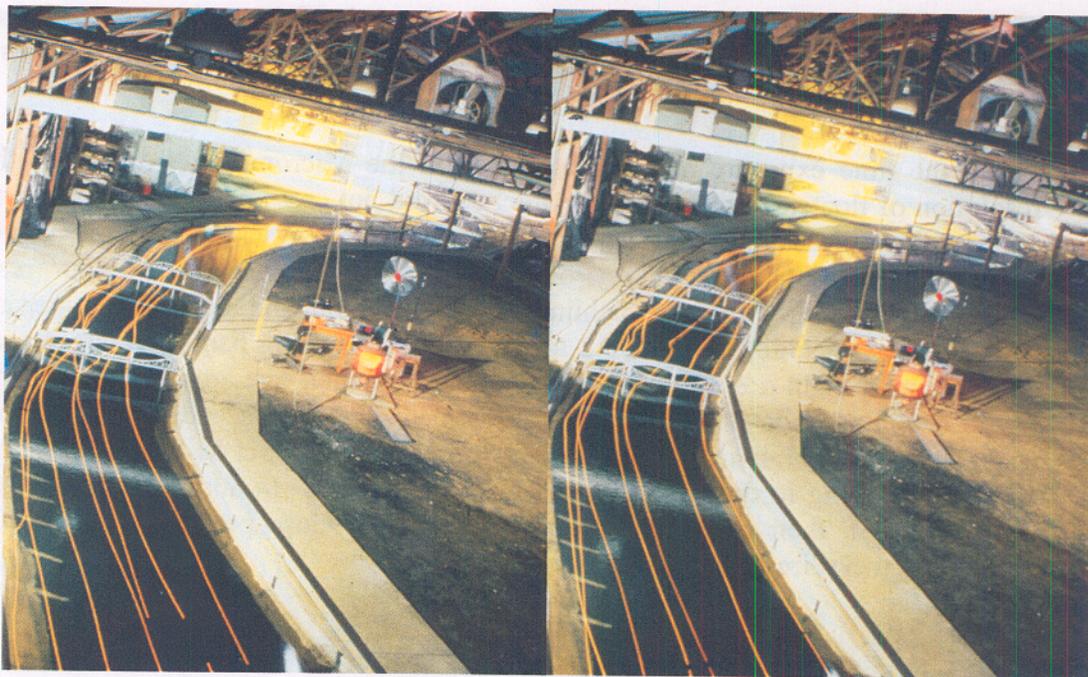
Figures 4 and 5. Flow visualization at WES, St. Louis Harbor Study, 19.2 Feet Stage

The above shortcoming of a non-continuous seeded float survey with low resolution is further verified in a particular flow visualization technique performed by WES in the St. Louis Harbor study in the early 1990s. Figures 4 and 5 are photographs illustrating a particular flow visualization method whereby reflective floating tracers were tracked using photographic time exposure. The flow and stage conditions observed in the two photos were exactly the same in the model, the only difference being that two different tests were done with floaters dropped in slightly different positions. In both tests, non-continuous, low resolution seeding was introduced in the most upstream part of the model and then tracked. This was the same method of seeding used in the prototype float survey at Vicksburg Front.

What is interesting to note is the fact that not only did the pathlines of flow cross in several locations, but the relative direction of flow was different in each photo, even though the flow conditions were exactly the same in the model. These tests verify that a float survey conducted in this manner is highly suspect in capturing true flow distribution and thus subject to erroneous interpretation of flow.

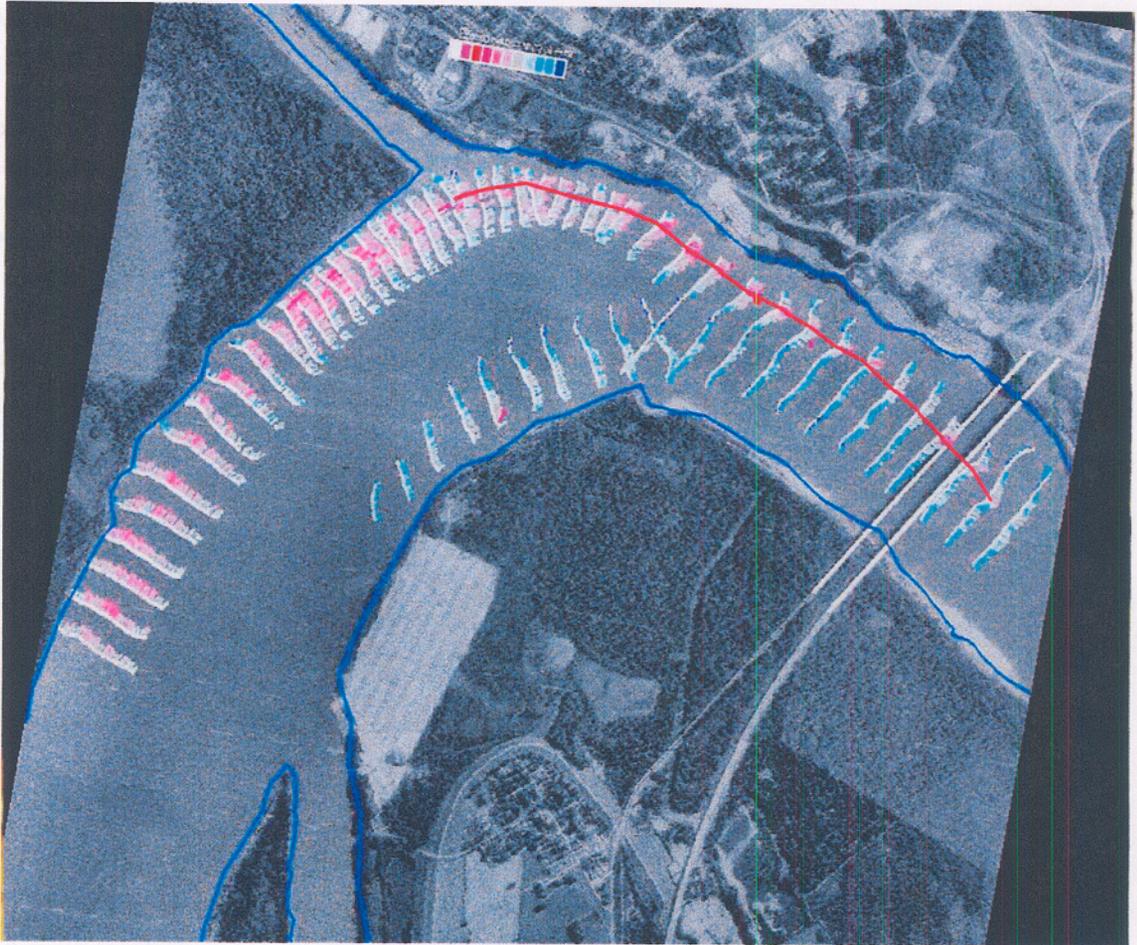
Figure 7. Pathline Established From ADCP profiles.

ADCP is a standard field data collection method of water flow used by USACE, USGS, and others. Hydroacoustic transducers are mounted on a vessel and generate pulses of sound at a known frequency. As the sound travels through the water, it is reflected in all directions by particulate matter (e.g., sediment, biological matter, bubbles). Some portion of the reflected energy travels back along the transducer axis toward the transducer where processing electronics measure the change in frequency. The Doppler shift is applied and thus the transducers reflect the velocity of the water along the axis of the acoustic beam. When tied to a compass and GPS, the three-dimensional direction of velocity is recorded. A vessel mounted with ADCP can thus collect near real-time velocity profile data at any given location of the river.

The particular vessel and ADCP system used to collect data through the Vicksburg Reach was the MV Boyer. The MV Boyer has a proven track record for collecting accurate velocity data with the ADCP. Calibration of velocity with the Price Current Meter using

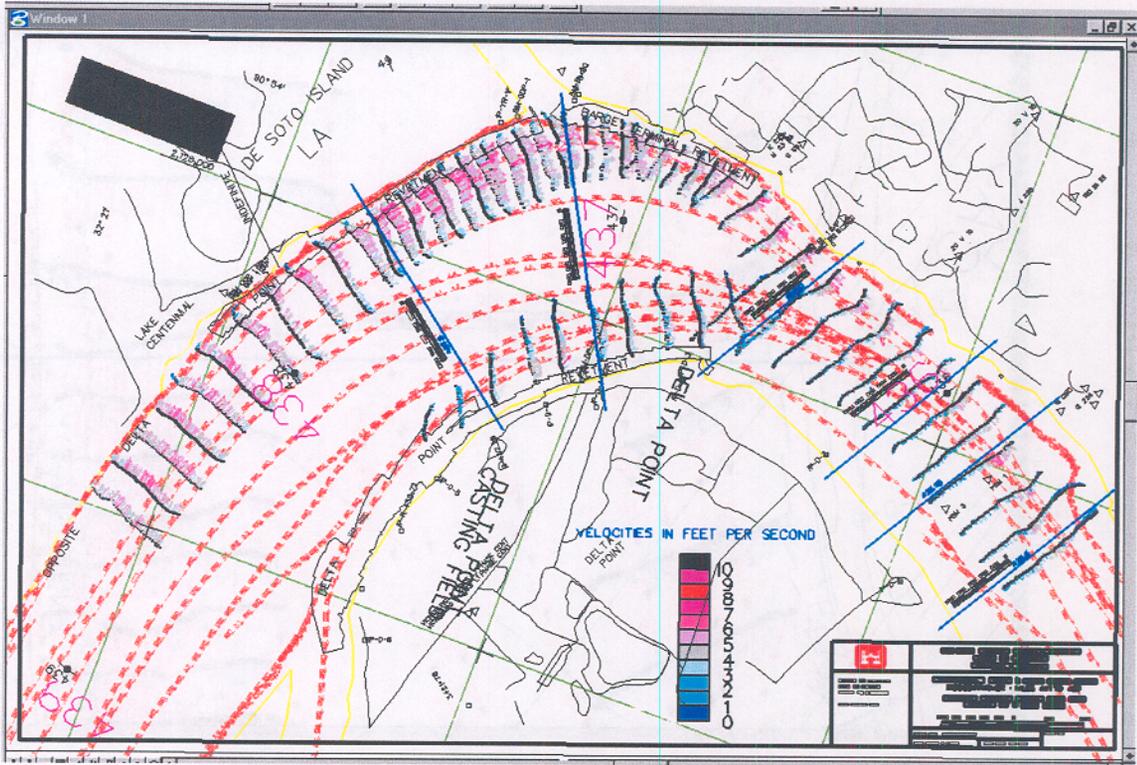
Figure 7. ADCP vs. GPS Float Survey

Figure 8 shows the plan view vector map of the ADCP prototype data superimposed on the GPS prototype float survey. Although each survey was taken at a different stage and flow condition, general comparisons and inferences can still be made about the characteristics of flow measured by the two methods of data collection. Results indicated some major differences that reinforce the observation that the float survey is highly suspect:

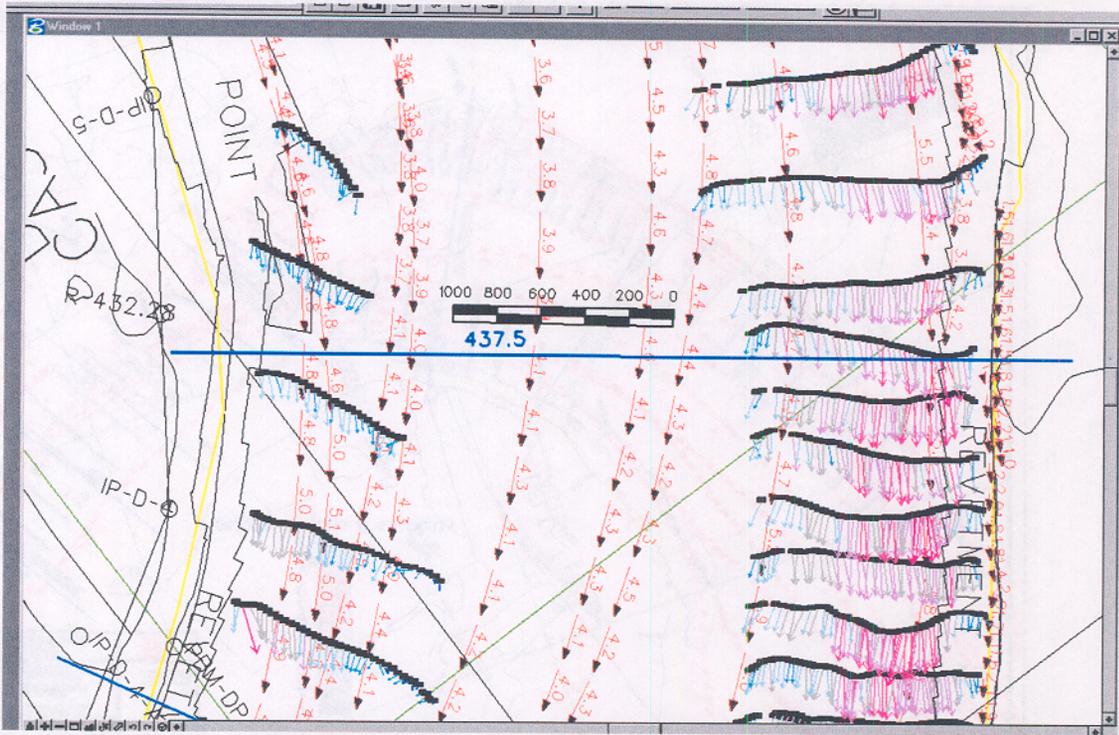
Figure 8. ADCP vs. GPS Float Survey in Critical Reach near Mile 437.5

1. Except for a few floats hugging the left descending bank, no floats existed within the majority of the main navigation channel, between Mile 437.5 Mile 436.5 (Figures 8, 9, and 10). This was a very critical area for the Vicksburg Front Study and was accurately and clearly defined with the ADCP data but not with the float survey. The one critical float that was used in Maynard's paper showing a difference in direction of flow along the main channel between the float survey and the Micromodel was actually outside the main navigation channel in this critical reach (the float path line was over the shallow bar at delta point. The path line of this float was not parallel with the path line of the thalweg established by the ADCP transects. This fact, combined with the discussion generated previously that this particular float deviated substantially in path line direction from another float placed in almost nearly the same position, make the float survey highly suspect.

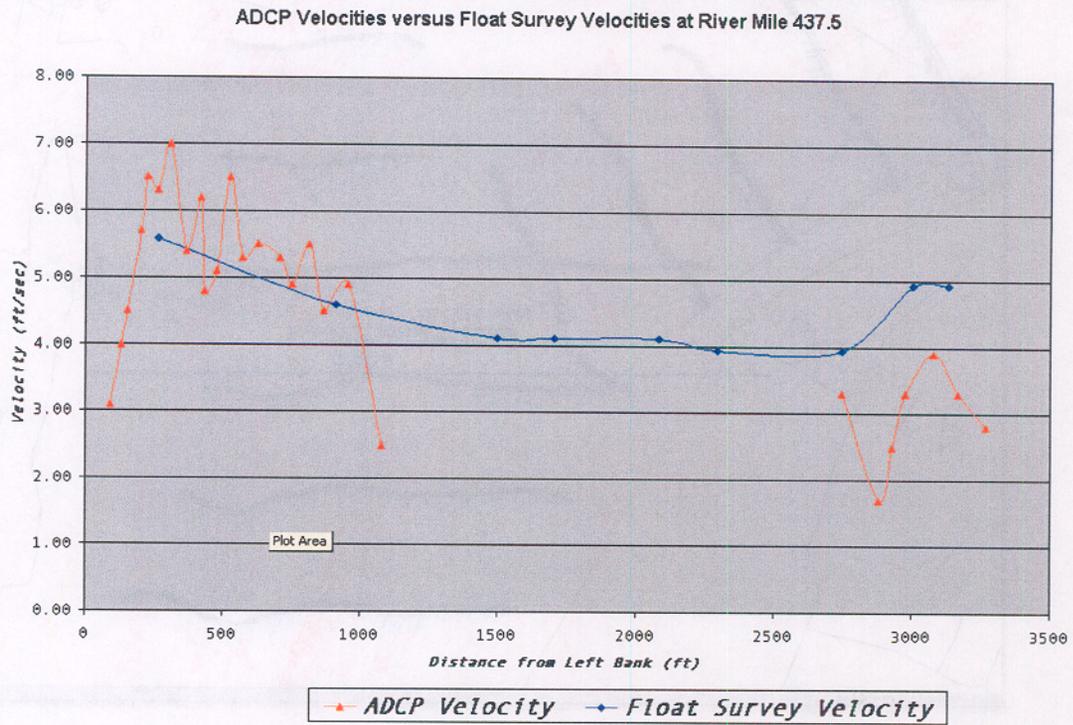
Figure 11. Velocity Comparisons, ADCP vs. Float Survey

2. The relative magnitude of velocity values of the float survey is suspect. Figures 11 through 13 are comparative profiles of the ADCP at 5 feet depth collected at low flow compared to the float survey collected near the surface at high flow. Results indicate that the highest magnitude of velocities recorded from the float surveys in the critical reach between Mile 437.5 and Mile 436 were actually lower than ADCP values collected at low flow. Velocity magnitude collected on any river or stream along the thalweg will always be comparatively higher as flow, stage, and energy increases. Thus, the float survey values in this critical reach are highly suspect.
