PIDGEON MITIGATION BANK
FINAL PROSPECTUS
FAYETTE COUNTY, TENNESSEE

MR. BOBBY PIDGEON
THE PIDGEON COMPANY
MOSCOW, TENNESSEE

APRIL 2025

Civil & Environmental Consultants, Inc.

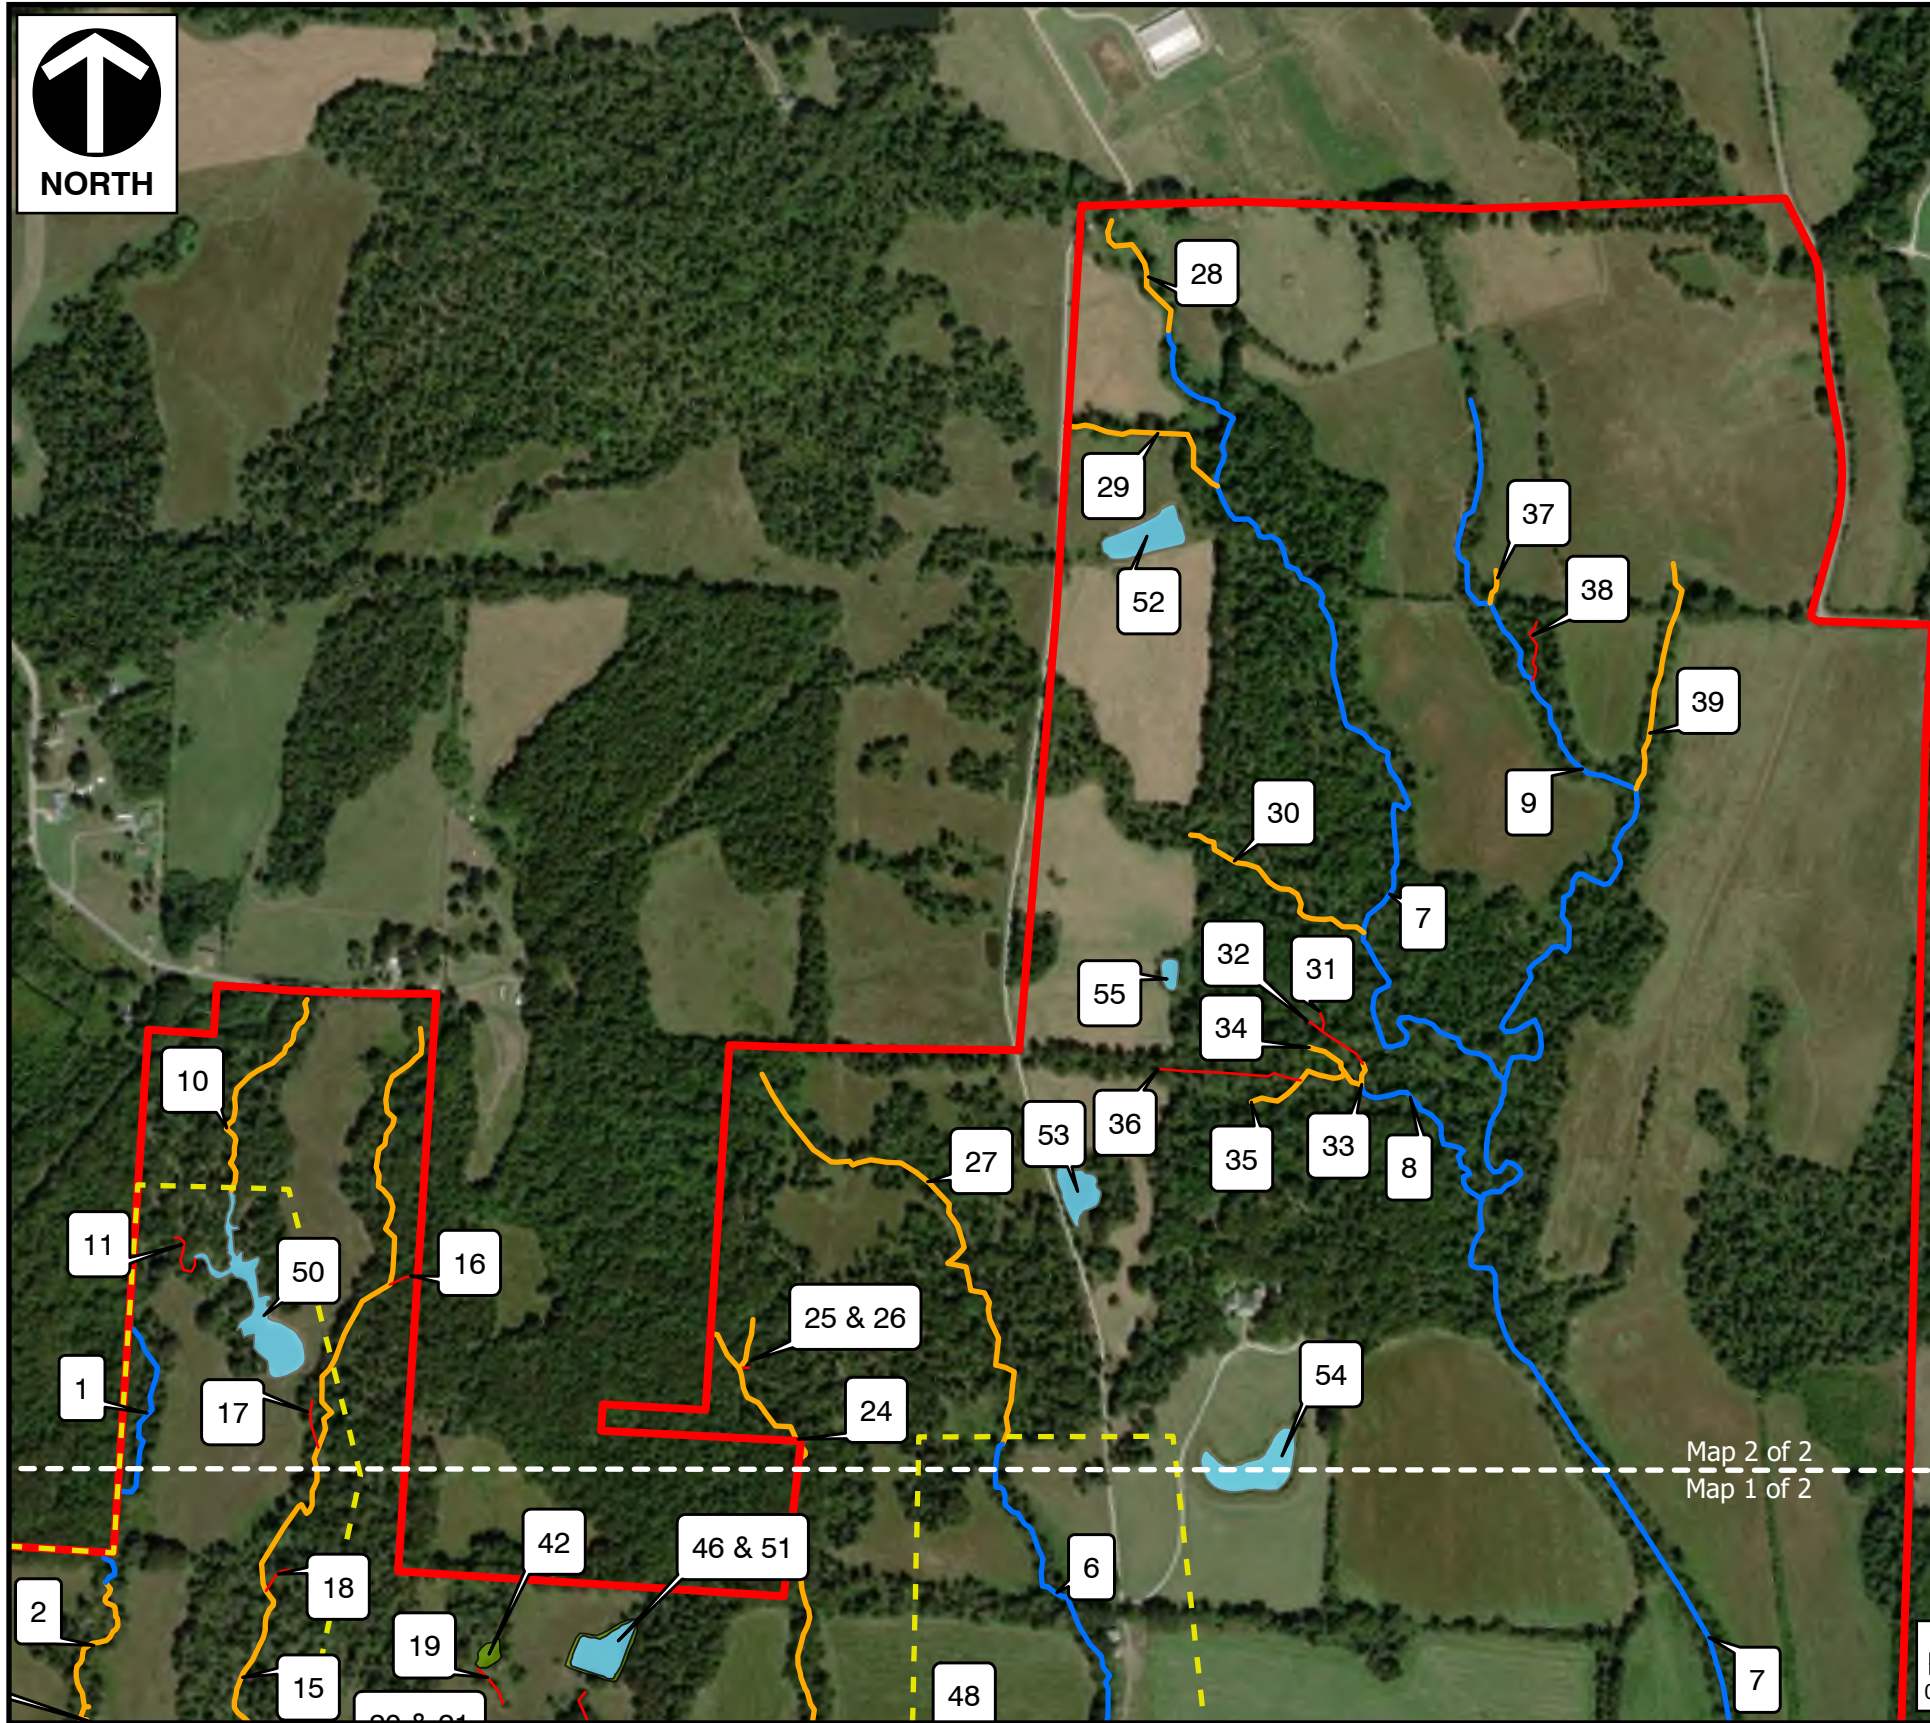
Feature Name (Map #)	Start		End		(l.f.)
STR-1 (1)	35.0384052	-89.3328008	35.0356774	-89.3330484	1,253
STR-4 (7)	35.0494910	-89.3197452	35.0325459	-89.3110940	8,179
STR-5 (8)	35.0414814	-89.3168989	35.0402861	-89.3152631	832
STR-6 (9)	35.0488570	-89.3157733	35.0415777	-89.3157733	3,736
WWC-2/EPH-2 (10)	35.0420048	-89.3306801	35.0339291	-89.3315830	917
WWC-3/UDF-1 (11)	35.0394094	-89.3323073	35.0391792	-89.3320319	239
WWC-8/UDF-2 (16)	35.0390811	-89.3291776	35.0389850	-89.3294836	98
WWC-9/UDF-3 (17)	35.0377110	-89.3304433	35.0372049	-89.3303346	188
WWC-15/EPH-9 (24)	35.0385716	-89.3252664	35.0341682	-89.3238767	1,929
WWC-16/UDF-7 (25)	35.0382175	-89.3247537	35.0382051	-89.3248806	38
WWC-17/EPH-10 (26)	35.0387347	-89.3247244	35.0382051	-89.3248806	202
WWC-18/EPH-11 (27)	35.0413712	-89.3247151	35.0374983	-89.3214197	2,136
WWC-20/EPH-12 (28)	35.0506524	-89.3205347	35.0494910	-89.3197452	575
WWC-21/EPH-13 (29)	35.0484309	-89.3210445	35.0478431	-89.3190360	736

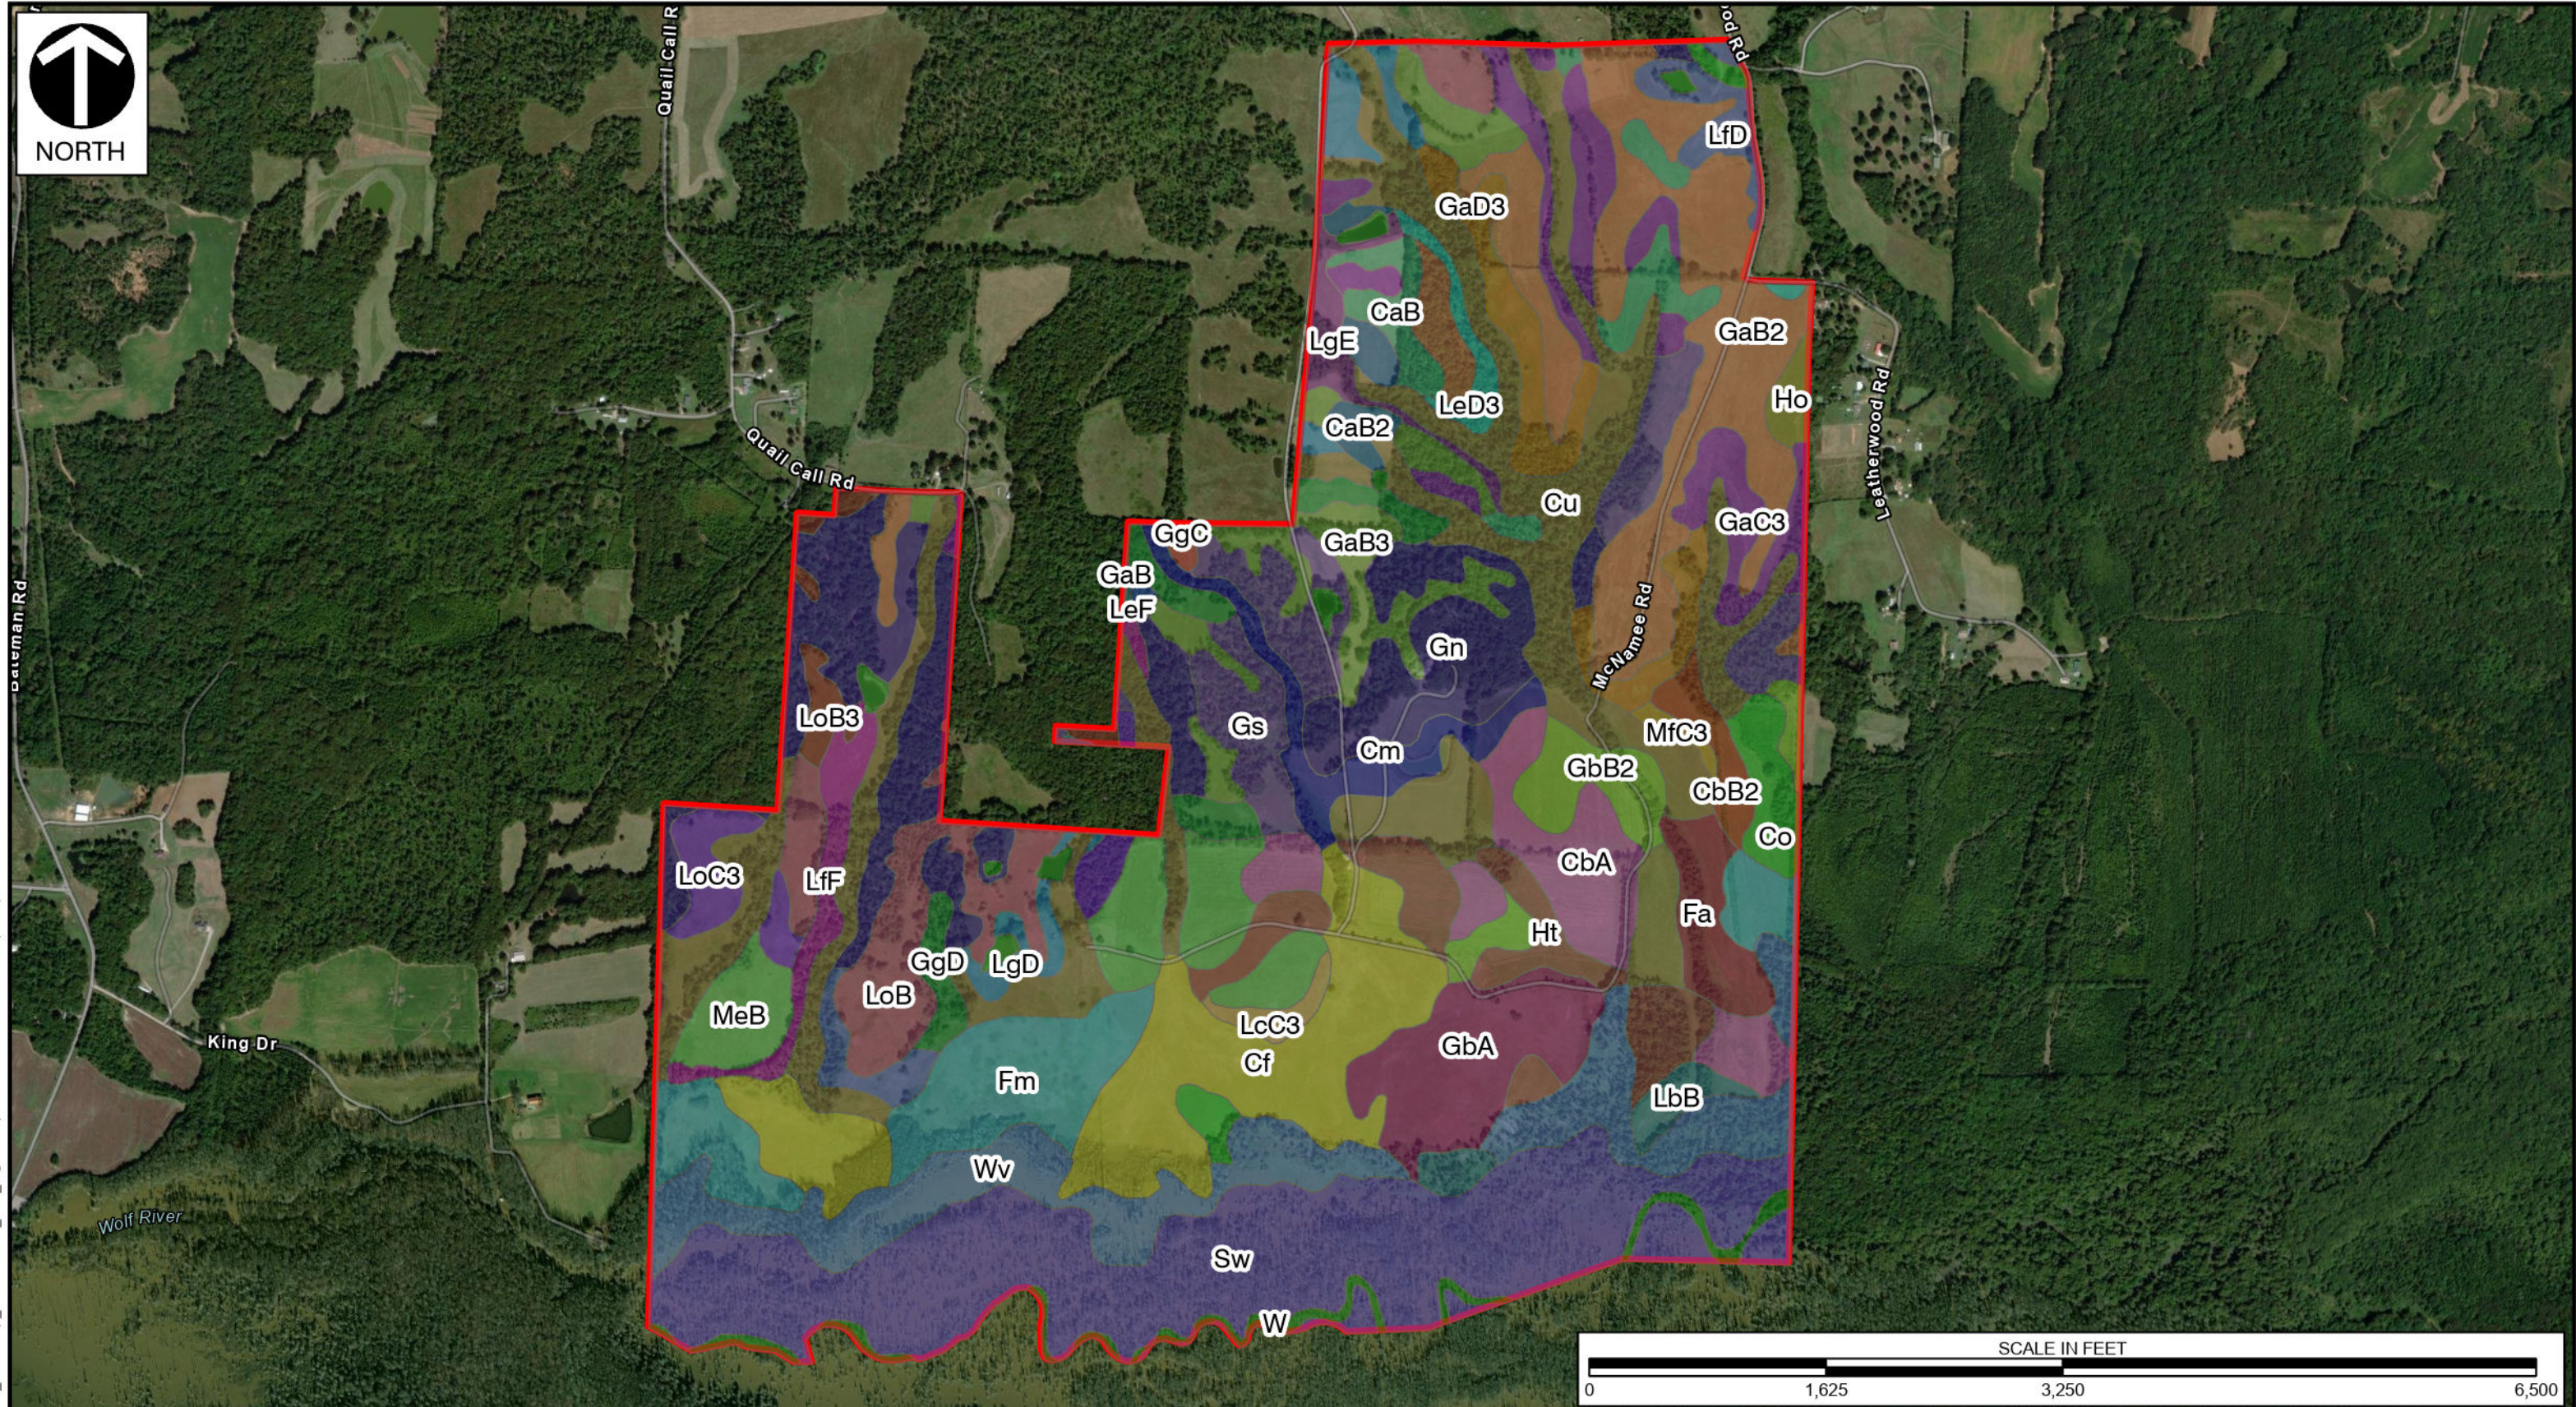
LEGEND			
Study Boundary	Falaya silt loam (Fm)	Gullied land sandy (Gn)	Loring silt loam 2-5% (LoB)
Calloway silt loam 0-2% slopes (CbA)	Grenada silt loam (GaB)	Gullied land silty (Gs)	Loring silt loam 2-5% slopes severely eroded (LoB3)
Calloway silt loam 2-5% slopes, eroded (CbB2)	Grenada silt loam 2-5% slopes severely eroded (GaB3)	Henry overwash (Ho)	Loring silt loam 5-8% slopes severely eroded (LoC3)
Calloway silt loam 2-5% slopes, moderately eroded (CaB2)	Grenada silt loam 5-8% severely eroded (GaC3)	Henry terrace (Ht)	Loring-Gullied land complex 12-20% slope (LgE)
Collins fine sandy loam, local alluvium (Cm)	Grenada silt loam 8-12% slopes severely eroded (GaD3)	Lexington silt loam (LbB)	Loring-Gullied land complex 5-12% slopes
Collins fine sandy loam (Cf)	Grenada silt loam eroded (GaB2)	Lexington silty clay loam (LcC3)	Memphis silt loam (MeB)
Collins silt loam 0-2% slopes (Co)	Grenada silt loam terrace 0-2% slopes (GbA)	Lexington-Ruston Gullied land complex 12-30% slopes (LfF)	Memphis silty clay loam (MfC3)

Collins silt loam 0-2% slopes, occasionally flooded (Cu)	Grenada silt loam terrace 2-5 % slopes (GbB2)	Lexington-Ruston Gullied land complex 8-12% slope (LdD)	Swamp (Rosebloom ponded) (Sw)
Falaya fine sandy loam (Fa)	Grenada-Gullied land complex 5-8% slopes (GgC)	Lexington-Ruston complex 12-30% slope (LeF)	Water (W)
	Grenada-Gullied land complex 8-12% slopes (GgD)	Lexington-Ruston complex 8-12% slopes (LeD3)	Waverly (Wv)

Swamp (Rosebloom ponded (Sw)) and Collins (Cu). Furthermore, a site assessment evaluating the current soil and hydrologic conditions and a thorough onsite evaluation of mitigation potential confirmed that the site would have a high probable rate of success, can meet the proposed performance standards, and would be an ideal location for proposed restoration.
