# OPERATION MAKE SAFE PROJECT UPDATE Nov. 16, 2011

## Birds Point - New Madrid Floodway Missouri

**New Madrid Project Office**

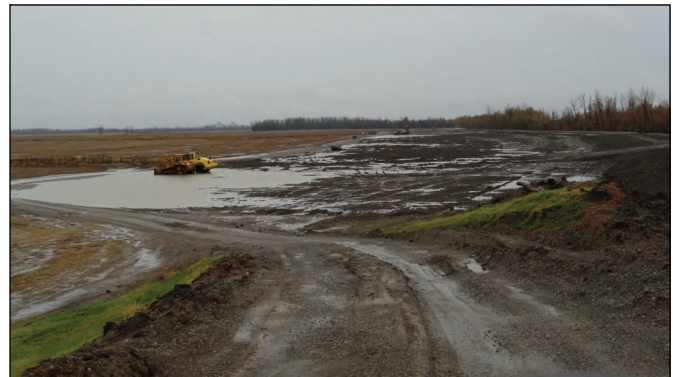
**Water pools at the upper crevasse Tuesday. More than four inches of rain has fallen since Monday night.**

**Upper crevasse:** A Corps of Engineers crew consisting of 26 personnel and 30 pieces of heavy equipment is on site here, at two nearby borrow sites, and at a maintenance facility. Survey results indicate that the entire 9,000 feet of levee is at or above a (Cairo) gage elevation of 51 feet. Before Monday night’s rain, crews had made excellent progress filling the land side of the levee back to level grade. Limited work to 55 feet has begun, with nearly 4,000 feet of foundation in place. Work will resume as the weather and ground conditions allow.

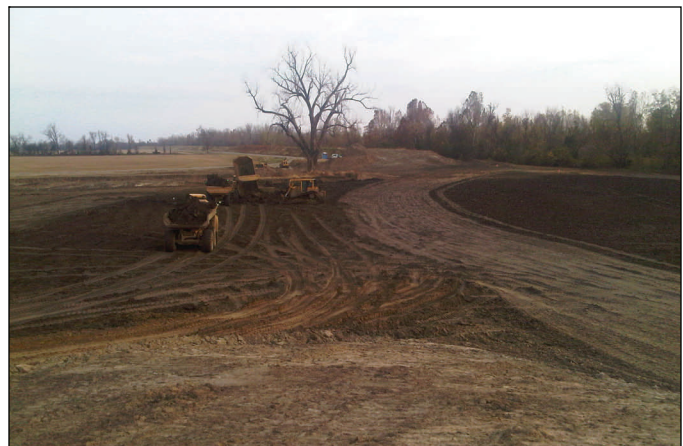
**Crews deliver and spread clay Monday at the center crevasse.**

**Center crevasse:** A Corps of Engineers crew consisting of 27 personnel and 20 pieces of heavy equipment is on site here and at a nearby clay borrow site. Four additional 25-ton off-road dump trucks were delivered last week, bringing the total number of trucks to eight. The 10-man night shift moved here Nov. 11. Work will resume as the weather and ground conditions allow.

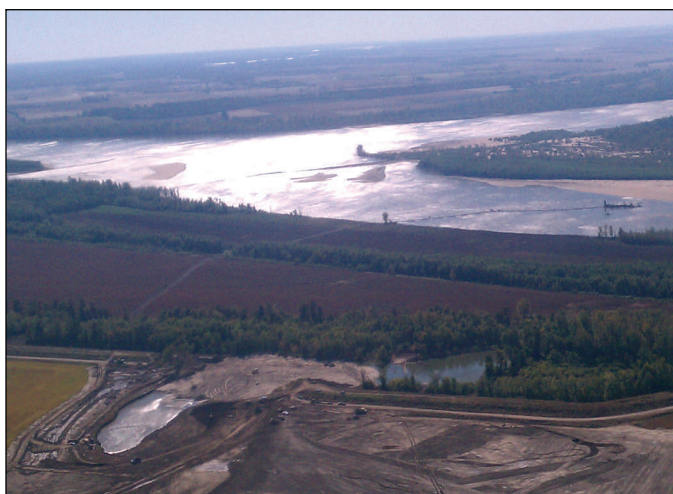
**The center crevasse scour hole as seen from the air Oct. 25. The dredge lowa is visible in the channel at top right. (Photo by Brad Hahn, courtesy of Great Lakes Dredge & Dock Company)**

The center crevasse is located near Seven Island Conservation Area. Repairs are required for 800 feet of levee at this location. A scour hole developed here, connecting with the existing 1937 scour hole. Work here includes separating the two scour holes, filling the new scour hole using sand dredged from the river bottom, and repairing the levee to the interim grade.

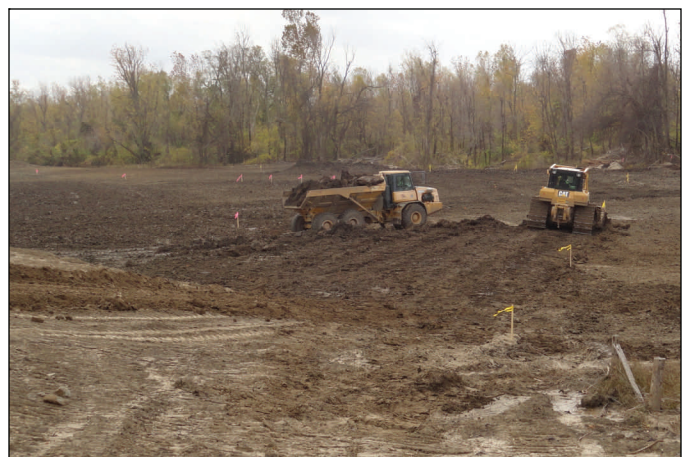
**Crews deliver and spread clay Sunday at the center crevasse.**
