OPERATION MAKE SAFE PROJECT UPDATE Sept. 2, 2011

Birds Point - New Madrid Floodway
Missouri

New Madrid Project Office

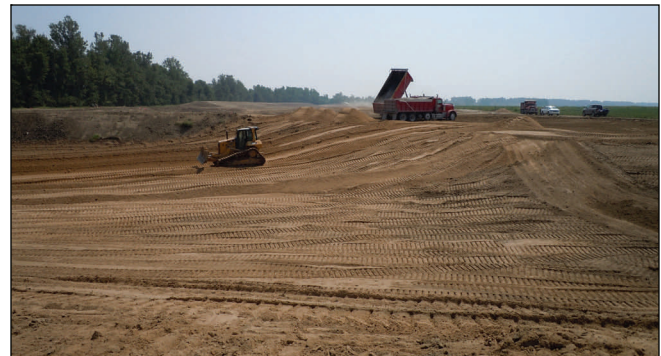
Filling the final scour hole with sand at the upper crevasse near Birds Point. A total of 132,740 tons of sand were delivered for the contract.

The upper crevasse is located at Birds Point, near the confluence of the Mississippi and Ohio rivers. Repairs are required for 9,000 feet of levee at this location. Work here includes filling five scour holes back to level grade, repairing four levee segments and constructing one segment realignment.

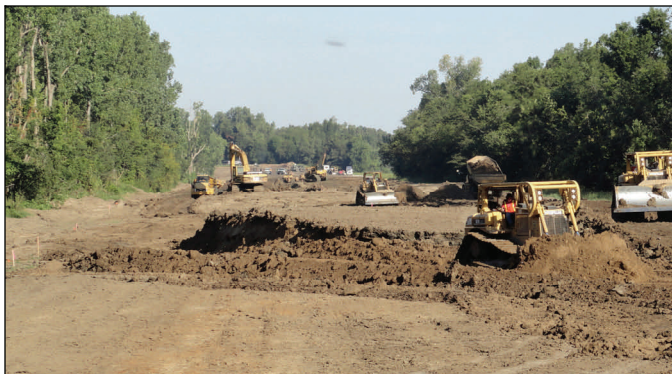
A flurry of activity at the lower crevasse. The crew is preparing the levee foundation and embankment material at the eastern end in preparation for repairs here.

Lower crevasse: A Vicksburg District crew consisting of 16 personnel and 13 pieces of heavy equipment are on site. Crews continue to make excellent progress drying oversaturated soil and placing material into a 2,000-foot levee segment.

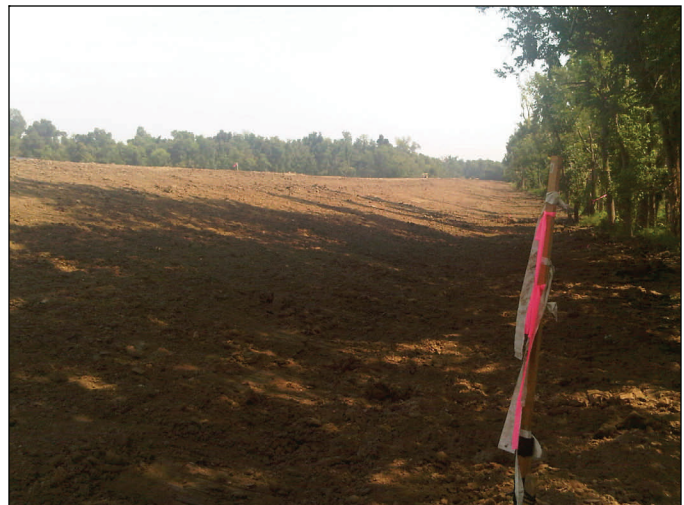
The levee at the western end of the lower crevasse is now within one foot of the interim protection elevation.

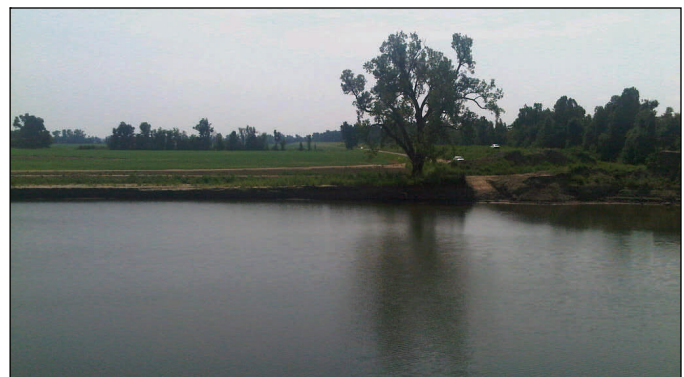
Center crevasse near Seven Island Conservation Area. The existing levee is visible behind the tree.

The center crevasse is located near Seven Island Conservation Area. Repairs are required for 800 feet of levee at this location. A scour hole developed here, connecting with the existing 1937 scour hole. The scope of work and construction schedule will be determined following completion of an environmental assessment in mid-September.
