Memphis Metropolitan Area Stormwater
Cypress Creek
Ecosystem Restoration
Feasibility Study
With Integrated Environmental Assessment

Draft

December 2015

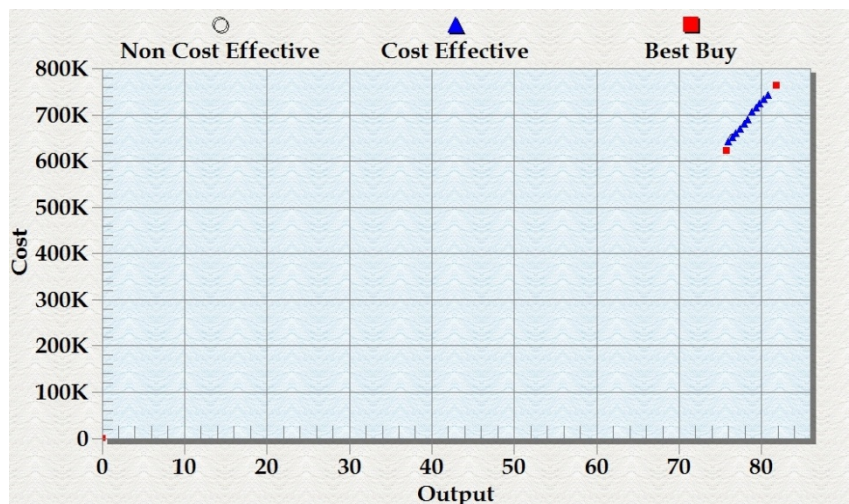
Figure 6. CE/ICA Results comparing average annual habitat units and average annual costs. (Average Annual costs were calculated based on a 3 year construction schedule and using the FY 2016 interest rate of 3.125%)

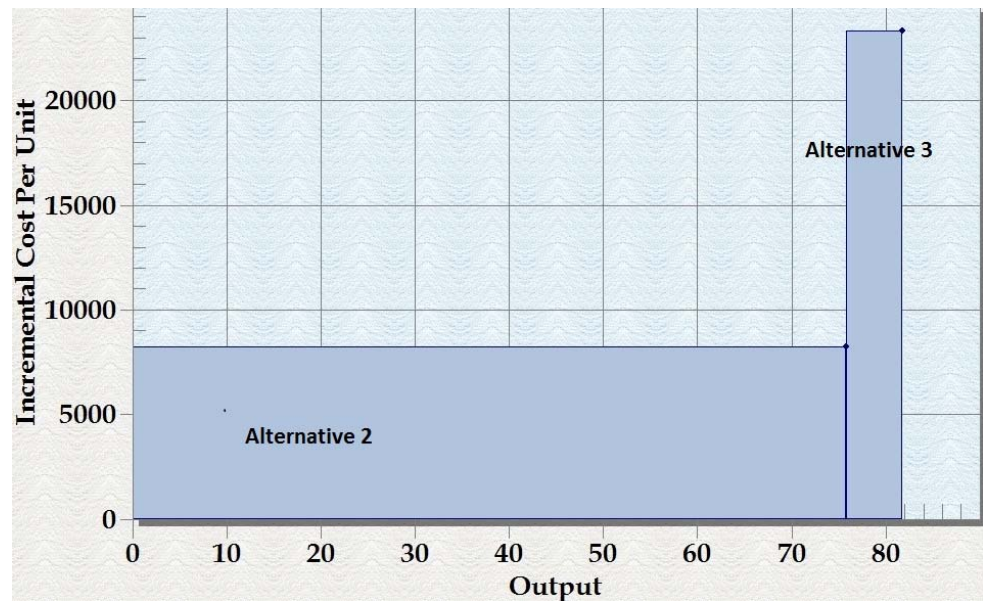
Figure 9. Comparison of alternatives using average annual cost and average annual habitat units.

The CE/ICA model compared results for Alternatives 2 and 3. Alternative 2 is more efficient and produces more habitat units per dollar than Alternative 3.

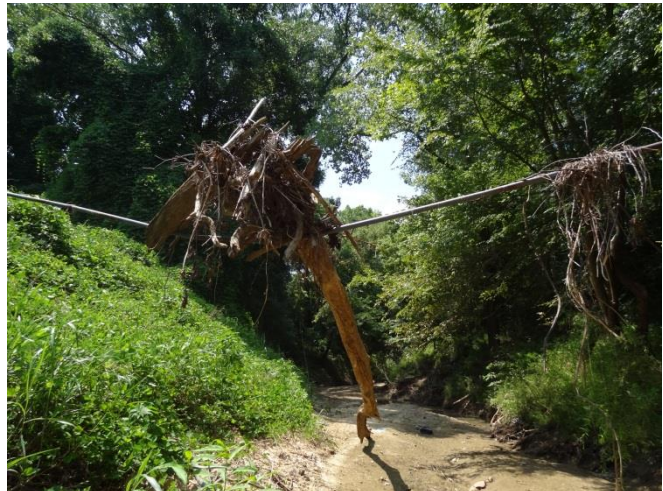
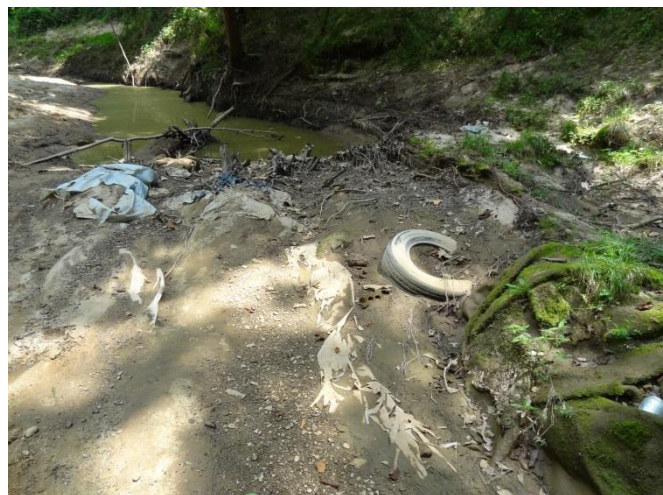
Mebane Road was the easternmost reach of Cypress Creek, and nearest its headwaters. It was the narrowest site (average width = 7.0 m; range 3.0-10.1 m) and its streamside habitat was forested (abandoned field) on the north bank and row crops on the south bank with a relatively wide buffer zone. Residential housing was not present near the site. The Mebane Road section of Cypress Creek could be considered an “interrupted flow” stream because portions of it were completely dry at the time of sampling (Figure 8, right). However, evidence of a torrent event was present in the form of a large tree, trapped by its roots in the overhanging electrical wires across the stream at Transect K. The Mebane Road site had a deep bend that prevented visualization of the entire reach from one end to the other. A very small side stream (~1 m) joined this section of Cypress Creek from the southern bank between Transects H and I (Figure 8, right). Household materials (furniture, carpet, tires, etc.) had been dumped into the mid-portion of the site. Poison ivy *Toxicodendron radicans* was a dominant stream-side plant and the invasive kudzu *Pueraria lobata* and privet *Ligustrum sinense* occurred sporadically throughout the reach. Tree species along the banks included birch, box elder, elm, oaks, sweet gum, sycamore and willow. Animal tracks indicated

the presence of raccoon and heron, and Fowler's toads were observed on site. The site had very little noise pollution and the road was lightly traveled during the sampling period.

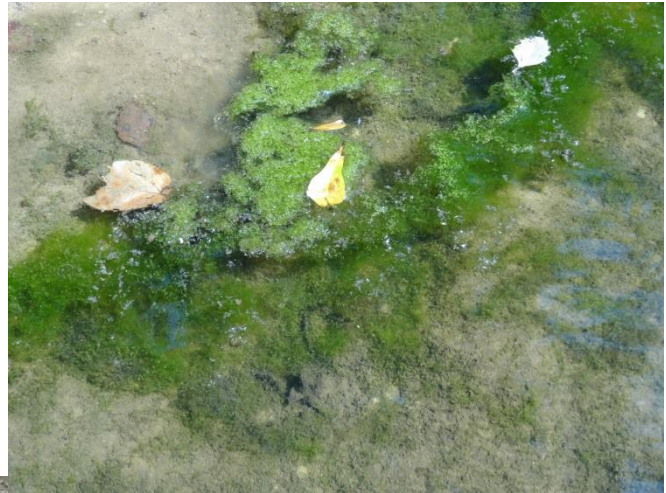
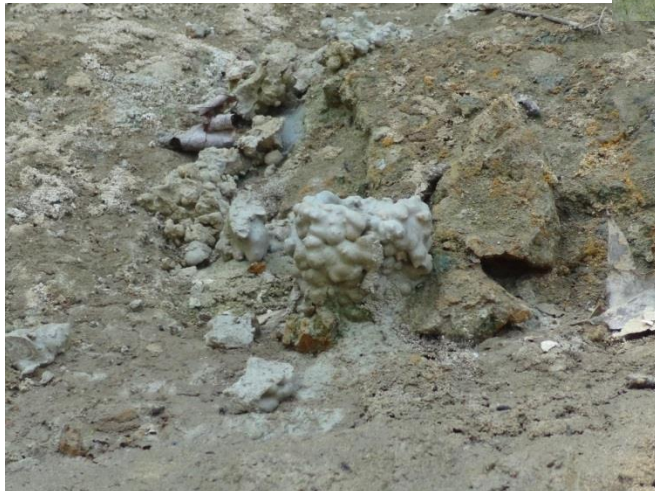
The **Hwy 196** site was slightly wider (average width = 9.4 m; range 2.7-13.0 m) than the Mebane Road site and streamside habit was forested (abandoned field) on the north bank and agricultural with a relatively narrow buffer zone on the south bank. Hwy 196 had water throughout its reach, but its flow was restricted to its deepest meanders when it was sampled. An approximately 3-m side stream joined this section of Cypress

Creek from the southern bank between Transects B and C (Figure 8, center). A large sewer pipe drained the agricultural field south of this section of Cypress Creek about 50 m upstream of Transect K. Some interesting findings at the Hwy 196 site included presence of algae and crawfish chimneys. Swallow nests were built on the west side of the bridge overpass suggesting

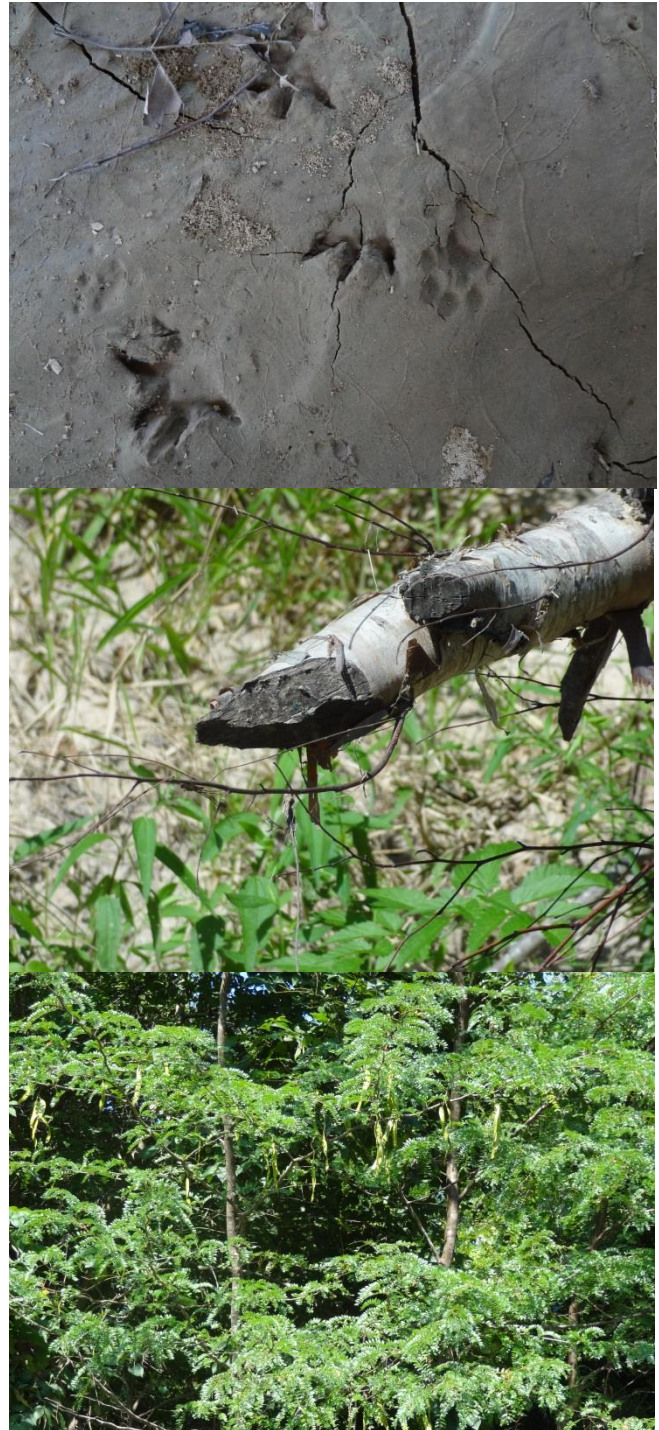
The **Hwy 205** site represented the terminal portion of Cypress Creek, and occurred in a section of the stream that was actually referred to as a “canal”. This reach was consistently the widest (average width = 16.4 m; range 15.2-17.7 m) and the straightest of the three sampled, with an unimpeded view of the entire reach. Streamside habitat was forested on the north bank and agricultural with a narrow buffer zone on the south bank. A transmission right-of-way intersected this section of Cypress Creek at Transect A on the north bank. Hwy 205 had water throughout its reach. An approximately 6-m side stream converged from the north between Transects H and I with this section of Cypress Creek (Figure 8, left). Animal tracks of coyote, deer, raccoon and heron were observed, as was evidence of beaver activity. Algae were present on and near the rip-rap at the downstream section of the site closest to the bridge overpass. Plants on the south bank included grasses and native cane, kudzu and privet. The north bank had much less kudzu and privet. Tree species were similar to those found at the other sites and also included locust, pawpaw and tulip poplar. This site was also very noisy because maintenance crews were resurfacing the road during the sampling period. The bridge overpass seemed to have a relatively steady stream of primarily passenger vehicle traffic.

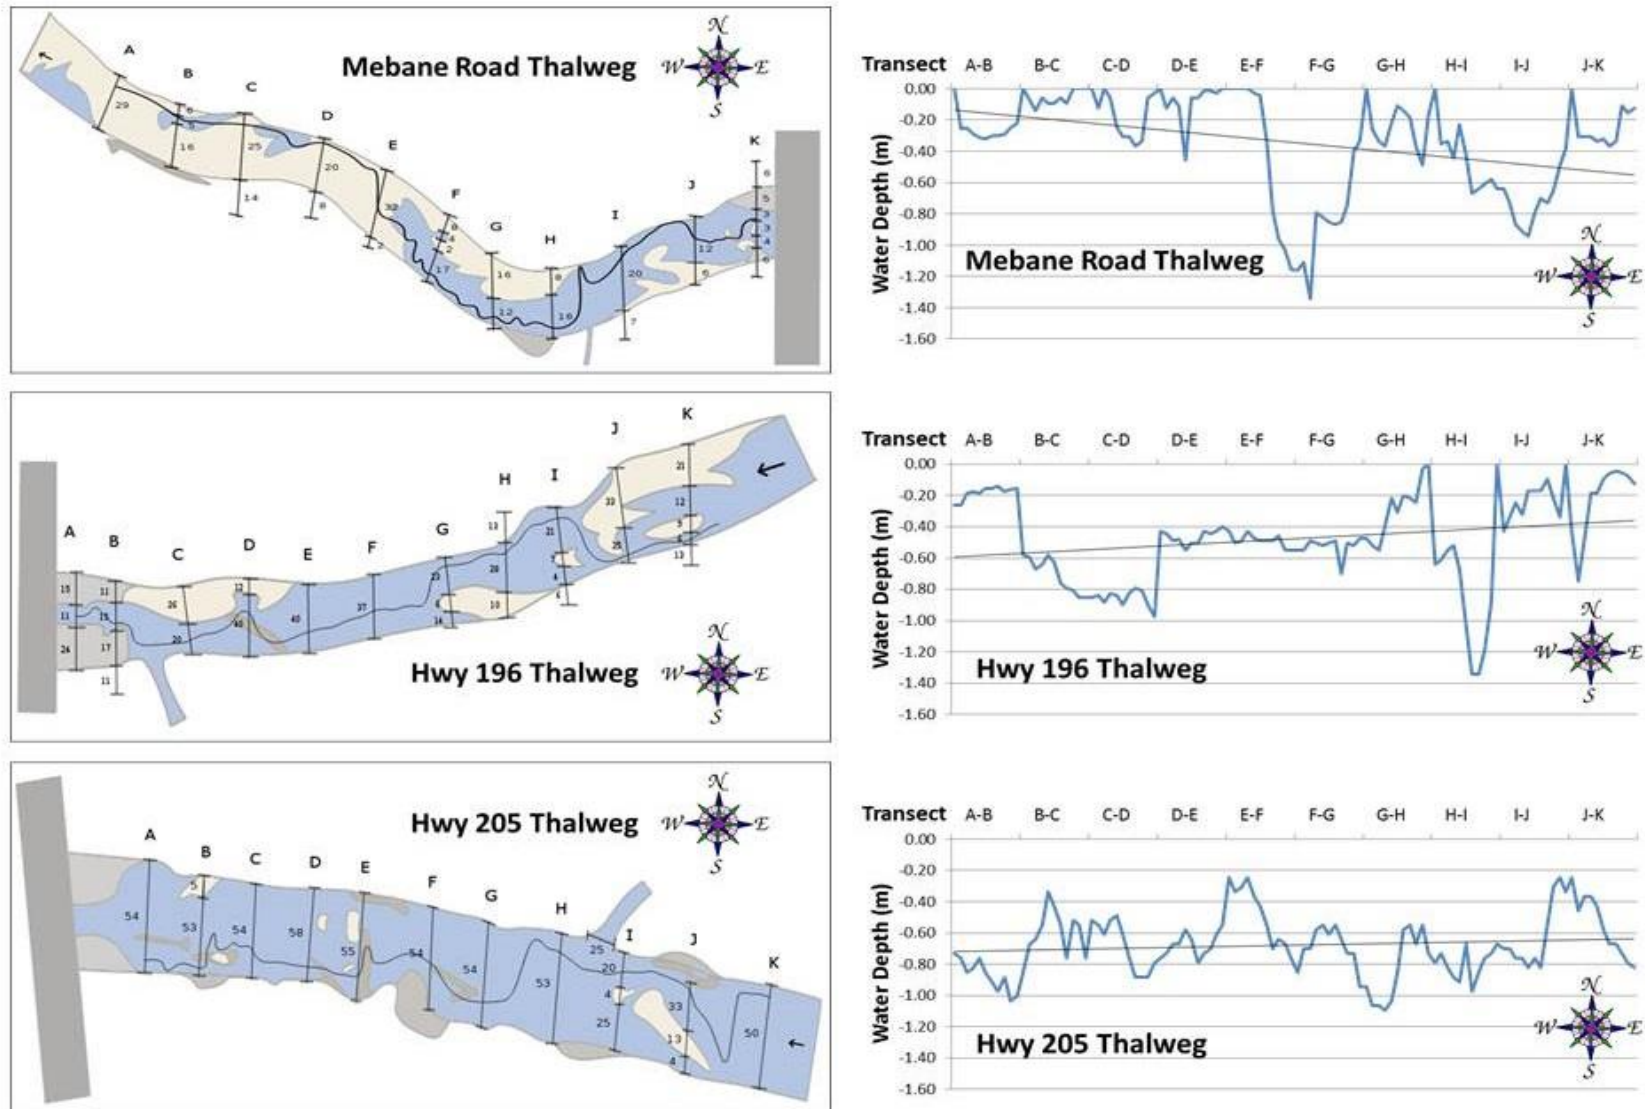
Figure 10. Thalweg (black line; left panels) and thalweg depth (m; right panels) for three locations at Cypress Creek, Shelby and Fayette County, Tennessee. A trendline is indicated in grey on the thalweg water depth.

Thalweg depth measurements for Mebane Road indicated the presence of two pools of at least 1-m depth in the upstream section of the reach. A trendline applied to the measurements indicated that the waters were deeper upstream and tended to get shallower at the downstream part of the reach. This reverse direction of the trendline for the Mebane Road site might be expected, given that its transects were established immediately downstream of a bridge overpass where rip-rap and other bank stabilization methods might have caused pools to develop. Thalweg depth measurements for Hwy 196 also indicated two pools of at least 1 m in depth, but the first was in the upper end of the reach and spanned the H-I transect and the other was in the downstream end of the reach and spanned two (the B-C and C-D) transects. The section of stream between the pools had a thalweg depth of ~0.5 m. The Hwy 196 trendline indicated that the thalweg got deeper as it proceeded downstream, which would be the expected response. The thalweg depth profile for Hwy 205 indicated an inconsistent depth along the reach and indefinite indication of specific pool features. Thus, the trendline for Hwy 205 was relatively flat. Trendlines for the three reaches, while not a statistical analysis, indicated that thalweg depth increased as Cypress Creek proceeded downstream.

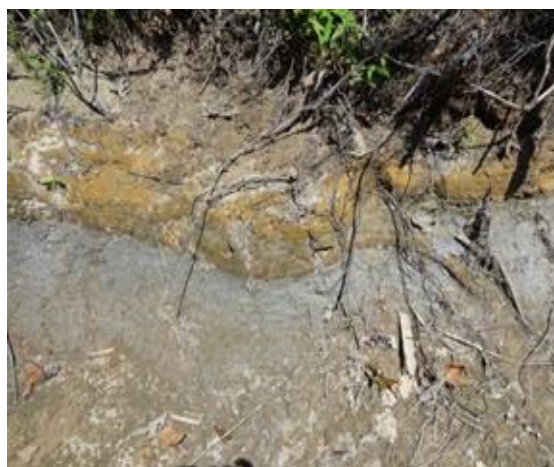
Figure 11. Exposed clay layer at Cypress Creek, Shelby and Fayette County, TN. Photo taken at Hwy 196 Transect D.

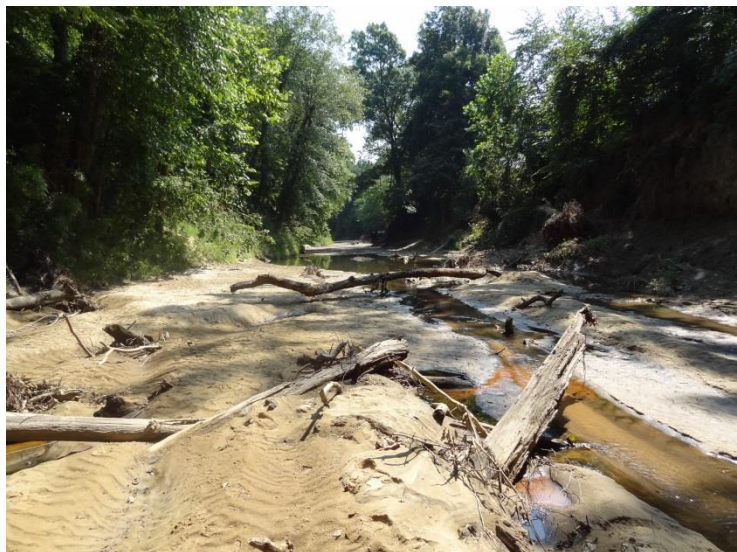
maintenance of populations than sites sampled upstream. Over 30% of the reach was considered a mixture of stable habitat. In this photo of the Hwy 196 site, the predominant aquatic habitat type is fallen logs. These would provide some habitat structure when submerged. They will cause sediment deposition, altering the water flow pattern and also the pool structure. However, the presence of such a large number of snags is

troubling, because it indicates the instability of the stream banks and the long-term loss of natural vegetation as stream banks continue to erode.

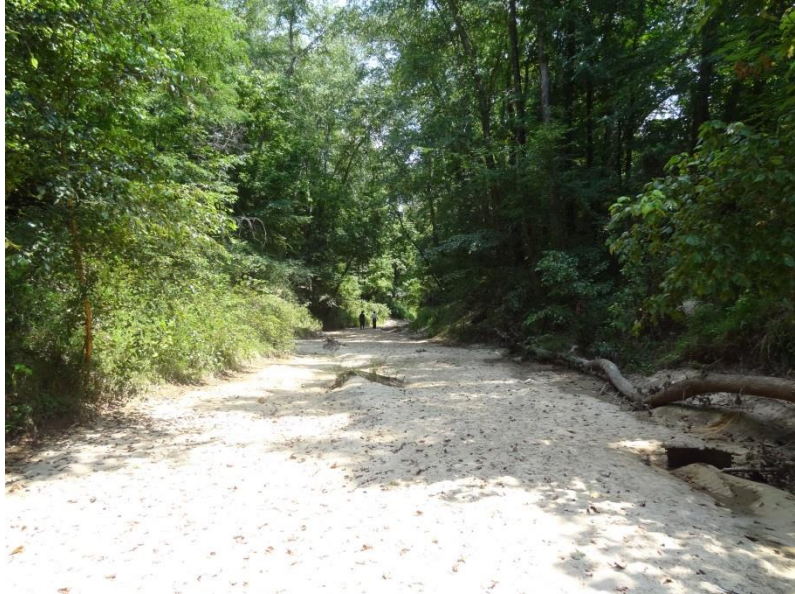
Channel Flow Status is an expression of the degree to which the channel is filled with water. This measure varied from “Poor” at the upstream Mebane Road site (as can be seen in the photo to the right, extensive portions of this reach were without water) to “Sub-optimal” at the most downstream site sampled. The amount of water in this stream is highly variable due to rain

events, increasing many-fold following a rain to water volumes that may even result in the stream being intermittent in flow during dry intervals. At the time of sampling, very little water was present in the channel at the Mebane site and was mostly present as standing pools. Water filled 25-75% of the available channel with some riffle substrate exposed at the intermediate location and water filled over 75% of the available channel with less than 25% of the substrate exposed at the most downstream sampling site. During conditions of lowered water flow, few habitats are available, and conditions following strong rain events result in strong current flows with little protection for aquatic organisms. This high flow removes habitat structure such that over time little habitat diversity remains to support biological diversity.

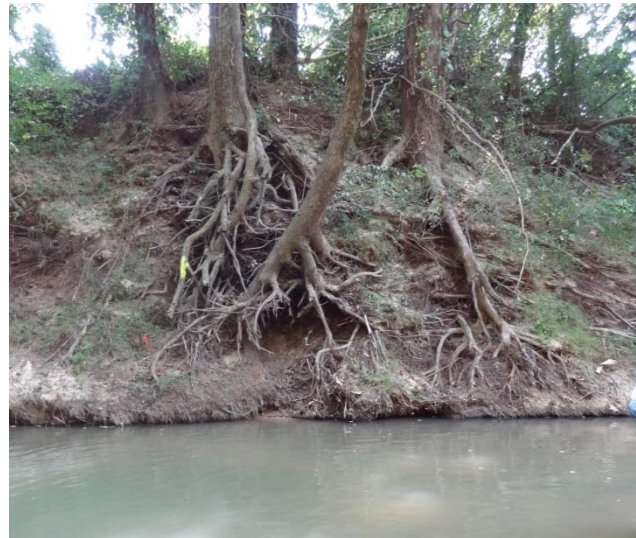
Bank Stability measures the susceptibility of the stream bank to erosion. Steep banks are considered to be unstable and are more likely to collapse than gently sloping banks. Unstable banks exhibit crumbling, unvegetated banks with exposed tree roots and exposed soil. This variable was considered “Marginal” at best along both banks in the reaches of Cypress Creek that were sampled. Many of the large tree specimens had exposed root systems and will no doubt succumb to erosion pressure in the near future. Thirty to sixty per cent of the banks exhibited severe signs of erosion. The eroded banks present in Cypress Creek reflect sediment movement, and provide a scarcity of cover and organic input to the stream.

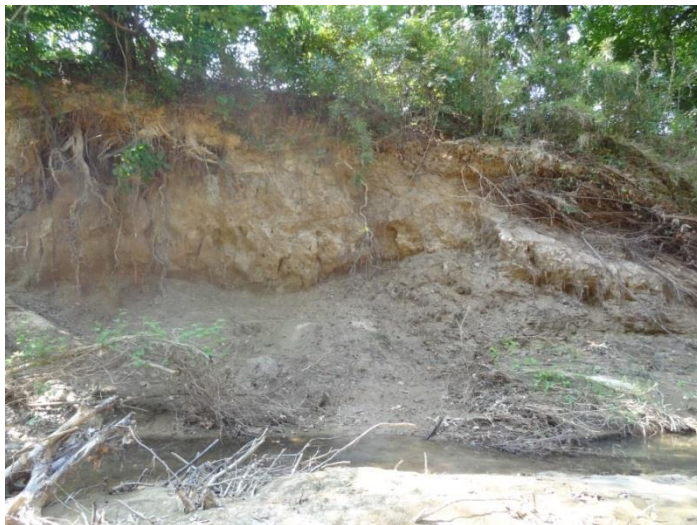
Bank Vegetative Protection measures the protection that plants afford to the stream bank and the near-stream portion of the riparian zone. The presence of root systems stabilizes stream banks, reducing the amount of soil lost to erosion. Vegetative banks provide habitat for fish and aquatic invertebrates. This variable was considered to be “Marginal” on both banks at all three sampling sites. The most downstream site, Highway 205,

exhibited patches of bare soil with little vegetative covering. The absence of good vegetative covering on the banks reflects the scouring effects of high water flows and contributes to the erosion of soil into the stream. The lack of peripheral plant growth along the stream provides little habitat coverage for aquatic organisms where the potential for high biodiversity is not realized.
