Wattensaw Bayou Mitigation Bank Prospectus

Lonoke County, Arkansas

Presented to the USACE Memphis District in February 2021

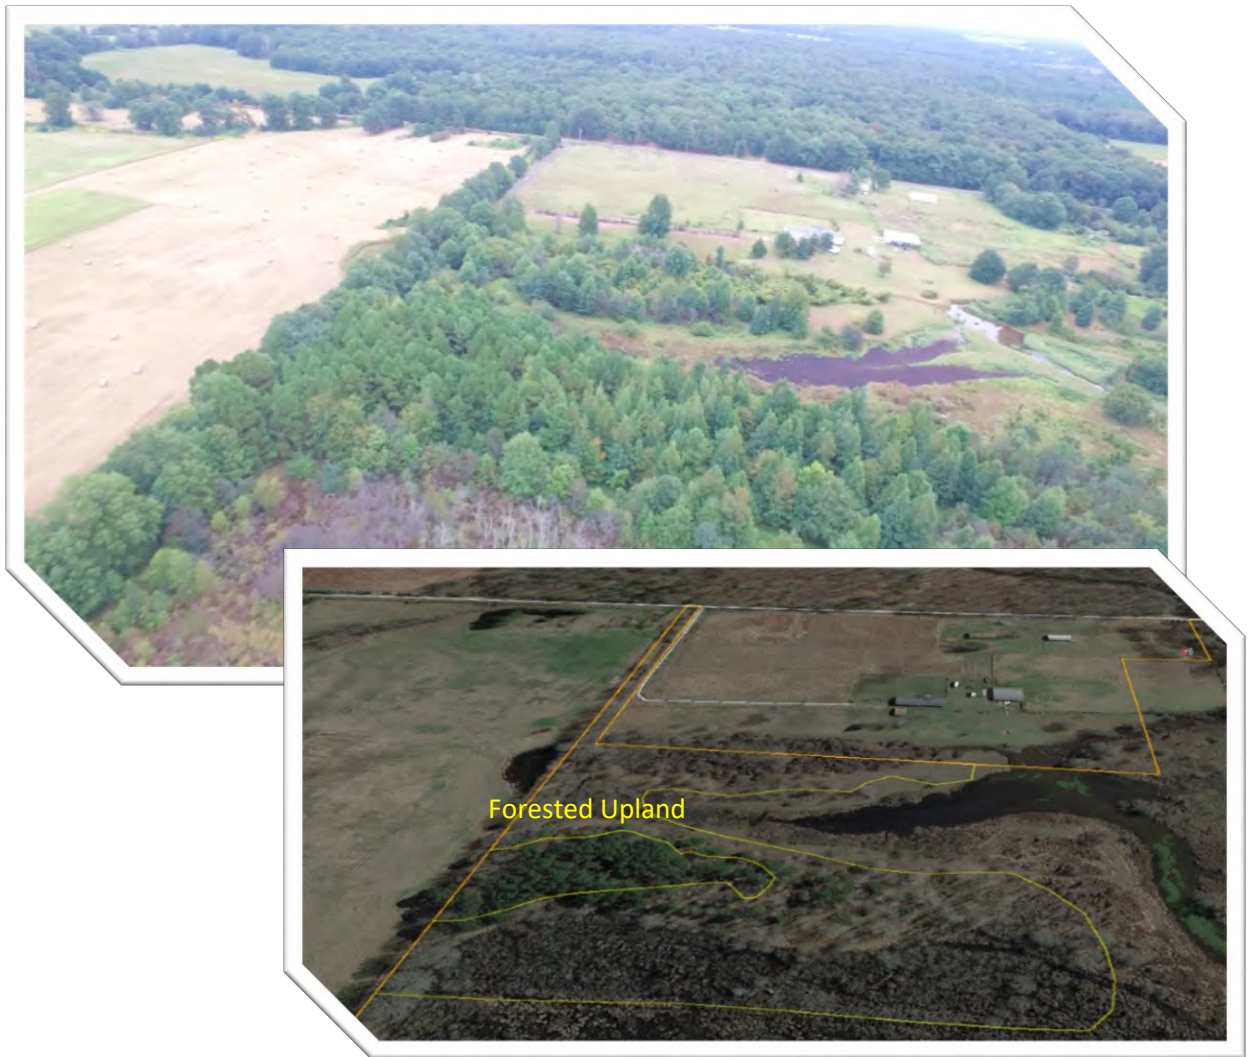
The elevation gradient between the wetland and the upland habitat in this area is gradual; nevertheless, the imagery above (taken on September 13, 2017) juxtaposed with the Google Earth derived figure and images from the September 11-13th site visit (Appendix B), validate the delineated boundary from field work conducted September 11-13th, 2017.

Soil type mapped for the upland area, located just south of the access road, is Tichnor silt loam, frequently flooded. This upland (data point R-1) failed to exhibit hydrophytic vegetation, hydric soil, and wetland hydrology indicators (Appendix B).
