HORSE CREEK STREAM AND WETLAND MITIGATION BANK

PROSPECTUS \ \ JUNE 2020

SOUTH FORK FORKED DEER WATERSHED
HUC 08010205

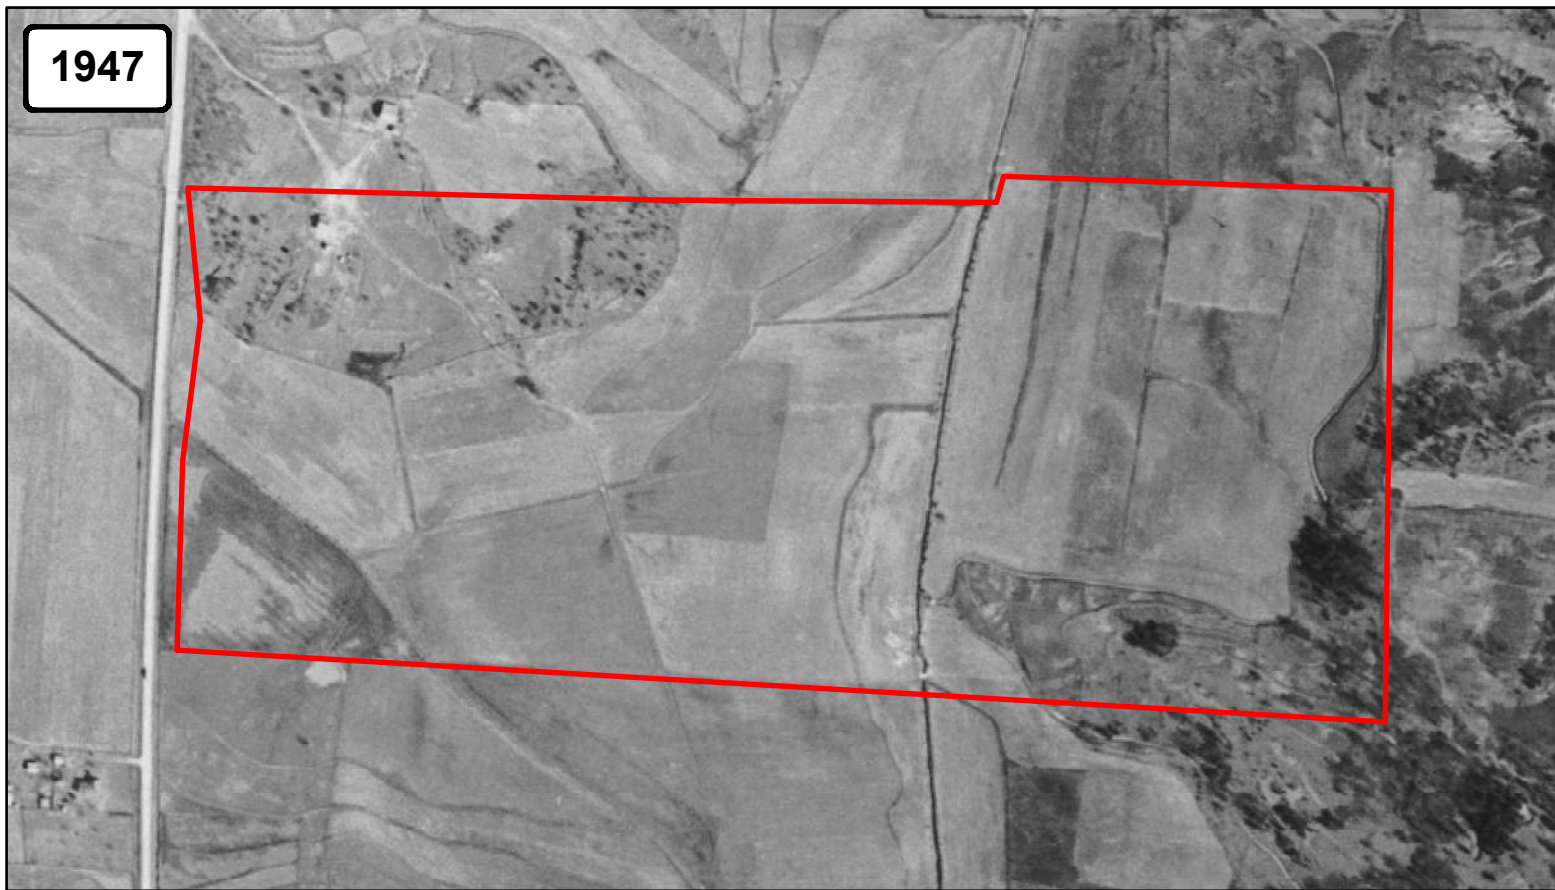
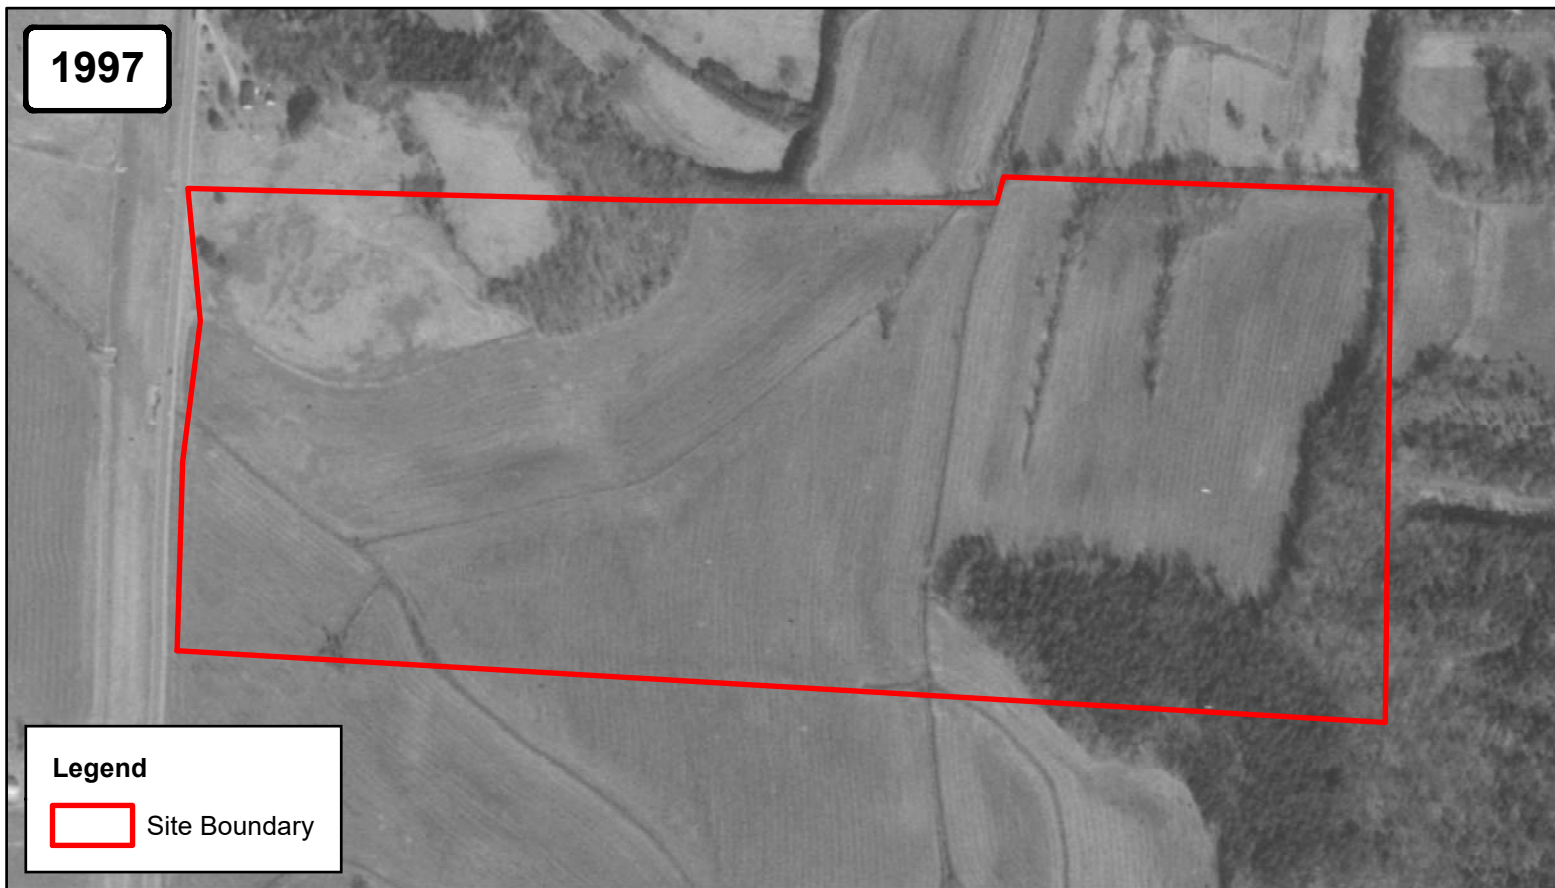
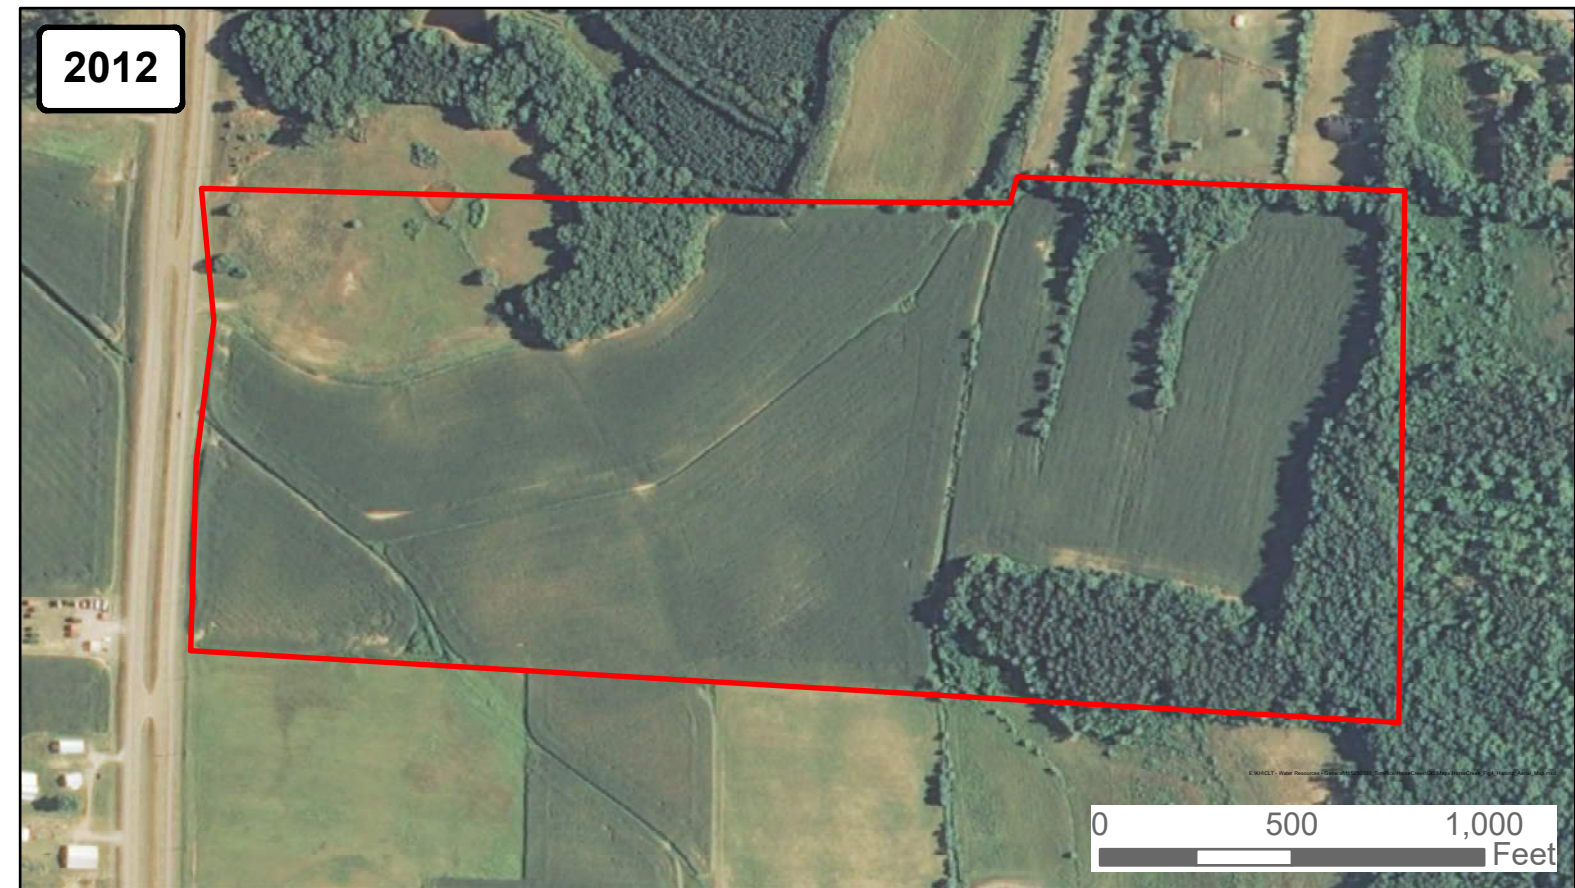
Figure #4
Chester County, TN
6/22/2020

Historic Aerials Map

Based on apparent saturation present on historical aerial imagery, and apparent saturation noted during the site visit, multiple areas within the agricultural fields were evaluated. These were present in two sub areas, one being areas on the northeast portion of the site adjacent to the inundated Bibb soils, and the other being slightly low-lying areas in the central agricultural portion of the site that collect and hold surface water flow. Hydrology in both these areas appears to be sourced from overland flow that pools in these slightly lower areas and slowly drains or percolates.

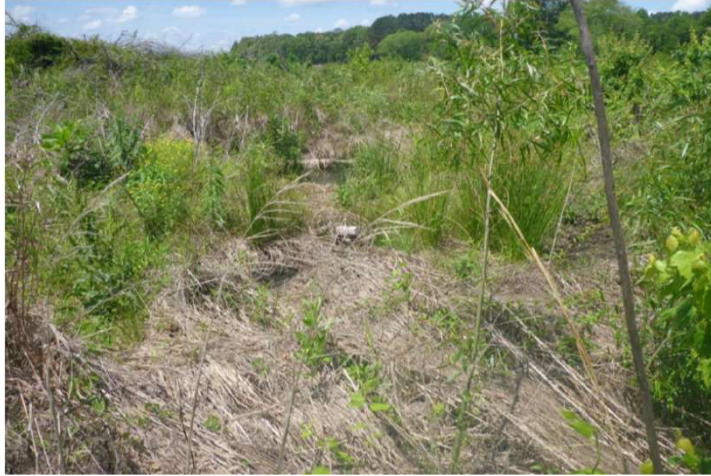
Photo No. 9

Remarks: Typical conditions in scrub/shrub wetland in Bibb soils in northeast of site

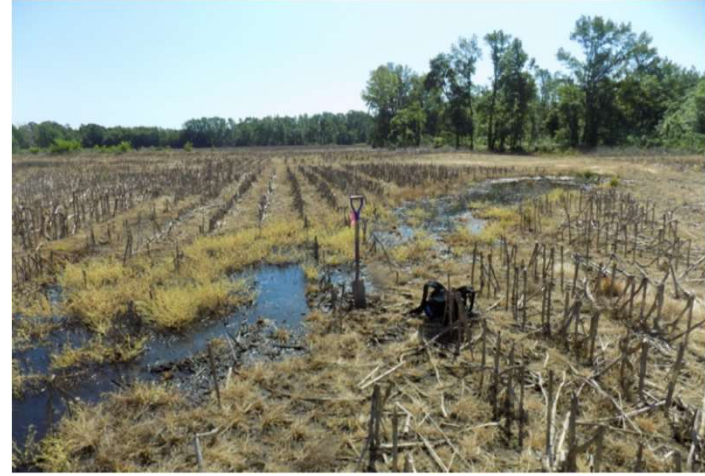
Photo No. 10

Remarks: Typical wetland conditions in west agricultural fields

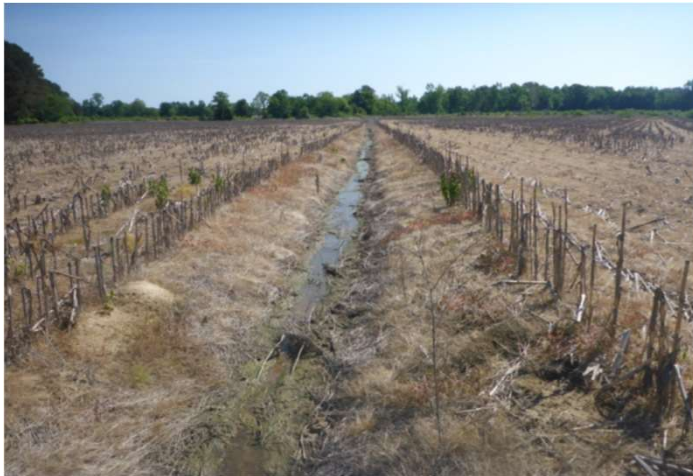
Photo No. 11

Remarks: Typical agricultural ephemeral ditch in west field

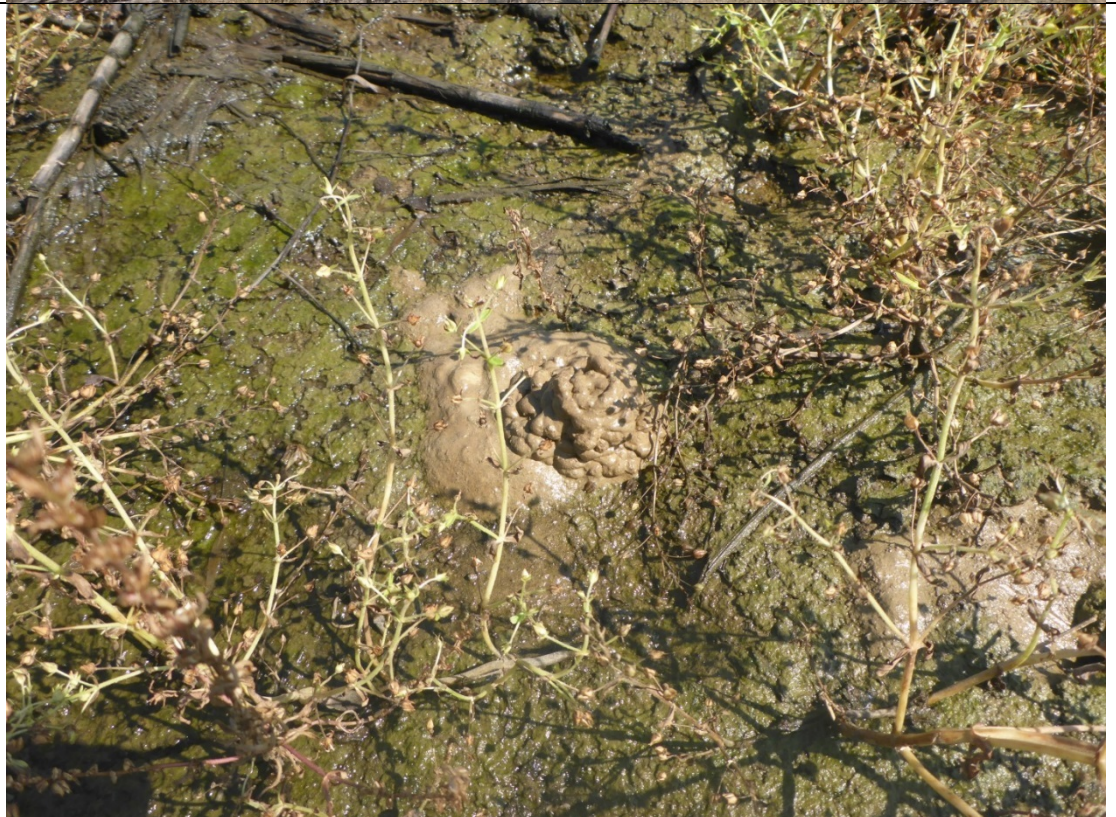
Typical hydrology indicators within the wetland areas of the agricultural fields, including Crayfish burrows, algal growth, and vegetative shift

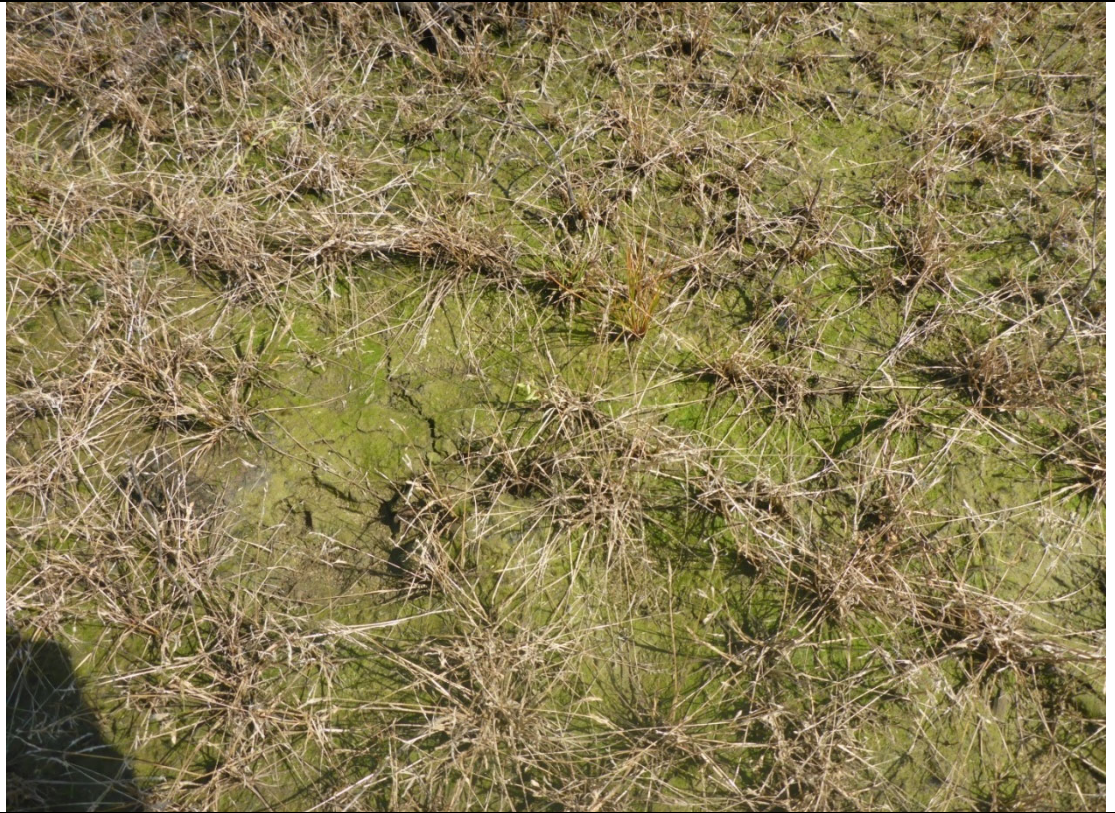
Typical hydrology indicators within the wetland areas of the agricultural fields, including algal mat, and some limited soil cracks

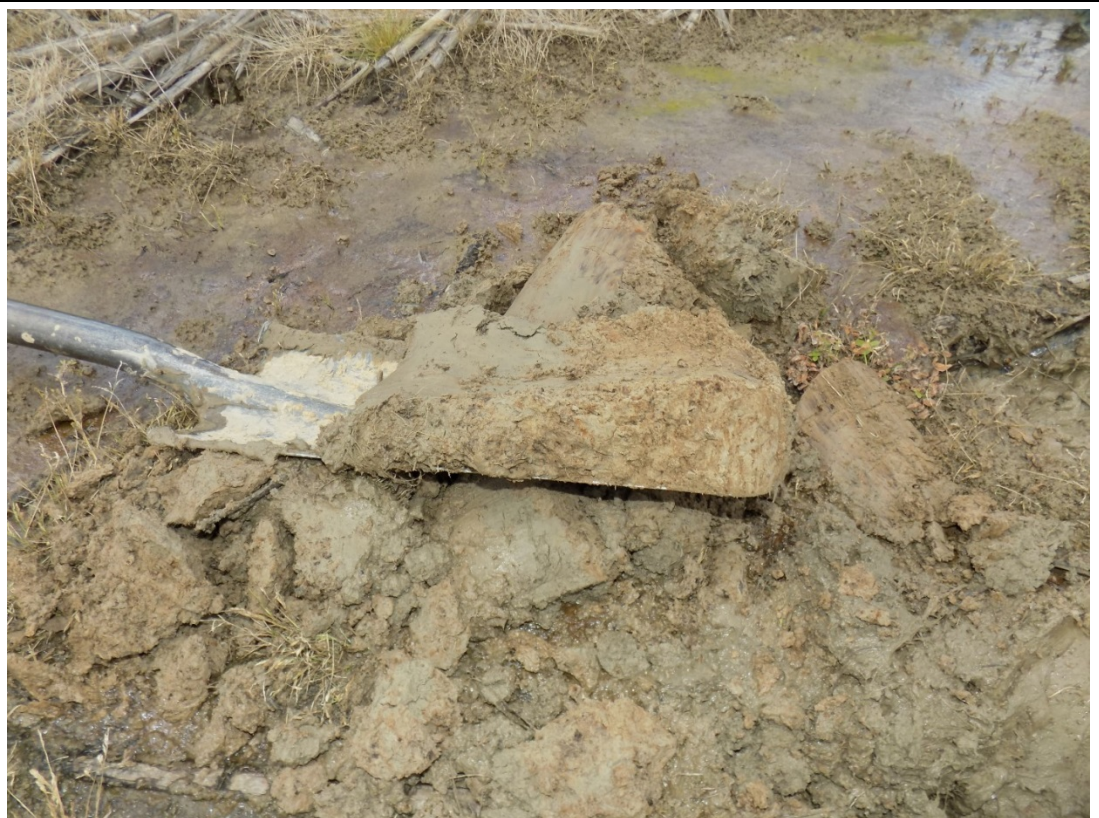
Hydric soils from SP-9

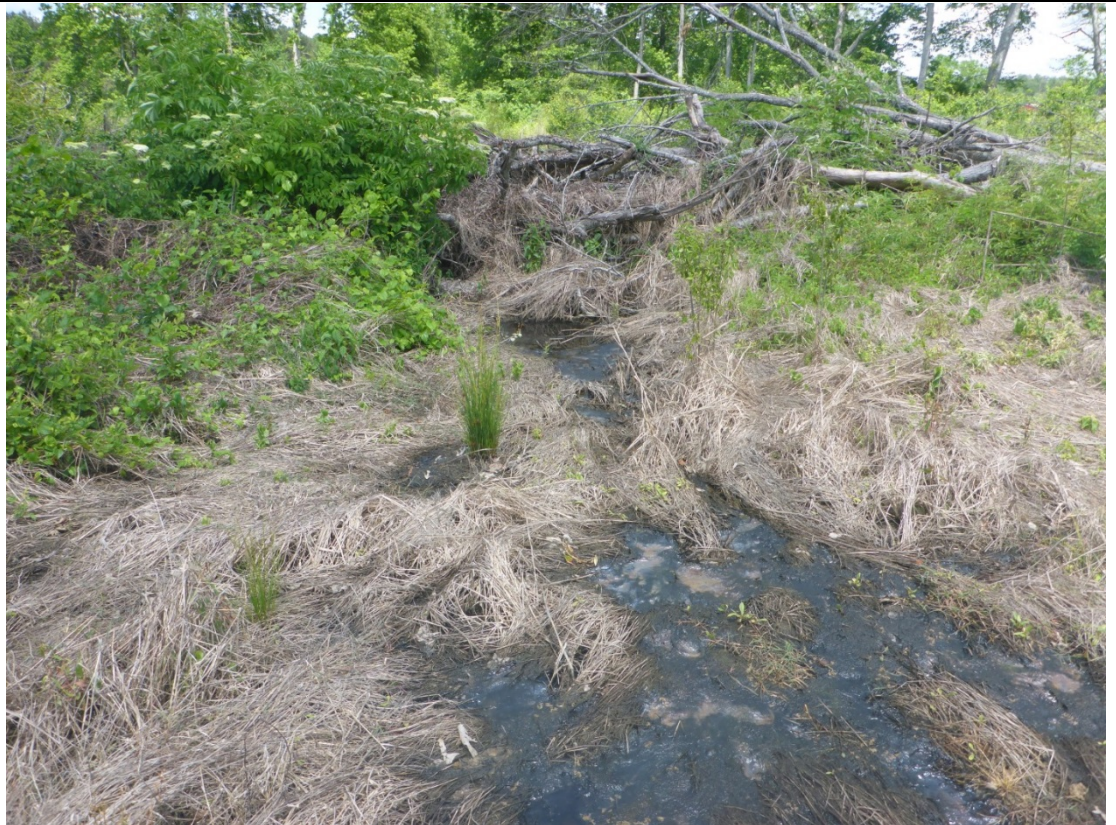
Drainage from the agricultural portions of Wetland 5 into the non-agricultural portion containing the Bibb soils

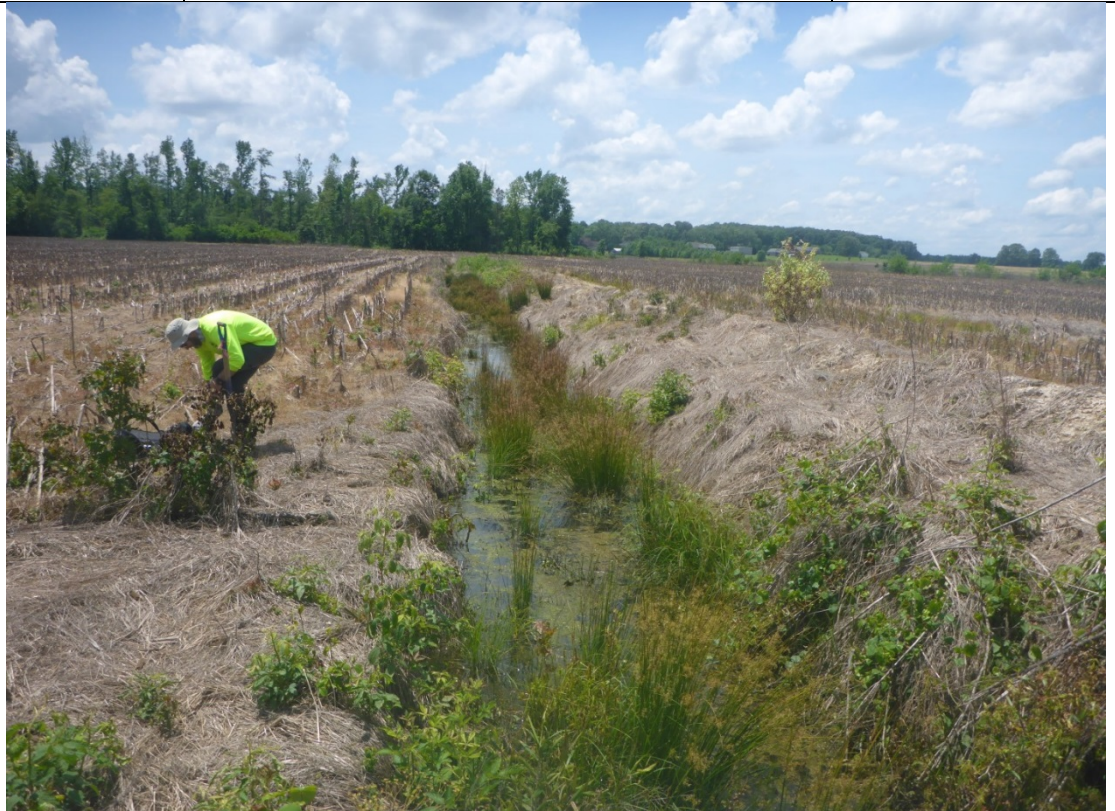
Typical view of one of the "fingers" on Wetland 5, a dug channel

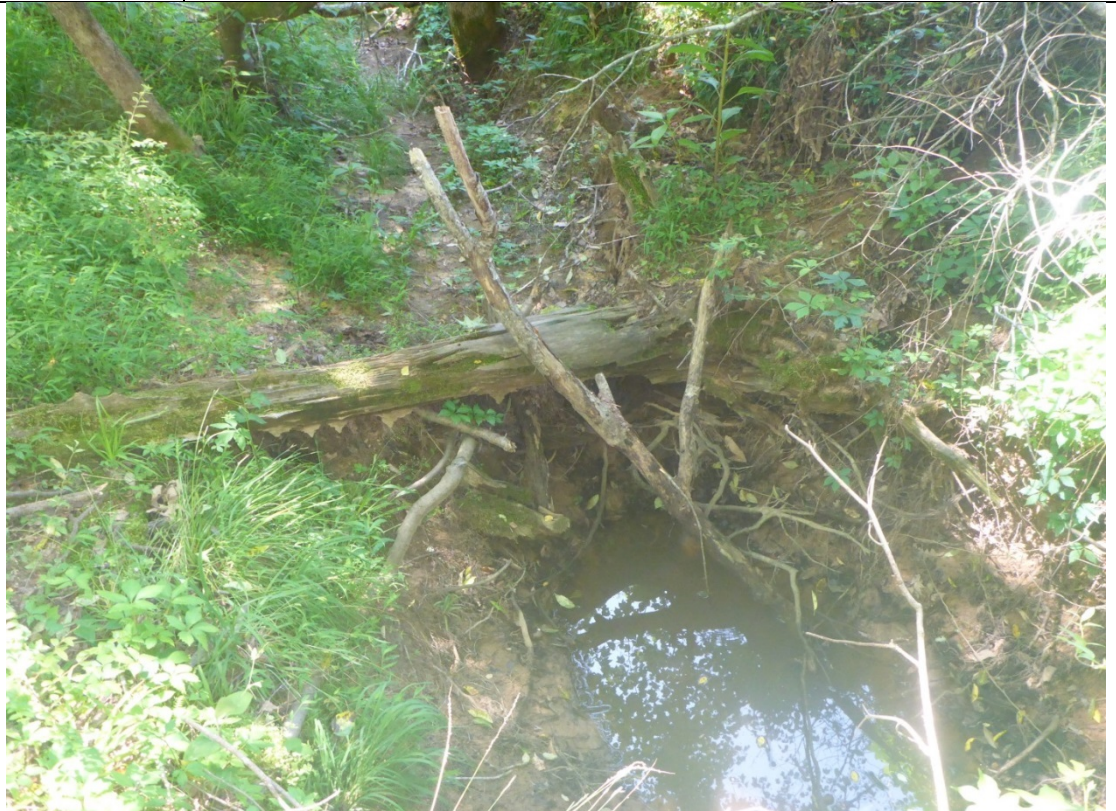
Single large head cut on EPH 3 (the only pool with water on the reach)

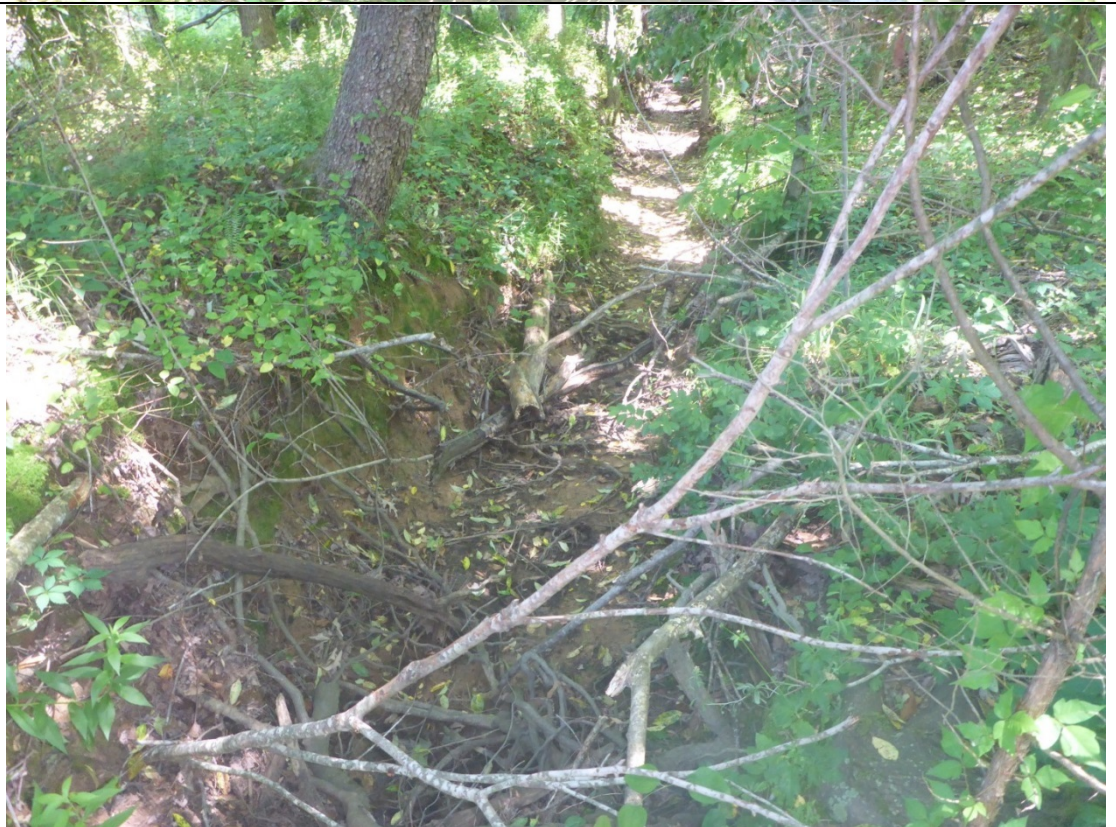
Photo No.
48

Downstream of the head cut on EPH 3

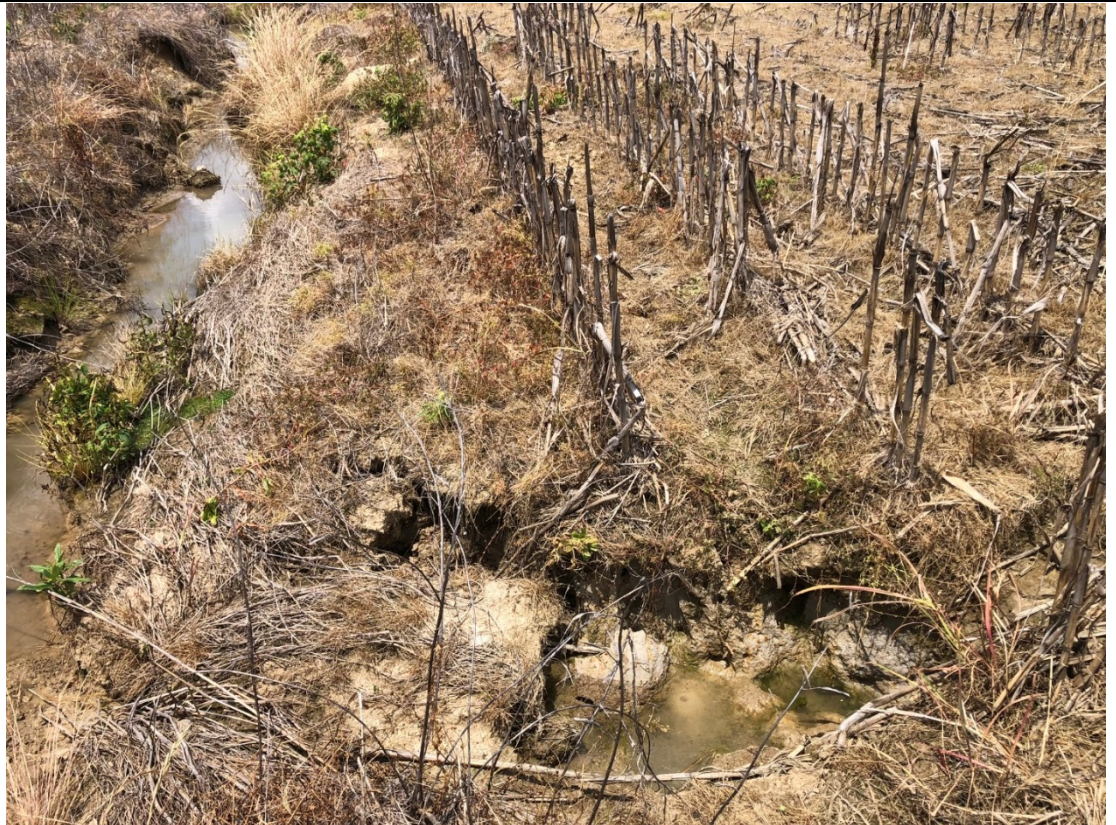
An example of inground drainage feeding into Tributary 1 at the bright line between EPH 5 and the tributary, just below the culvert in the previous photograph
