Johnson Creek, DeSoto County, MS: Fluvial Geomorph Level I Channel Stability Assessment & Reconnaissance Report

Appendix C. Memphis Metropolitan Stormwater – North DeSoto Count Feasibility Study

Christopher P. Haring and David S. Biedenbarn

March 2021

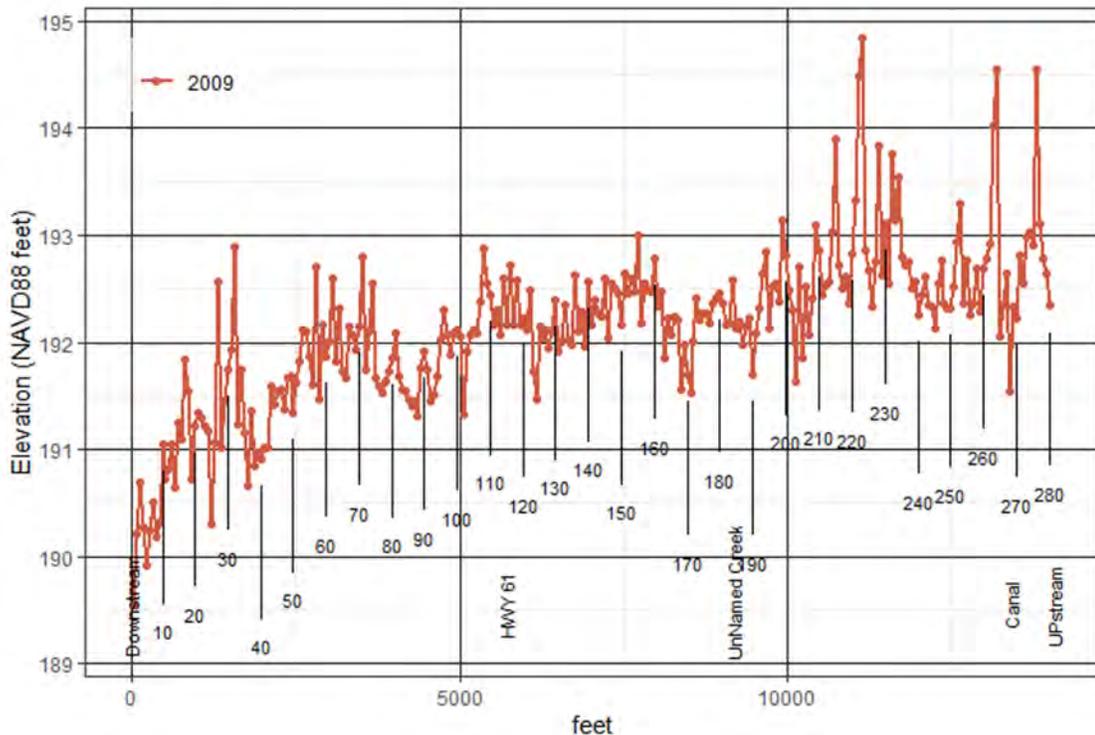
The Reach 1 site map is illustrated in Figure 14 and the water surface profile from 2009 is plotted in Figure 15. Reach 1 ends at the edge of a previous Mississippi River meander and the bank heights increase immediately upstream. The LiDAR water surface slope in this reach is 0.0002 ft/ft. Based on the LiDAR cut cross-sections, channel bank

Figure 15. FG level 1-Johnson Creek Reach 1: LiDAR water-surface profile with cross-section locations

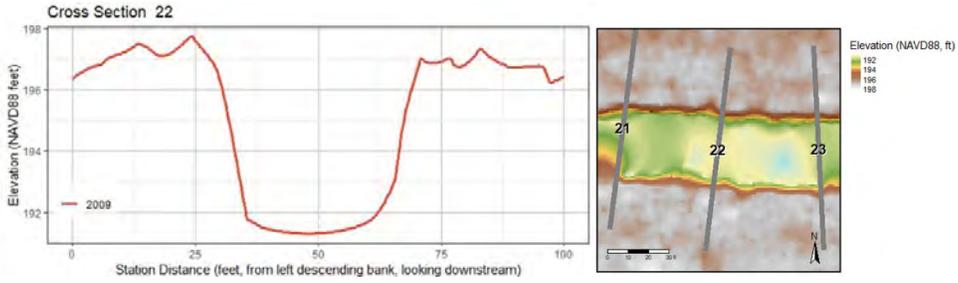
Figure 16. Cross-section 22, illustrating high banks in Lower Reach 1.

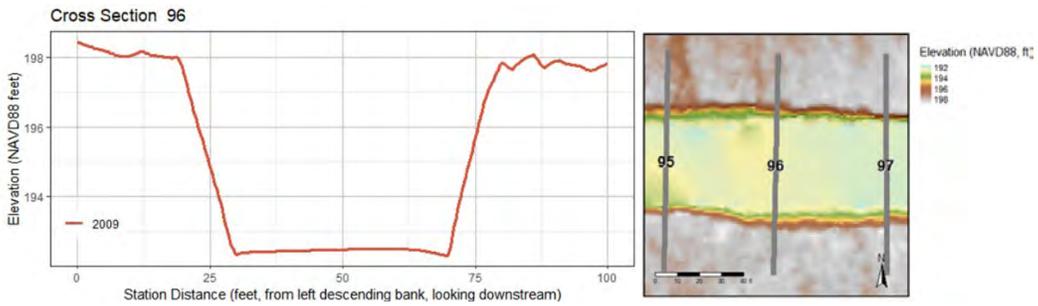
Figure 17. Cross-section 96, illustrating high banks in Lower Reach 1.

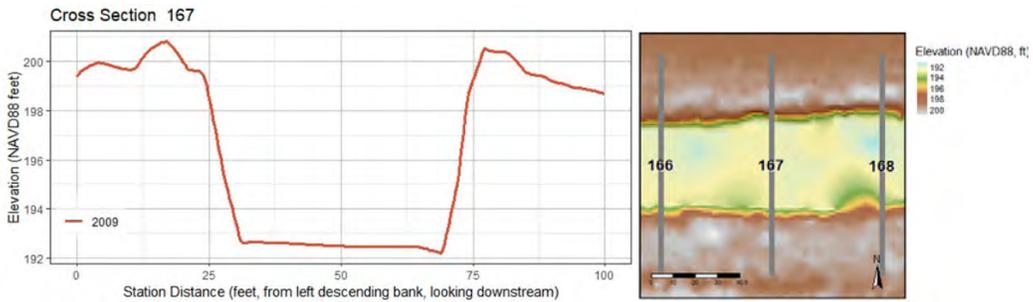
Figure 18. Cross-section 167, illustrating high banks in Middle Reach 1.

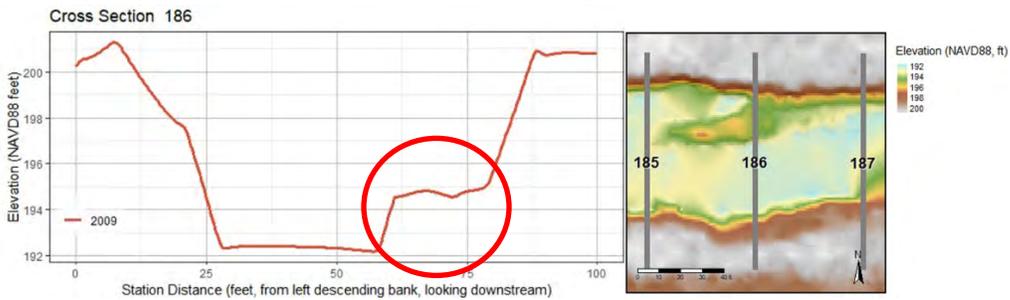
Figure 19. Cross-section 186, illustrating right floodplain berm development.

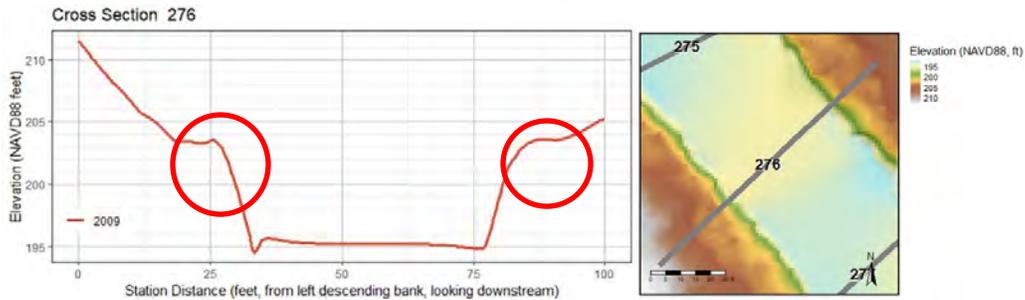
Figure 20. Cross-section 276, illustrating right & left bank floodplain berms

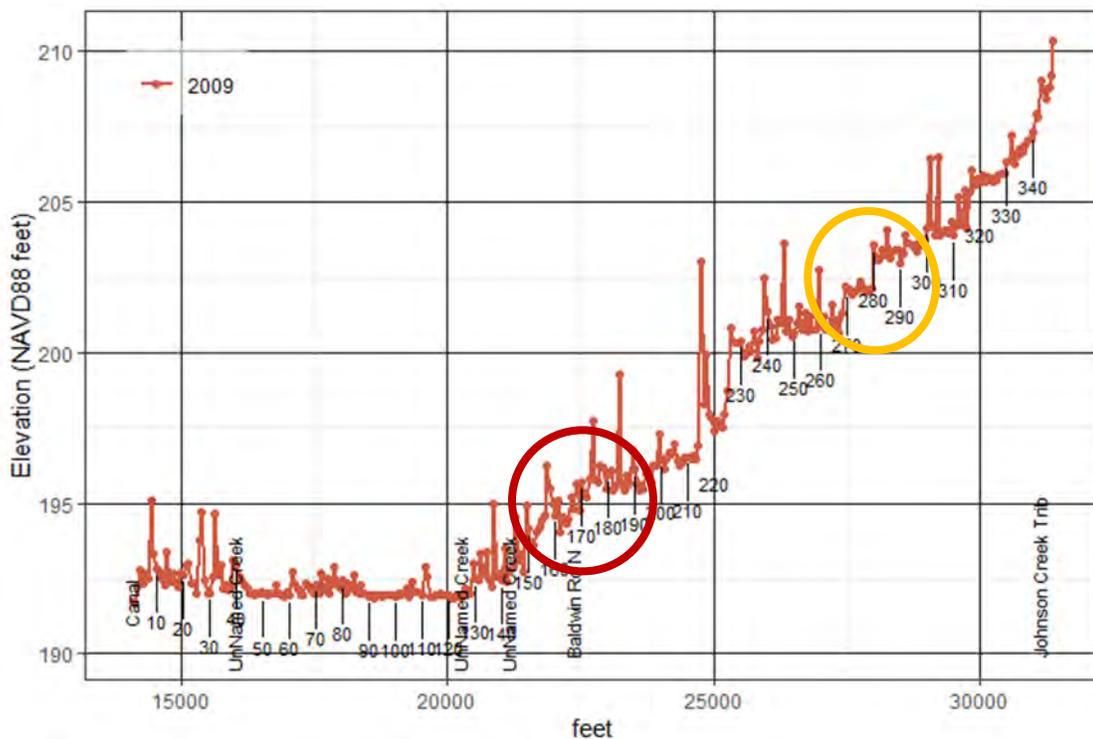
Figure 22. FG level 1-Johnson Creek Reach 2: LiDAR water-surface profile with cross-section locations

The same LiDAR surface slope (0.0002 ft/ft) was collected from the start of the downstream end of the reach to approximate station 20,500 (ft.) identified as lower Reach 2. The slope then increases significantly with a steep transition at station 25000 (ft.) and then again at approximate station 31,000 (ft.), identified as upper Reach 2. The slope of the upper Reach 2 is 0.0016 ft/ft. The high potential for nick points and zones were discovered during FG LiDAR analysis and verified during the site visits to the Baldwin Road Bridge and Odums Crossing subdivision (Figures 4-6). Sinuosity within the lower Reach 2 is relatively straight with a value of 1. Sinuosity ranges 1.1 to 2.1 so there is some meandering occurring within the incised channel.

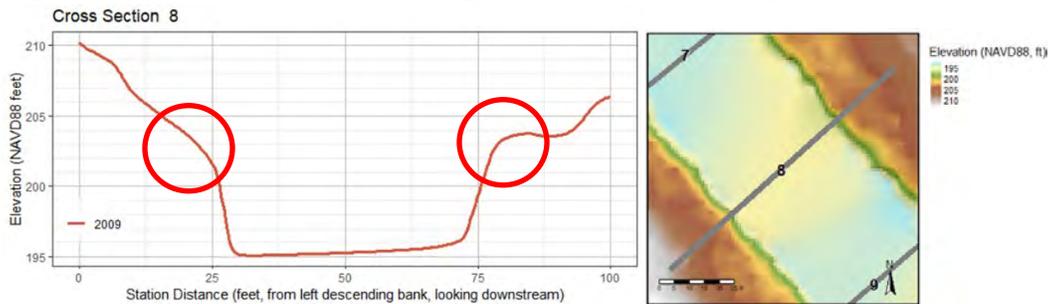
Based on cross-section analysis, as expected a similar range of average channel bank heights were found in downstream Reach 2 as in upper Reach 1. The lower Johnson Creek is actively building floodplain berms that are about 5-8 ft. with bank heights ranging from 8 to 12 ft. Lower Reach 2 has experienced channel degradation and is progressing through a recovery phase with the flat channel slopes and relative access to floodplain berms. The lower Reach 2 channel is a CEM type IV-V.

Figure 25. Cross-section 8, illustrating floodplain berm building in lower Reach 2.

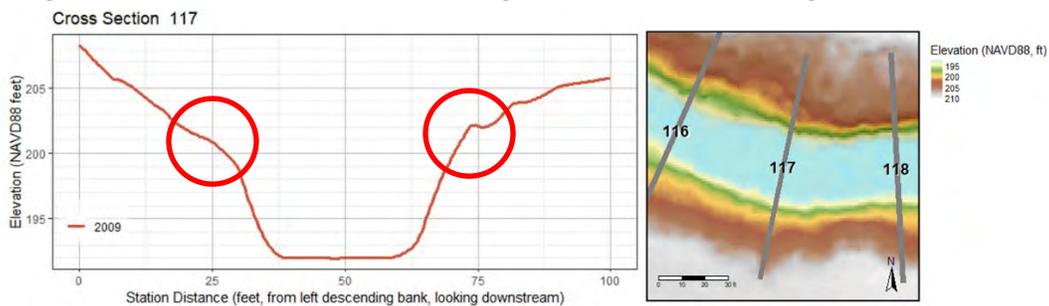
Figure 26. Cross-section 117, illustrating floodplain berm building in lower Reach 2.

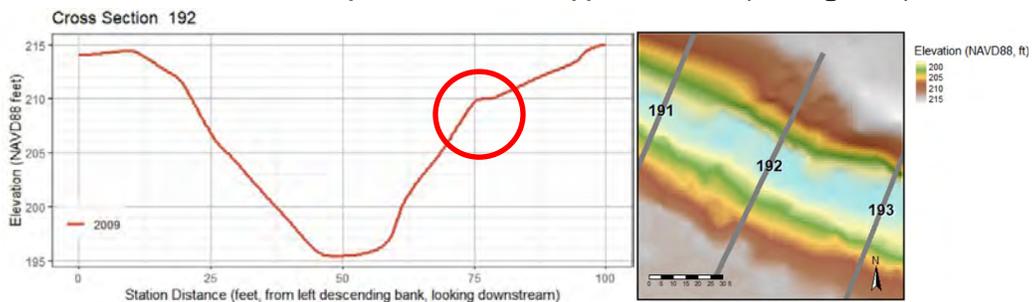
The upper Reach 2 has a significantly steeper slope and the main channel trends are not actively building floodplain berms but are progressing through a series of channel degradation areas. Nick points and zones are developed on areas where erosion resistant materials (Figure 24). There is a noticeable change in bank heights (channel type) from downstream Reach 1 and lower Reach 2 with bank heights at 15 to 20 ft. (Figures 25-27). The steeper slope paired with incised channel form and steep side-banks with little or no floodplain berms or access to an active floodplain represents typical degrading channel locations. With the steep slope and lack of active floodplain connections the upper Reach 2 channel is a CEM type III.

Figure 27. Cross-section 192, illustrating lack of floodplain berm building with abandoned floodplain terraces in upper Reach 2 (see Figure 8).

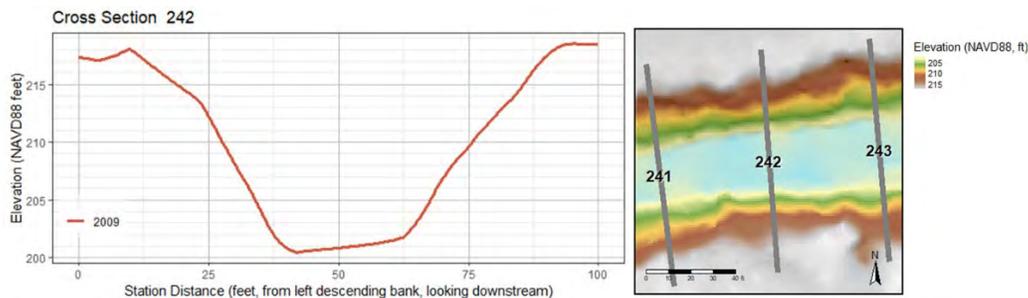
Figure 28. Cross-section 242, illustrating lack of floodplain berm development in upper Reach 2

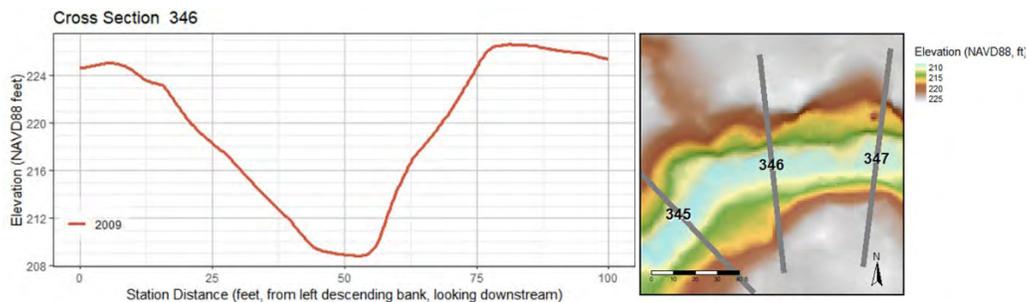
Figure 29. Cross-section 346, illustrating no active floodplain berm building in upper Reach 2

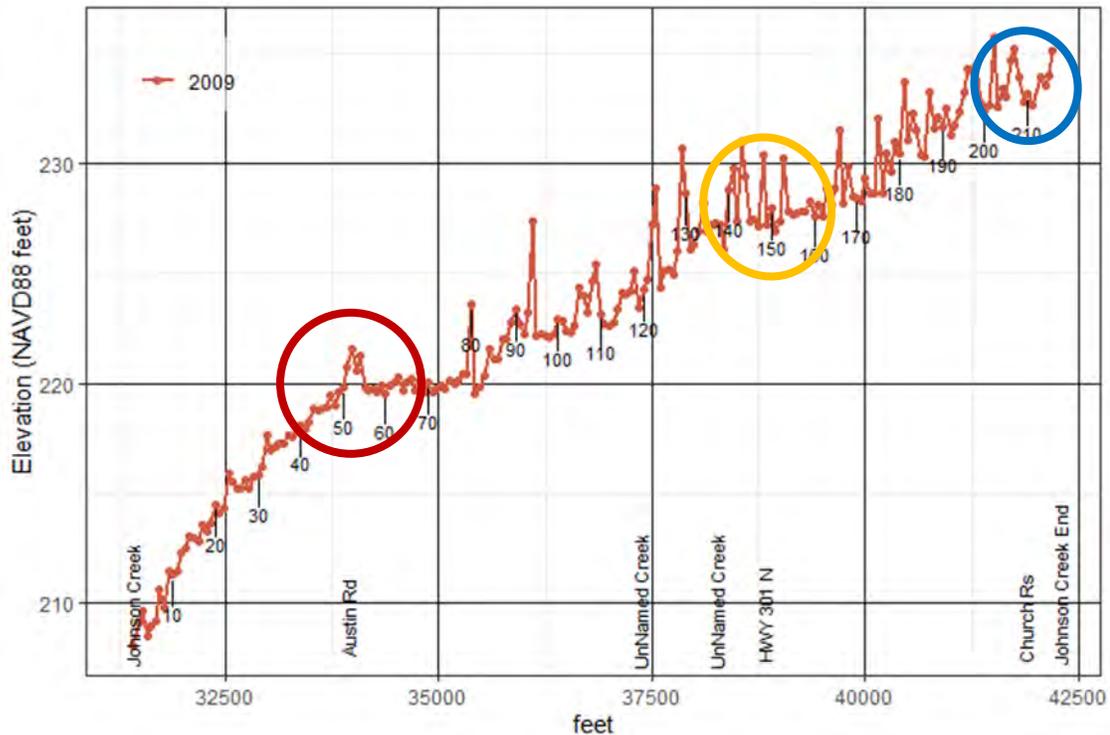
Figure 31. FG level 1-Johnson Creek Reach 3: LiDAR water-surface profile with cross-section locations

The LiDAR water surface slope of 0.0024 (ft/ft) is significantly steeper than Reach 2. The downstream 2000 ft of Reach 3 is the steepest at 0.007 (ft/ft). The slope then decreases significantly upstream of the Austin Road Bridge which appears to be providing some form of limited grade control (Figure 31). The old bridge piles, riprap and concrete are providing limited bed protection (Figure 32). Field verification of the FG data found nick zones upstream (Figure 33). Sinuosity within lower Reach 3 had the highest values from 1 to 1.25. The rest of the reach had values less than 1.15 and most were around 1.

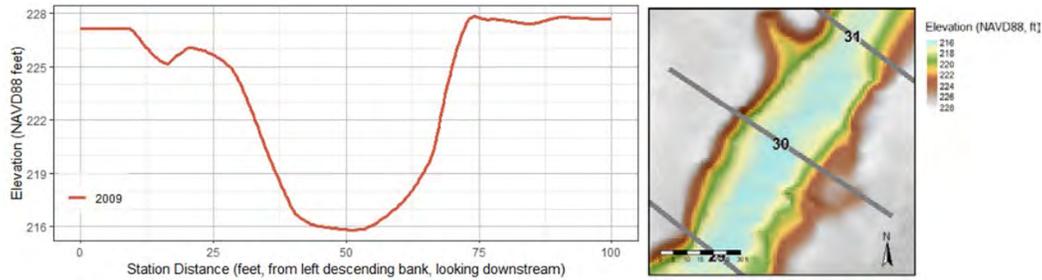
The lower Johnson Creek Reach 3 has bank heights ranging from 10-12 ft. and variable channel widths depending on where nick points or nick zones are located. Qualitatively, visually comparing the cross-sections (Figures 34 and 35) illustrates the variability in cross-sectional area and bed levels. There is approximately 1550 ft. between cross-sections 30 and 61 but there is a larger cross-sectional area in the downstream cross-section and is also 4 ft lower in bed elevation. This information coupled with the field identification of nick points likely shows a degraded downstream cross-section with continued degradation occurring up to the upstream cross-section. Paired with oversteepened channel slopes and relatively straight sinuosity, channel incision will continue to lower the bed elevation as it

works upstream and widens and increases cross-sectional area. There are relatively no floodplain berms being formed in any of Reach 3, this also being an indicator of channel degradation and an entrenched channel. The lower Reach 3 channel is a CEM type III.

Figure 34. Cross-section 30, illustrating entrenched channel with no access to active floodplain-lower Reach 3.

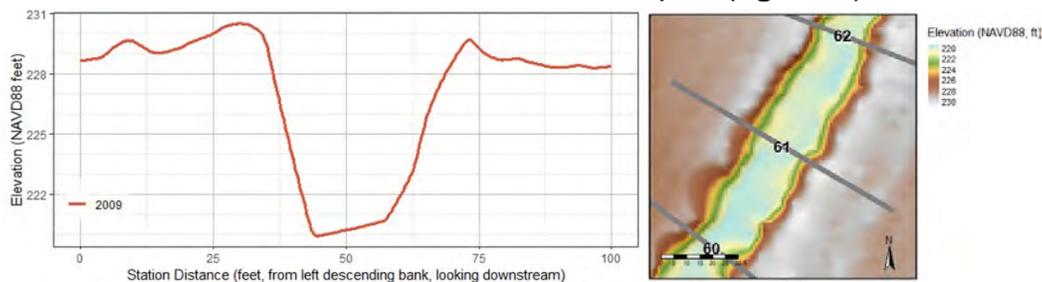
Figure 35. Cross-section 61, upstream of Austin Road Bridge-illustrating entrenched channel with no access to active floodplain (Figure 33).

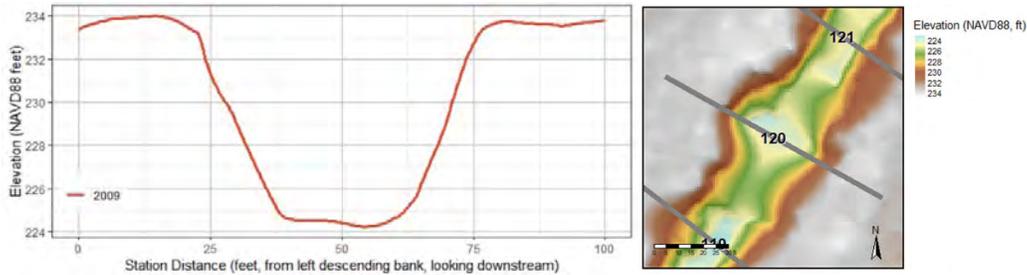
The mid and upper Reach 3 has a flatter slope than the lower section of the reach but again shows all the signs of a typical degrading channel system. Low sinuosity, steep channel slopes, and relatively no floodplain berms or connections to an active floodplain are qualitative signs that a channel is in a degrading condition. A similar progression of cross-sectional area and channel bed elevations can be illustrated between cross-section plots (Figures 36-38). In the field, nick points and zones were identified. Bank heights ranged from 8 to 10 ft. with channel widths from 10 to greater than 25 ft. The mid and upper Reach 3 channel is also a CEM type III.

Figure 36. Cross-section 120, illustrating lack of floodplain berm building with abandoned floodplain terraces in upper Reach 3 (see Figure 8).

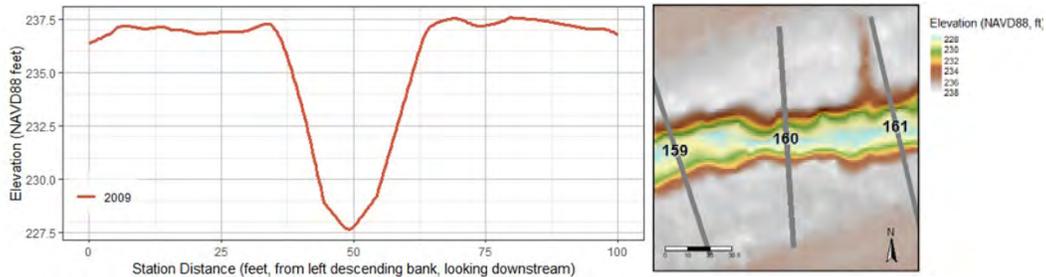
Figure 37. Cross-section 160, upstream of Highway 301 Bridge illustrating lack of floodplain berm development in upper Reach 3

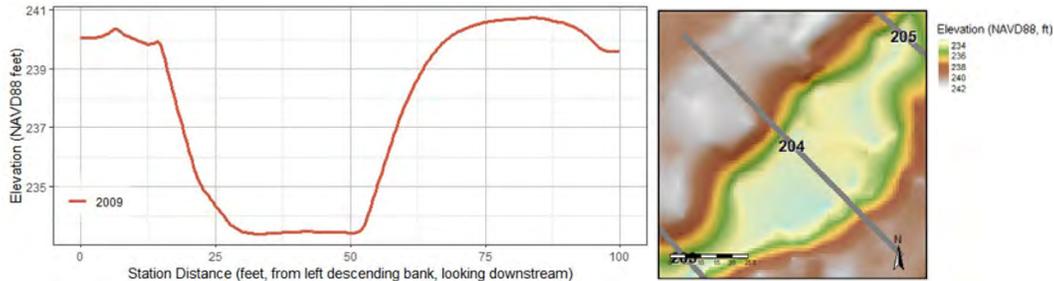
Figure 38. Cross-section 204, upstream of Church Road Culverts illustrating no active floodplain berm building in upper Reach 3

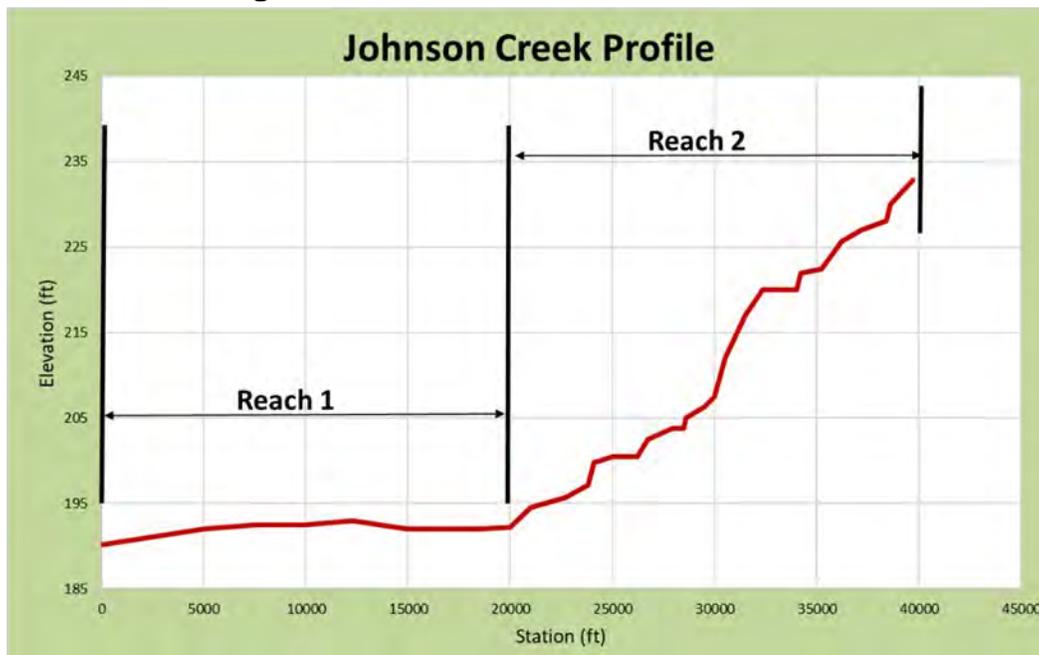
Figure 43. 2009 LiDAR Profile for Johnson Creek

The following is a very preliminary assessment with recommendations for Johnson Creek based on limited field investigations and analysis of the 2009 Lidar surveys using the FG Level 1 Channel Stability Assessment approach. One of the primary goals of this project is to minimize channel degradation, channel erosion, and sedimentation to support aquatic ecosystem form and function. This assessment addresses the channel stabilization, erosion control and sedimentation aspects of these goals. Base on additional reach valuations, the FG Reaches 1, 2 and 3 were changed into two reaches for this Recommendations Section (Figure 43). The new break for defined Reaches 1 and 2, is in the profile slope break located at approximately the same location as the Mississippi River alluvial materials and just downstream of the Baldwin Road Bridge.

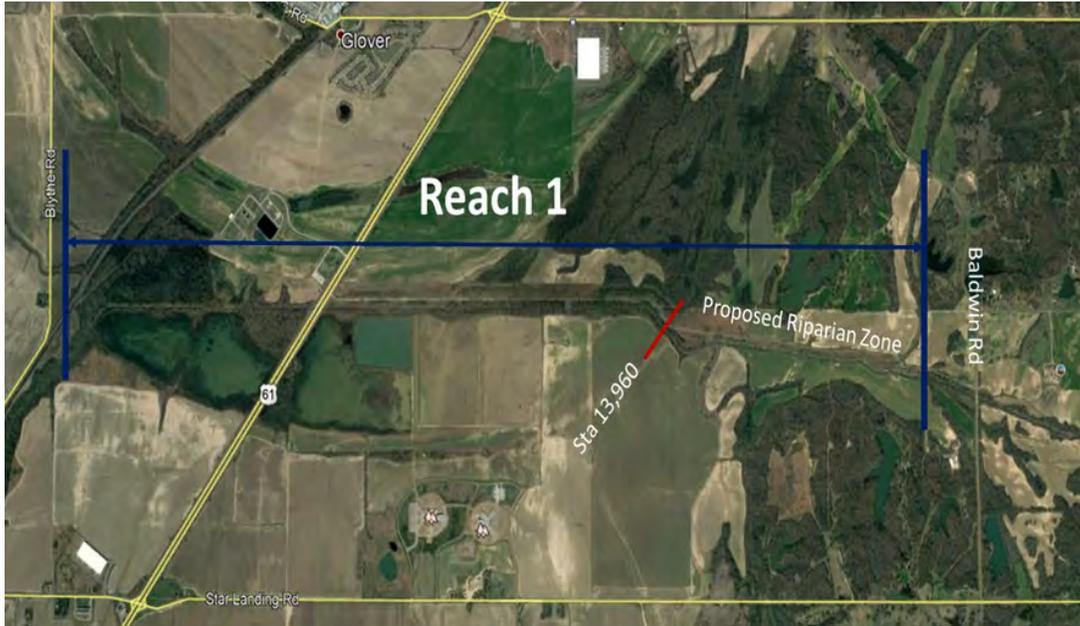
Figure 44. Johnson Creek Reach 1

Reach 1 extends from about a mile downstream of Hwy 61 to approximate Sta 20,000 just downstream of Baldwin Road (Figures 1 and 2). Based on the limited field investigations and examination of the Lidar surveys, it

appears that this reach of Johnson Creek is relatively stable vertically, with bank erosion only occurring in isolated locations. This would roughly correspond to CEM Types IV –V. Therefore, grade control would not be required in this reach. Additionally, bank stabilization should only be considered if critical locations are identified that must be stabilized to protect some valuable riparian features. It was observed that downstream of about Sta 13,960 (Figure 44), there was a significant riparian zone consisting of woody vegetation. However, upstream of about Sta 13,960 there was a noticeable lack of established riparian vegetation. Therefore, consideration should be given to the establishment of a woody riparian zone upstream of Sta 13,960.

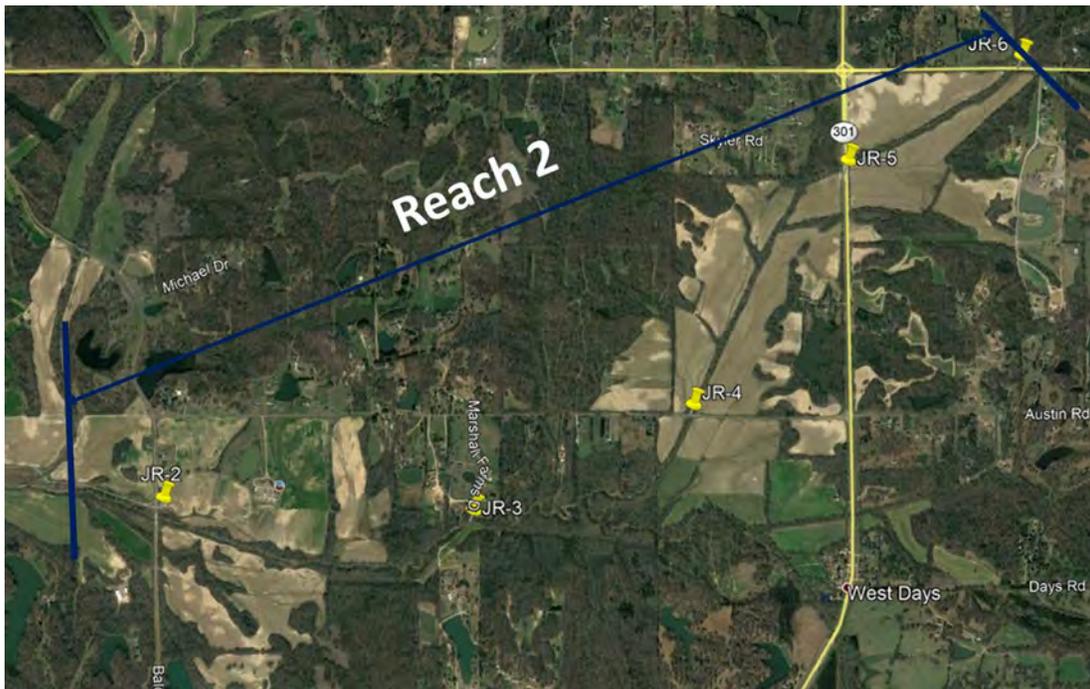
Figure 45. Johnson Creek Reach 2

Reach 2 extends from approximate Sta 20,000 (downstream of Baldwin Rd) to just upstream of Church Rd (approximate Sta 40,000). The limits of this reach are shown in Figure 45. The field investigations confirmed that this entire reach was subject to degradation, albeit, at a relatively slow rate due to the hard clay throughout the bed. Although the degradation rate appears to be relatively slow, this continued incision will contribute to the long-term deterioration of the channel system, inducing accelerated bed and bank erosion and sediment supply to downstream reaches. Therefore, for this preliminary assessment, a conservative plan of a series

With respect to bank instability, the field investigations were too limited to provide a complete assessment of the degree of erosion in this reach. However, the preliminary observations suggest that localized areas of bank erosion exist, but they may be more localized than systematic. Therefore, bank stabilization is only included as needed to protect the proposed grade control structures. Table 1 provides a preliminary and conservative estimate of the linear feet of bank stabilization that will be required for each grade control structure. In total, approximately 6,300 feet of bank stabilization may be required.

of sloping rock grade control structures is recommended. For this plan it was simply assumed that each structure would have a 3.5-foot drop with a flat pool upstream which would provide a tailwater for the next upstream structure. Figures 46 and 47 show the tentative locations of these 11 proposed structures proposed. Again, it must be emphasized that this is a conservative assessment and that the final locations, heights and number of structures could vary considerable after a more thorough analysis.

A total of 11 new grade control structures and approximately 6,300 feet of bank stabilization are recommended (Table 1). In addition, a woody riparian zone of approximately 6,000 feet is proposed. Grade control structures described in this report are sloping loose rock riprap structures, and bank stabilization structures will be assumed to longitudinal stone toe protection with tiebacks.
