## **Draft: Nolehoe Creek, DeSoto County, MS: Fluvial Geomorph Level I Channel Stability Assessment & Reconnaissance Report**

Appendix C. Memphis Metropolitan Stormwater – North DeSoto Count Feasibility Study

Christopher P. Haring and David S. Biedenbarn

March 2021

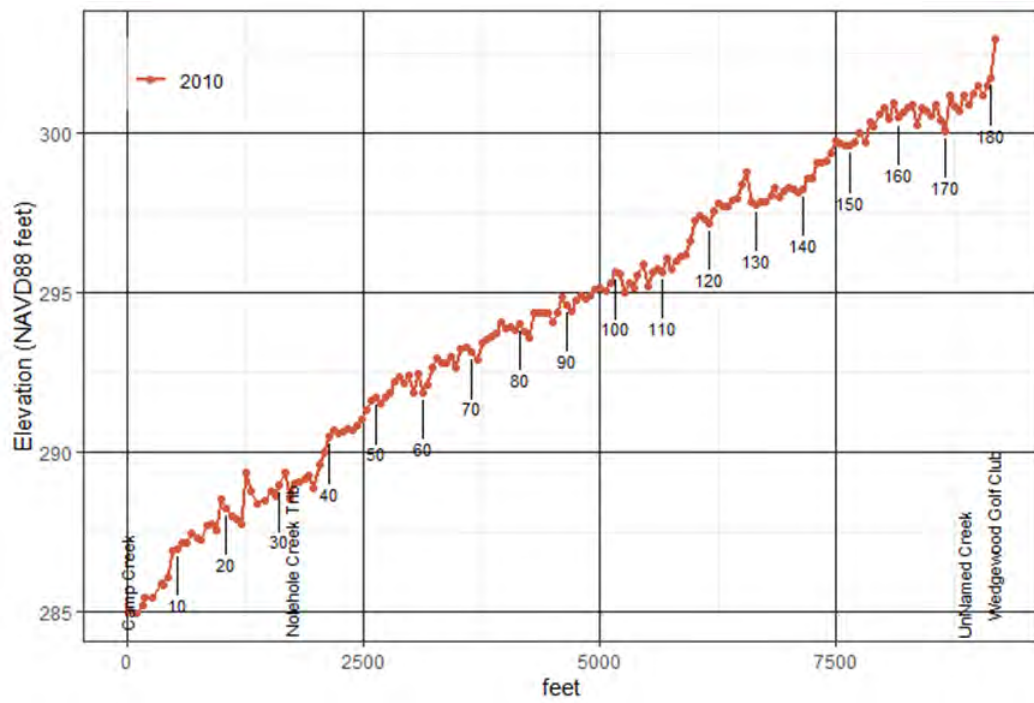
Figure 15. FG level 1-Nolehoe Creek Reach 1: LiDAR water-surface profile with cross-section locations

Limited field investigations revealed that this is a sand and gravel bed stream, but sediment depths were generally less than 2 feet. While there were no active signs of channel degradation (knickpoints, overwidening, etc.) observed at the Sandridge Road area, comparison of the 2011 thalweg survey with the DHP equilibrium slope curve suggested that some portions of the channel could be slightly degradational. However, comparisons with the Coldwater equilibrium slope curve suggest that the channel should be relatively stable. The lack of a comprehensive field investigation, coupled with the survey being 10 years old, makes it difficult to make definitive conclusions about the present-day vertical stability of this reach.

Therefore, a conservative approach was adopted, which assumes that although Reach 1 appears to be approaching vertical stability (possibly CEM stage IV), some additional degradation could occur, particularly if the future flow regime changes as the watershed becomes more urbanized, or additional incision migrates up from Camp Creek. Inspection of Google Earth imagery reveals that this is a straight reach with alternate bars and numerous areas of local bank instability. There are also numerous gullies occurring in this reach. The LiDAR profile within the lower 2,500 feet of the reach has a relatively steep slope of 0.0045 ft/ft compared to the rest of the reach. This may indicate new bed degradation from Camp Creek adjustments that maybe working upstream into Noehoe Creek.

Reach 1 appears to have widespread local bank instability along the entire reach. It is difficult to state with certainty whether this is systematic instability associated with a degradational regime, or if it is local instability associated with alternate bars and locally shifting alignments. For Reach 1, we feel that the most effective way to achieve the project goals to minimize channel degradation, channel erosion, and sedimentation is through the construction of a series of grade control structures. The location of the proposed six grade control structures for Reach 1 are shown in Figures 32 and 33. It must be emphasized that the locations of these structures is preliminary and that final locations, and structure grades may change based on more detailed investigations. These structures would not only stabilize the channel grade against any future degradation but would also improve the local bank stability in this reach.

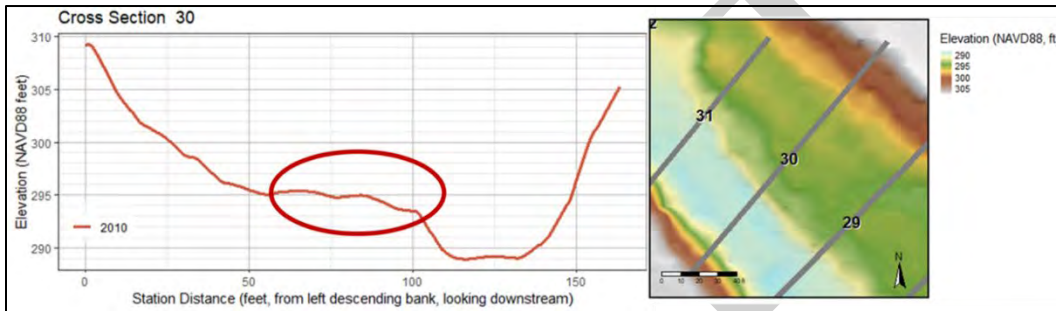
Figure 17. Cross-section 30, illustrating left-bank floodplain berm building.

Based on the LiDAR cut cross-sections, channel bank heights vary throughout the reach from 15 to 25 ft to the terrace level to 5-7 ft for actively building the floodplain berms. The channel has actively built floodplain berms within the incised channel margins shown in Figures 16-20. This is typically a sign of the channel adjusting with reduced downcutting and is approaching a new state of dynamic equilibrium (CEM IV). There may still be some localized streambank erosion as the channel continues to adjust. Floodplain berm elevations and associated channel stationing were collected from the LiDAR cross-sections and analyzed to determine the newly forming floodplain slope. The slope is calculated at 0.0022 ft/ft which is flatter than the interpolated LiDAR channel slope in the reach at 0.0033 ft/ft. The flatter slope is likely due less developed floodplain berms on the upstream section of the reach with continued adjustments to the elevation as the channel further develops. The floodplain should continue to build and develop as additional sediment deposition and channel adjustments occur within Reach 1, assuming it continues to trend toward a CEM stage V. However, it must be stated that this is all based on a preliminary assessment, and therefore, definitive conclusions about the future state of the channel are difficult to make. While the channel does appear to be approaching a CEM stage IV at this time, some degradation could occur if future urbanization accelerates, or further incision migrates upstream from Camp Creek.

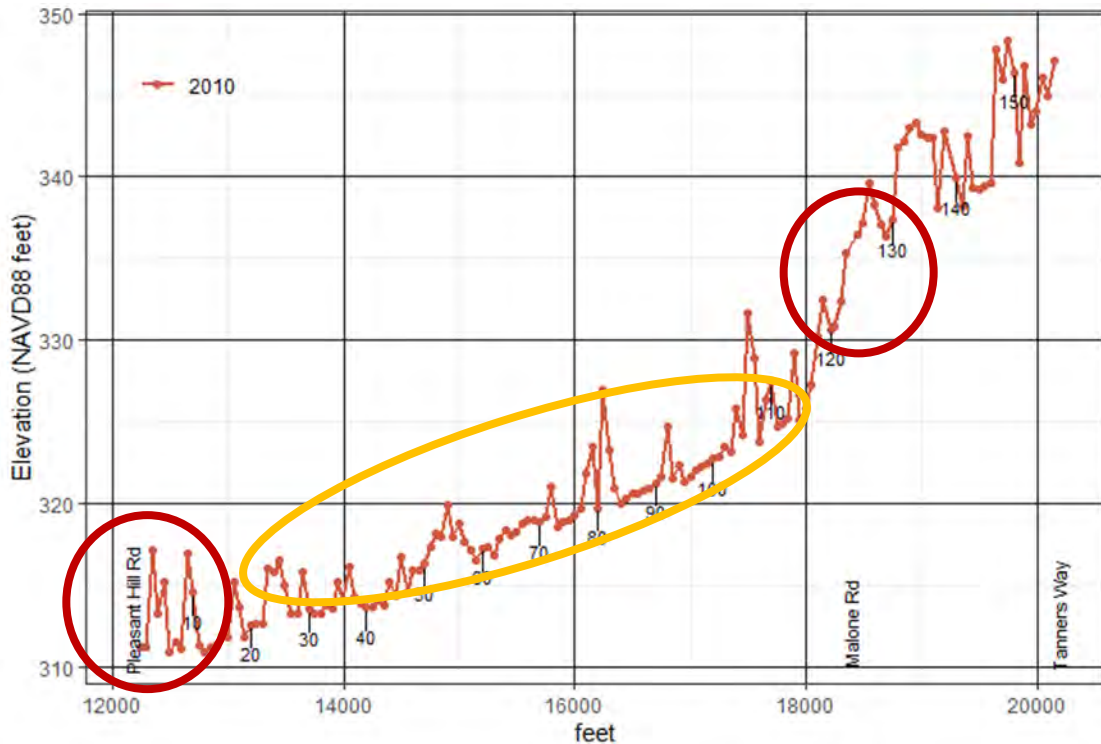
Figure 22. FG level 1-Nolehoe Creek Reach 2: LiDAR water-surface profile with cross-section locations

before it terminates at a water retention pond at Tanner's Way Cove. The channel slopes based on the LiDAR range from 0.0037 ft/ft downstream of the Malone Street Culvert to 0.0052 ft/ft upstream. There are more channel breaks within the reach especially immediately downstream of the culvert and at the far upstream end of the reach. These areas were not well documented during the field site visit and should be further investigated.

Comparison of the DHP equilibrium slope curve suggest that Reach 2 is degradational. However, according to the Coldwater curve, only the upper 2,000 feet of the reach is degradational. The limited field investigations indicated that the channel bed was comprised predominantly of a hard clay material, with little to no sediment accumulation in the bed. As in Reach 1, we have adopted a conservative approach and have assumed that the channel may have degradational tendencies, albeit, at a very extremely slow rate due to the presence of the resistant bed material.

As discussed previously, it appears that Reach 2 has essentially become locked in place and has limited environmental quality. For this reason, we feel that there is an opportunity to enhance the habitat conditions in this reach with a series of sloping rock riffle type of grade control structures.

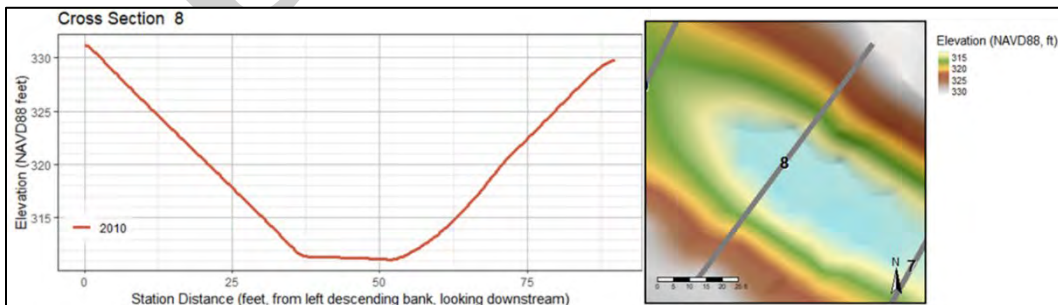
Figure 23. Cross-section 8, illustrating lack of floodplain berm building in lower Reach 2.

Based on the LiDAR cut cross-sections, a similar range of average channel bank heights were found in Reach 2. The terrace level was approximately 15 to 20 ft, while the actively building floodplain berms are about 5-7 ft. One major difference between the reaches is the Reach 2 channel has not built floodplain berms extensively within the incised channel margins of the lower section of the reach (Figures 23-27). This is the section that has erosion resistant materials (Figure 23) and is acting more like a threshold channel than an alluvial channel. There is a noticeable change in bank heights (channel type) from downstream of the Malone Street culvert that is over-steepened and degrading to upstream of the culvert that has stabilized and built active floodplain berms on each side of the channel. The farthest upstream section transitions back to a more incised channel
