Draft: Nolehoe Creek, DeSoto County, MS: Fluvial Geomorph Level I Channel Stability Assessment & Reconnaissance Report

Appendix C. Memphis Metropolitan Stormwater – North DeSoto Count Feasibility Study

Christopher P. Haring and David S. Biedenbarn

March 2021

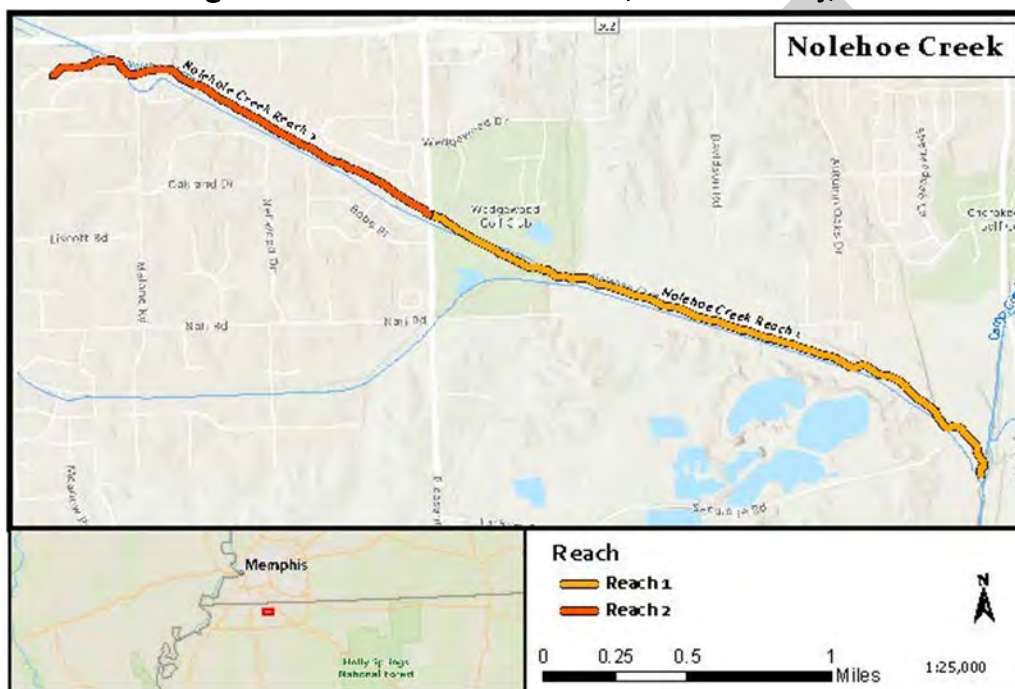
Figure 1. Nolehoe Creek Watershed, De Soto County, MS

channelization within the watershed. As illustrated in Figure 1, both Reach 1 and 2 have relatively straight channel alignments that were channelized for agricultural production.

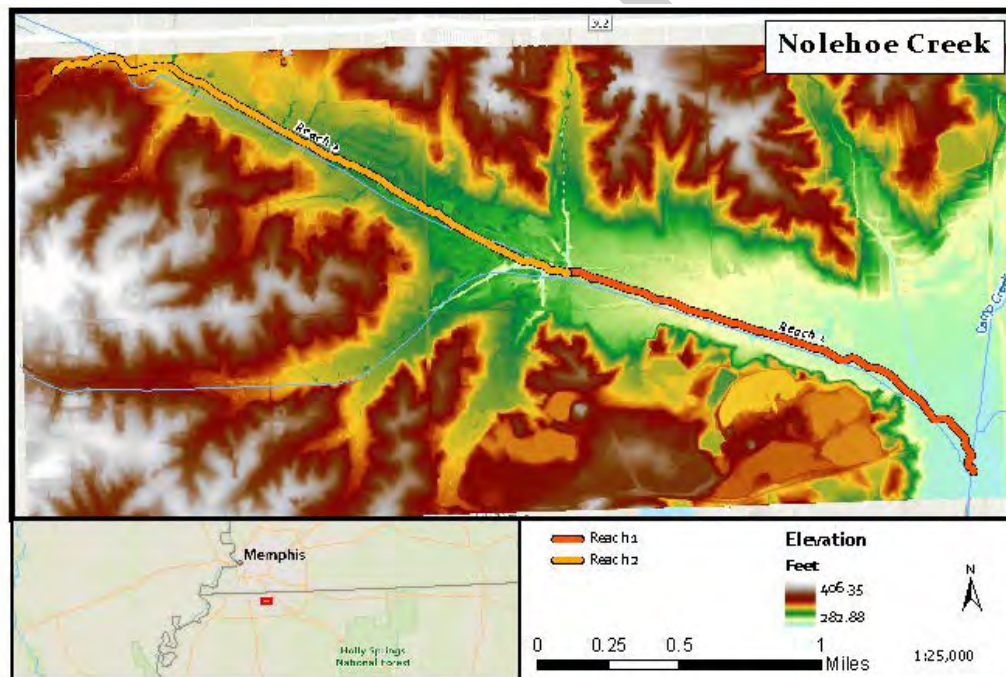
Figure 11. Nolehoe Creek Study Reaches (1-2)

For this preliminary assessment, Nolehoe Creek was divided into two broad reaches: (1) Reach 1 extends from the confluence with Camp Creek up to the Pleasant Hill Drive Culvert; and (2) Reach 2 extends from the Pleasant Hill Drive culvert upstream to the Tanner's Way Cove (Figure 1).

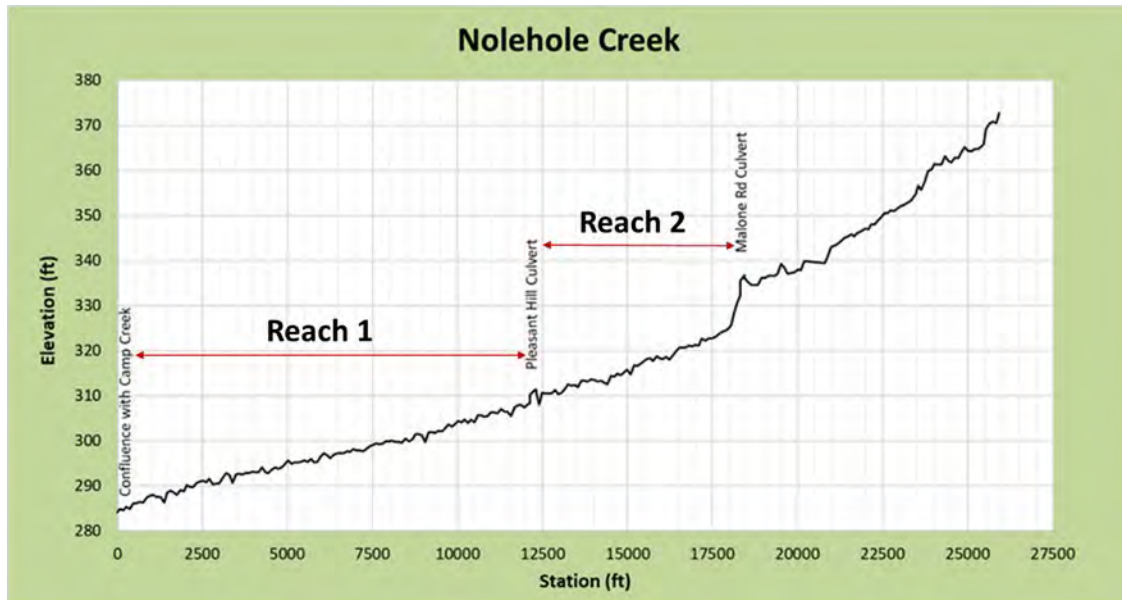
Figure 12. Thalweg Survey of Nolehoe Creek Study Reaches (1-2)

This report provides a preliminary assessment for Nolehoe Creek based on limited field investigations and FG analysis of the 2009-2010 Lidar and 2011 thalweg surveys. Comparison of the Lidar survey with the 2011 thalweg showed that these two surveys were in close agreement. Figure 12 shows the 2011 thalweg profile for Nolehoe Creek. One of the primary goals of this project is to minimize channel degradation, channel erosion,

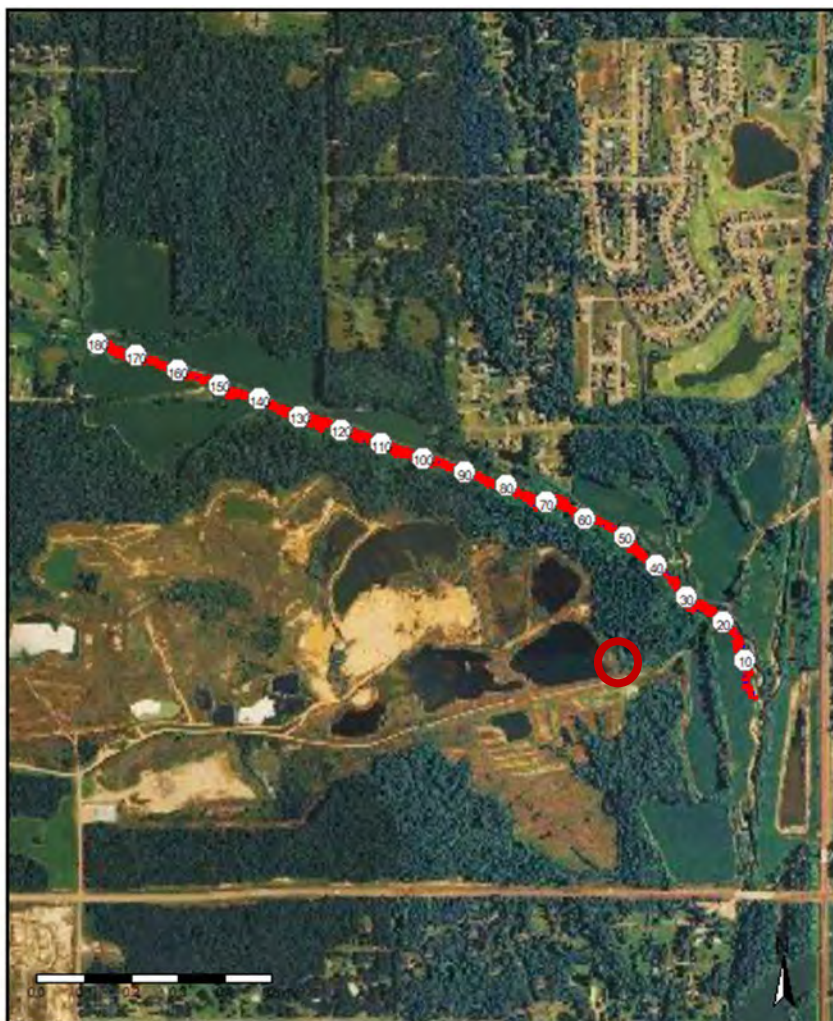
Figure 14. Nolehoe Creek Reach 1: Cross-section Location Map

Based on the LiDAR cut cross-sections, channel bank heights vary throughout the reach from 15 to 25 ft to the terrace level to 5-7 ft for actively building the floodplain berms. The channel has actively built floodplain berms within the incised channel margins shown in Figures 16-20. This is typically a sign of the channel adjusting with reduced downcutting and is approaching a new state of dynamic equilibrium (CEM IV). There may still be some localized streambank erosion as the channel continues to adjust. Floodplain berm elevations and associated channel stationing were collected from the LiDAR cross-sections and analyzed to determine the newly forming floodplain slope. The slope is calculated at 0.0022 ft/ft which is flatter than the interpolated LiDAR channel slope in the reach at 0.0033 ft/ft. The flatter slope is likely due less developed floodplain berms on the upstream section of the reach with continued adjustments to the elevation as the channel further develops. The floodplain should continue to build and develop as additional sediment deposition and channel adjustments occur within Reach 1, assuming it continues to trend toward a CEM stage V. However, it must be stated that this is all based on a preliminary assessment, and therefore, definitive conclusions about the future state of the channel are difficult to make. While the channel does appear to be approaching a CEM stage IV at this time, some degradation could occur if future urbanization accelerates, or further incision migrates upstream from Camp Creek.

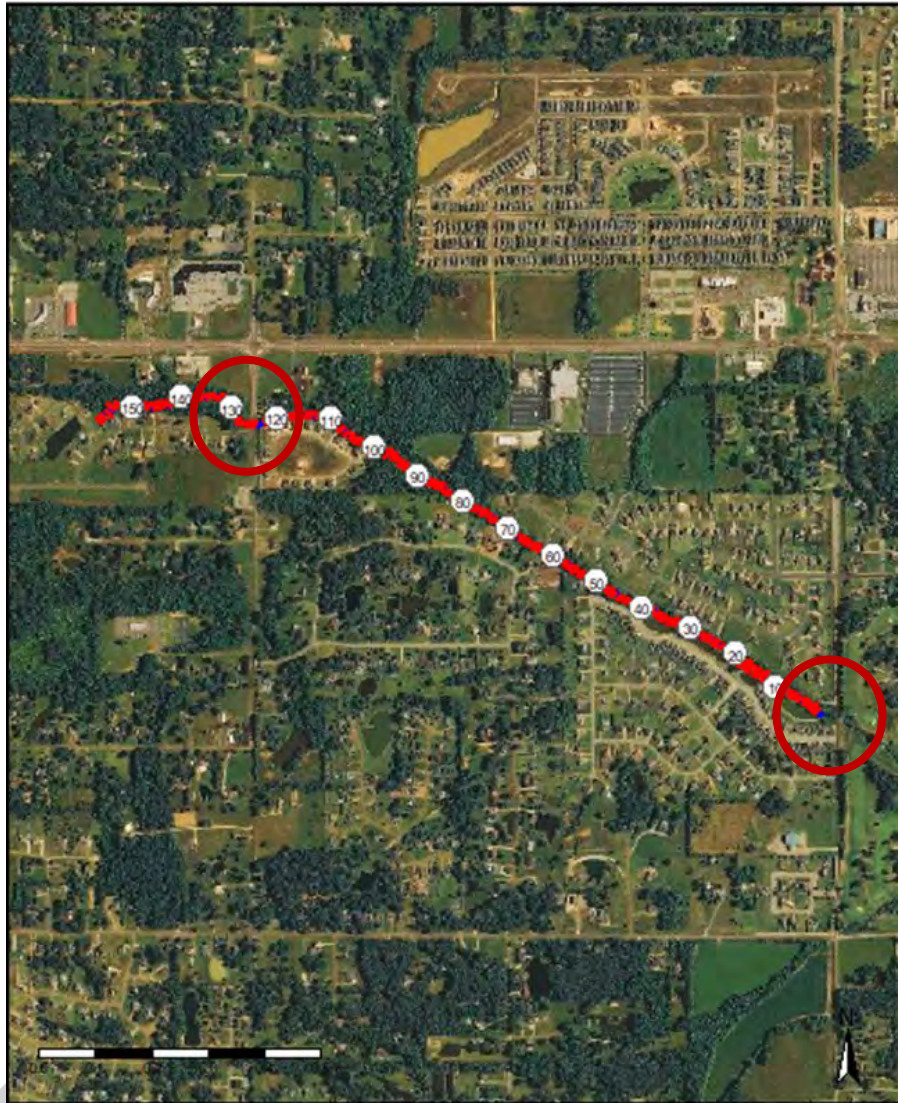
Figure 21. Nolehoe Creek Reach 2: Cross-section Location Map

The Reach 2 site map is illustrated in Figure 21 and the water surface profile from 2009-2010 plotted in Figure 22. There are two main road crossing within this reach that are functioning as GCS’s. They are outlined in Figures 21 and 22 with red circles. Also, within the reach is a zone of erosion resistant materials in the channel bed and banks (orange circle). The material was identified during the site visit (Figures 9 and 10).

Based on the LiDAR cut cross-sections, a similar range of average channel bank heights were found in Reach 2. The terrace level was approximately 15 to 20 ft, while the actively building floodplain berms are about 5-7 ft. One major difference between the reaches is the Reach 2 channel has not built floodplain berms extensively within the incised channel margins of the lower section of the reach (Figures 23-27). This is the section that has erosion resistant materials (Figure 23) and is acting more like a threshold channel than an alluvial channel. There is a noticeable change in bank heights (channel type) from downstream of the Malone Street culvert that is over-steepened and degrading to upstream of the culvert that has stabilized and built active floodplain berms on each side of the channel. The farthest upstream section transitions back to a more incised channel

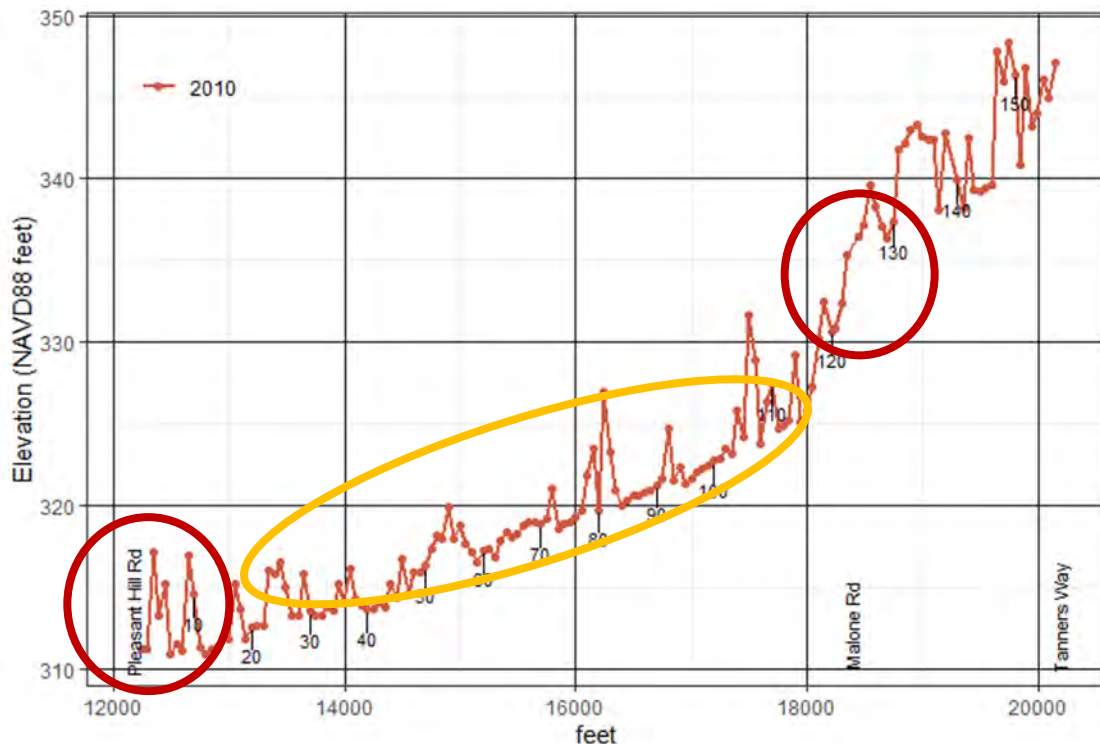
Figure 22. FG level 1-Nolehoe Creek Reach 2: LiDAR water-surface profile with cross-section locations

before it terminates at a water retention pond at Tanner's Way Cove. The channel slopes based on the LiDAR range from 0.0037 ft/ft downstream of the Malone Street Culvert to 0.0052 ft/ft upstream. There are more channel breaks within the reach especially immediately downstream of the culvert and at the far upstream end of the reach. These areas were not well documented during the field site visit and should be further investigated.
