Johnson Creek, DeSoto County, MS: FluvialGeomorph Level I Channel Stability Assessment & Reconnaissance Report

Appendix C. Memphis Metropolitan Stormwater – North DeSoto Count Feasibility Study

Christopher P. Haring and David S. Biedenbarn

March 2021

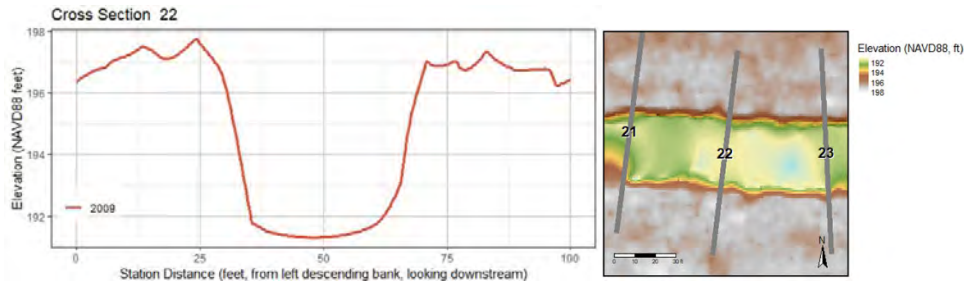
Figure 16. Cross-section 22, illustrating high banks in Lower Reach 1.

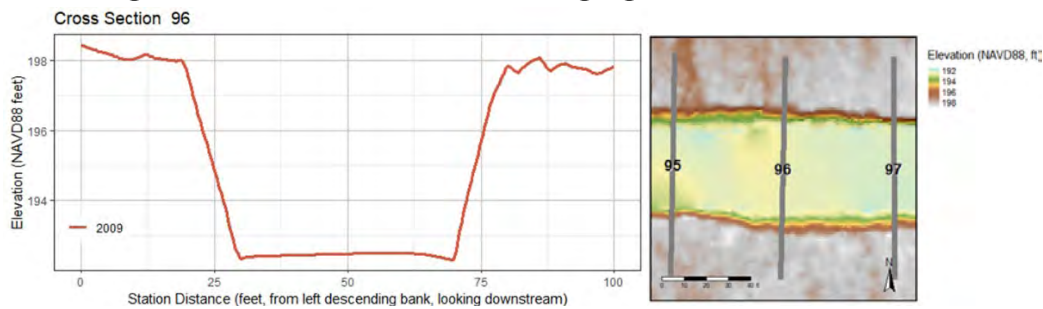
Figure 17. Cross-section 96, illustrating high banks in Lower Reach 1.

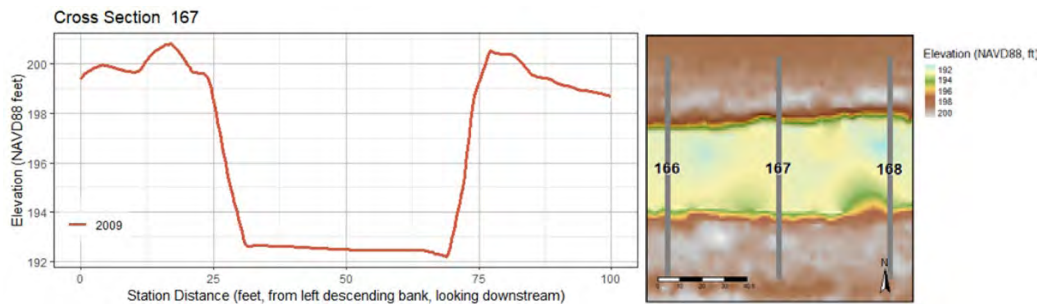
Figure 18. Cross-section 167, illustrating high banks in Middle Reach 1.

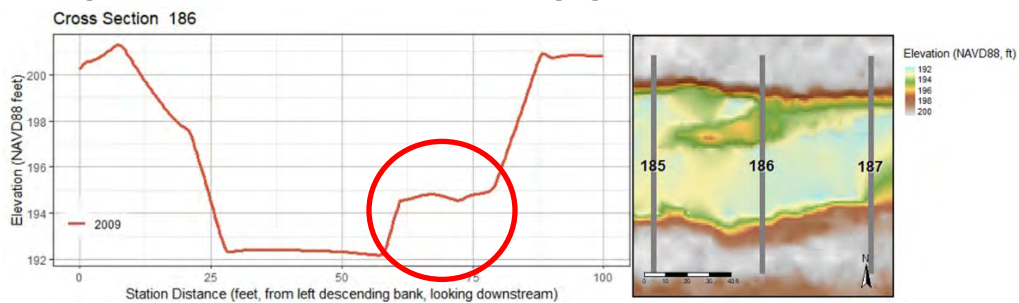
Figure 19. Cross-section 186, illustrating right floodplain berm development.

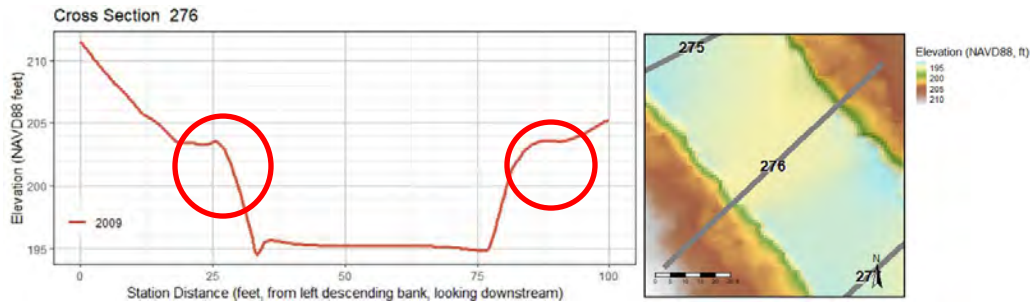
Figure 20. Cross-section 276, illustrating right & left bank floodplain berms

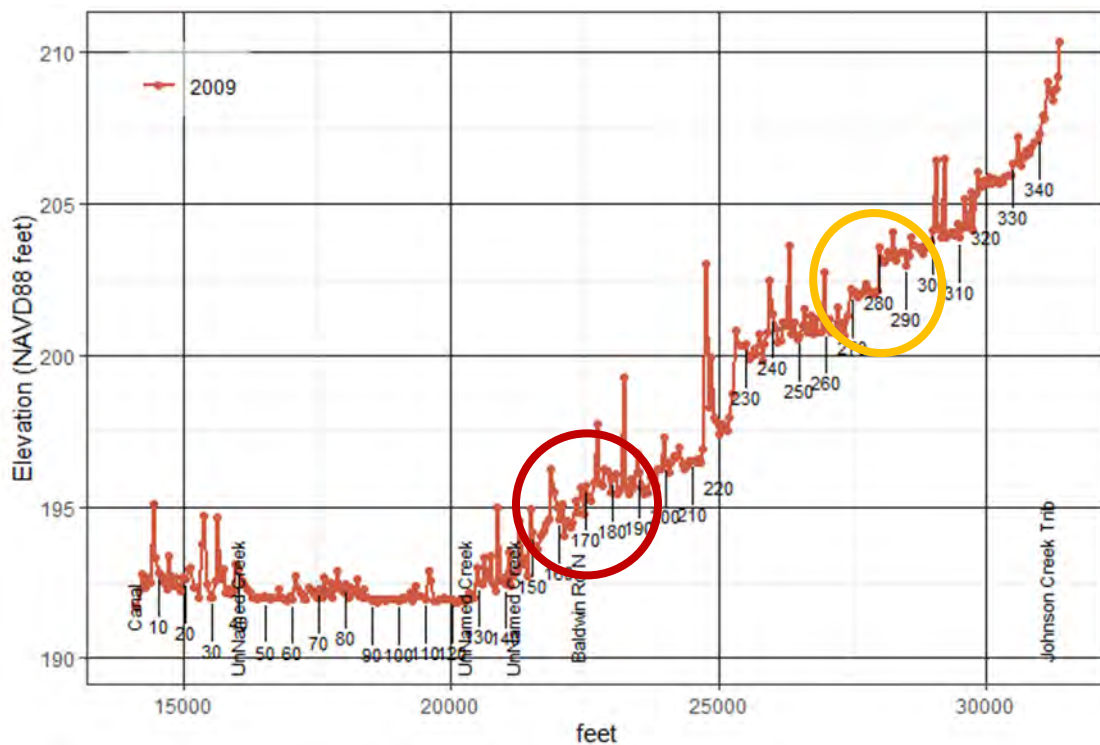
Figure 22. FG level 1-Johnson Creek Reach 2: LiDAR water-surface profile with cross-section locations

The same LiDAR surface slope (0.0002 ft/ft) was collected from the start of the downstream end of the reach to approximate station 20,500 (ft.) identified as lower Reach 2. The slope then increases significantly with a steep transition at station 25,000 (ft.) and then again at approximate station 31,000 (ft.), identified as upper Reach 2. The slope of the upper Reach 2 is 0.0016 ft/ft. The high potential for nick points and zones were discovered during FG LiDAR analysis and verified during the site visits to the Baldwin Road Bridge and Odums Crossing subdivision (Figures 4-6). Sinuosity within the lower Reach 2 is relatively straight with a value of 1. Sinuosity ranges 1.1 to 2.1 so there is some meandering occurring within the incised channel.

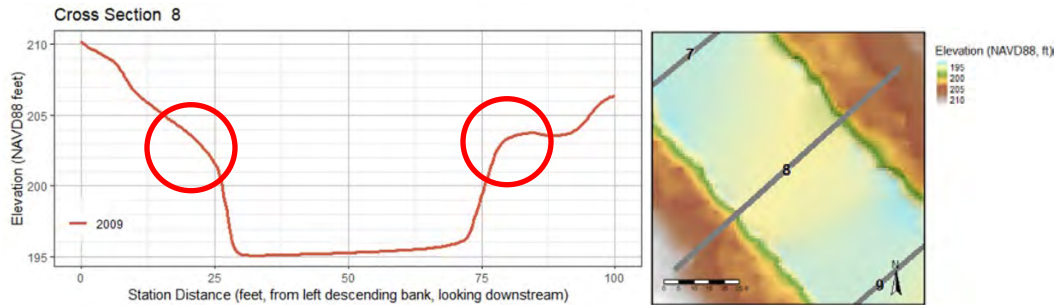
Based on cross-section analysis, as expected a similar range of average channel bank heights were found in downstream Reach 2 as in upper Reach 1. The lower Johnson Creek is actively building floodplain berms that are about 5-8 ft. with bank heights ranging from 8 to 12 ft. Lower Reach 2 has experienced channel degradation and is progressing through a recovery phase with the flat channel slopes and relative access to floodplain berms. The lower Reach 2 channel is a CEM type IV-V.

Figure 25. Cross-section 8, illustrating floodplain berm building in lower Reach 2.

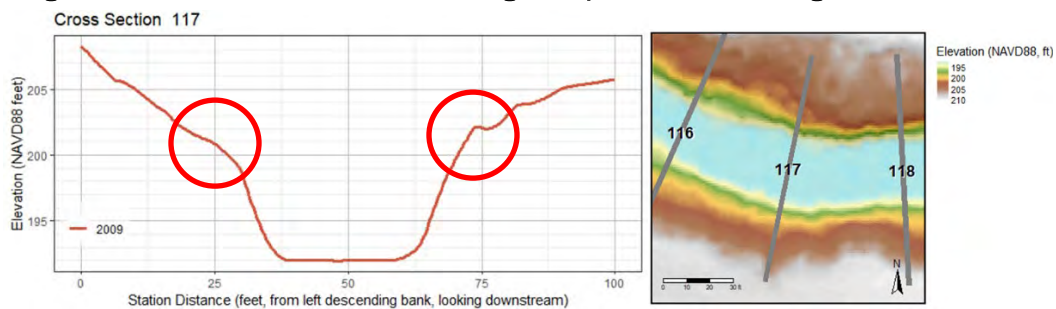
Figure 26. Cross-section 117, illustrating floodplain berm building in lower Reach 2.

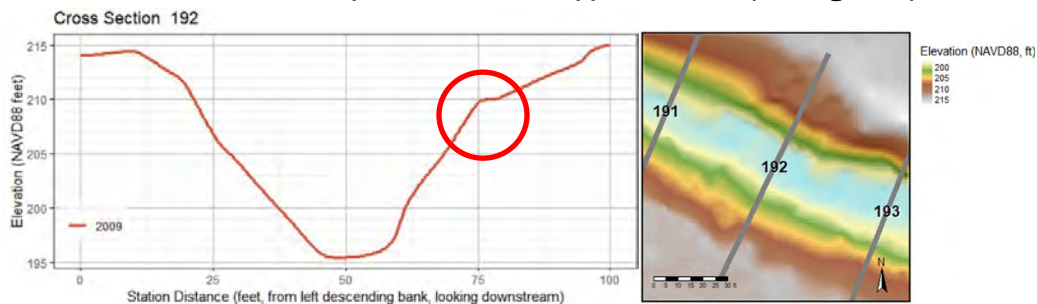
The upper Reach 2 has a significantly steeper slope and the main channel trends are not actively building floodplain berms but are progressing through a series of channel degradation areas. Nick points and zones are developed on areas where erosion resistant materials (Figure 24). There is a noticeable change in bank heights (channel type) from downstream Reach 1 and lower Reach 2 with bank heights at 15 to 20 ft. (Figures 25-27). The steeper slope paired with incised channel form and steep side-banks with little or no floodplain berms or access to an active floodplain represents typical degrading channel locations. With the steep slope and lack of active floodplain connections the upper Reach 2 channel is a CEM type III.

Figure 27. Cross-section 192, illustrating lack of floodplain berm building with abandoned floodplain terraces in upper Reach 2 (see Figure 8).

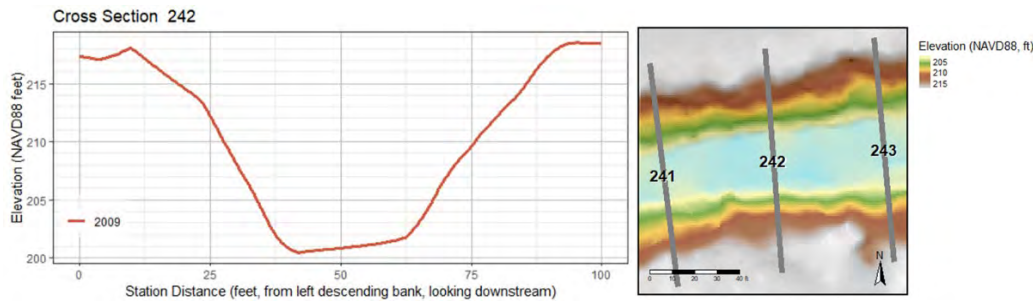
Figure 28. Cross-section 242, illustrating lack of floodplain berm development in upper Reach 2

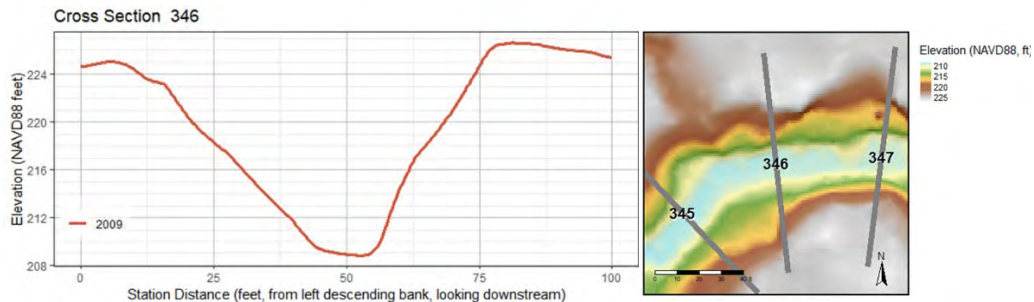
Figure 29. Cross-section 346, illustrating no active floodplain berm building in upper Reach 2

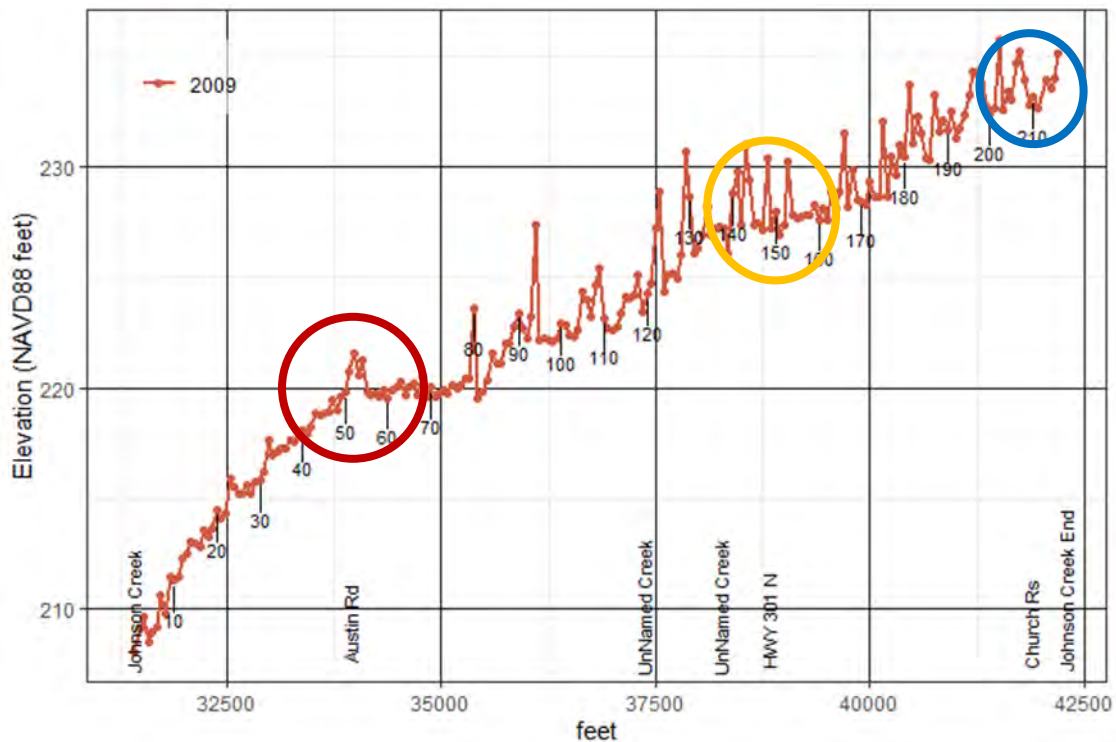
Figure 31. FG level 1-Johnson Creek Reach 3: LiDAR water-surface profile with cross-section locations

The LiDAR water surface slope of 0.0024 (ft/ft) is significantly steeper than Reach 2. The downstream 2000 ft of Reach 3 is the steepest at 0.007 (ft/ft). The slope then decreases significantly upstream of the Austin Road Bridge which appears to be providing some form of limited grade control (Figure 31). The old bridge piles, riprap and concrete are providing limited bed protection (Figure 32). Field verification of the FG data found nick zones upstream (Figure 33). Sinuosity within lower Reach 3 had the highest values from 1 to 1.25. The rest of the reach had values less than 1.15 and most were around 1.

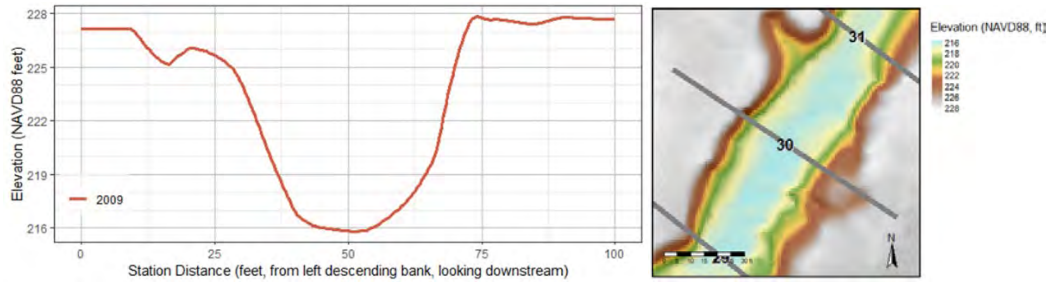
The lower Johnson Creek Reach 3 has bank heights ranging from 10-12 ft. and variable channel widths depending on where nick points or nick zones are located. Qualitatively, visually comparing the cross-sections (Figures 34 and 35) illustrates the variability in cross-sectional area and bed levels. There is approximately 1550 ft. between cross-sections 30 and 61 but there is a larger cross-sectional area in the downstream cross-section and is also 4 ft lower in bed elevation. This information coupled with the field identification of nick points likely shows a degraded downstream cross-section with continued degradation occurring up to the upstream cross-section. Paired with oversteepened channel slopes and relatively straight sinuosity, channel incision will continue to lower the bed elevation as it

works upstream and widens and increases cross-sectional area. There are relatively no floodplain berms being formed in any of Reach 3, this also being an indicator of channel degradation and an entrenched channel. The lower Reach 3 channel is a CEM type III.

Figure 34. Cross-section 30, illustrating entrenched channel with no access to active floodplain-lower Reach 3.

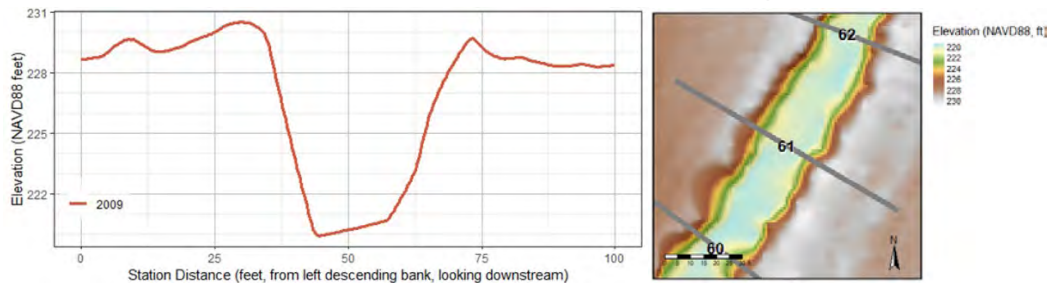
Figure 35. Cross-section 61, upstream of Austin Road Bridge-illustrating entrenched channel with no access to active floodplain (Figure 33).

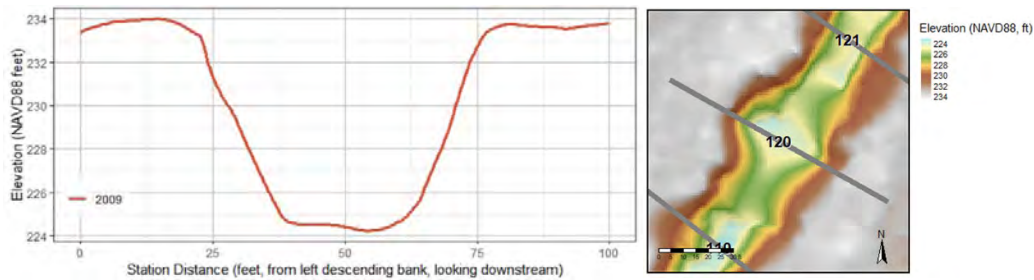
The mid and upper Reach 3 has a flatter slope than the lower section of the reach but again shows all the signs of a typical degrading channel system. Low sinuosity, steep channel slopes, and relatively no floodplain berms or connections to an active floodplain are qualitative signs that a channel is in a degrading condition. A similar progression of cross-sectional area and channel bed elevations can be illustrated between cross-section plots (Figures 36-38). In the field, nick points and zones were identified. Bank heights ranged from 8 to 10 ft. with channel widths from 10 to greater than 25 ft. The mid and upper Reach 3 channel is also a CEM type III.

Figure 36. Cross-section 120, illustrating lack of floodplain berm building with abandoned floodplain terraces in upper Reach 3 (see Figure 8).

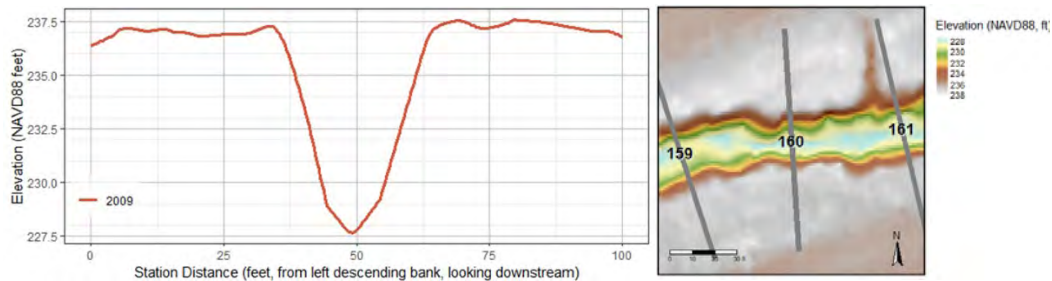
Figure 37. Cross-section 160, upstream of Highway 301 Bridge illustrating lack of floodplain berm development in upper Reach 3

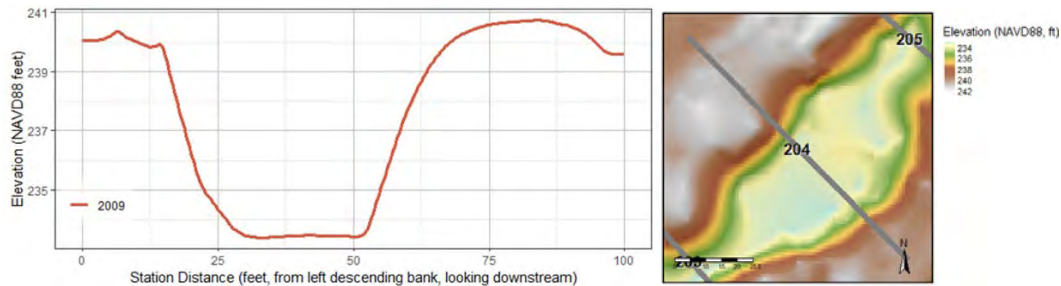
Figure 38. Cross-section 204, upstream of Church Road Culverts illustrating no active floodplain berm building in upper Reach 3

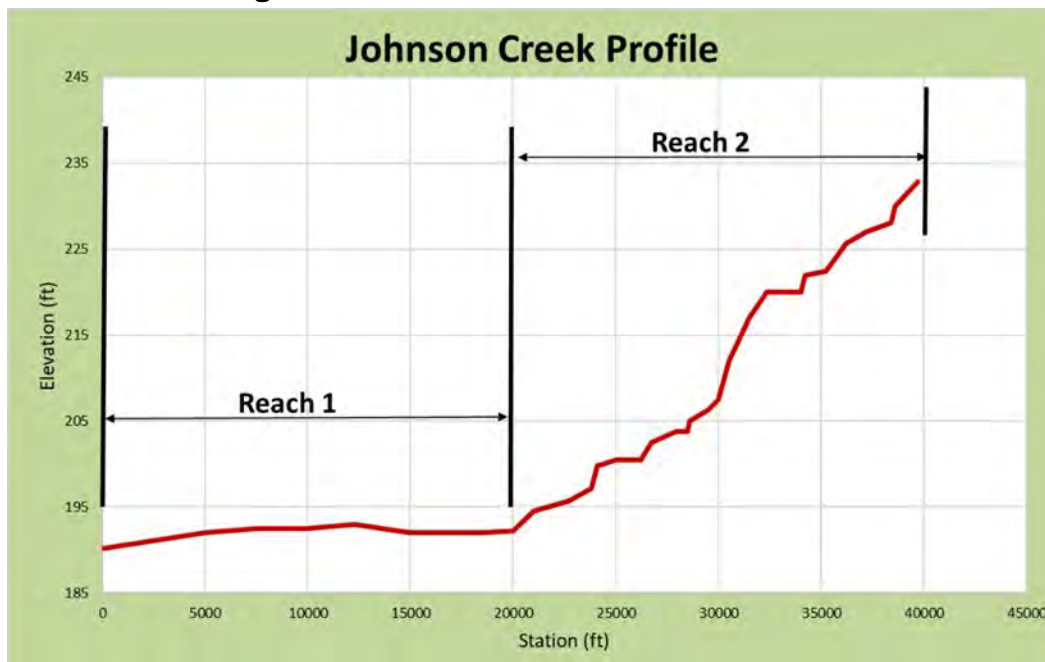
Figure 43. 2009 LiDAR Profile for Johnson Creek

The following is a very preliminary assessment with recommendations for Johnson Creek based on limited field investigations and analysis of the 2009 Lidar surveys using the FG Level 1 Channel Stability Assessment approach. One of the primary goals of this project is to minimize channel degradation, channel erosion, and sedimentation to support aquatic ecosystem form and function. This assessment addresses the channel stabilization, erosion control and sedimentation aspects of these goals. Based on additional reach valuations, the FG Reaches 1, 2 and 3 were changed into two reaches for this Recommendations Section (Figure 43). The new break for defined Reaches 1 and 2, is in the profile slope break located at approximately the same location as the Mississippi River alluvial materials and just downstream of the Baldwin Road Bridge.

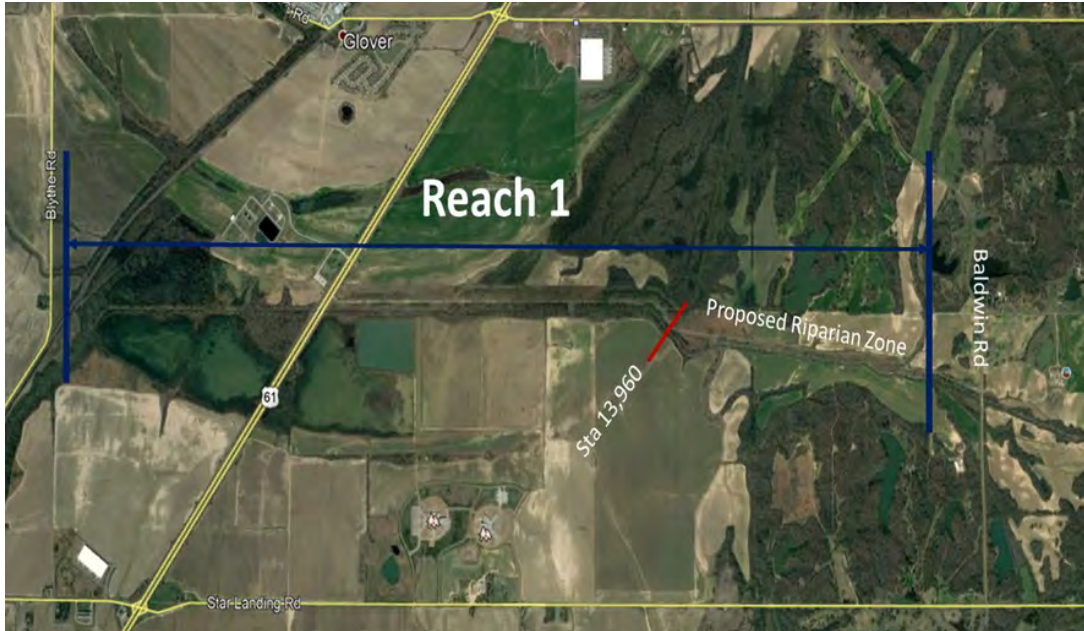
Figure 44. Johnson Creek Reach 1

Reach 1 extends from about a mile downstream of Hwy 61 to approximate Sta 20,000 just downstream of Baldwin Road (Figures 1 and 2). Based on the limited field investigations and examination of the Lidar surveys, it

appears that this reach of Johnson Creek is relatively stable vertically, with bank erosion only occurring in isolated locations. This would roughly correspond to CEM Types IV –V. Therefore, grade control would not be required in this reach. Additionally, bank stabilization should only be considered if critical locations are identified that must be stabilized to protect some valuable riparian features. It was observed that downstream of about Sta 13,960 (Figure 44), there was a significant riparian zone consisting of woody vegetation. However, upstream of about Sta 13,960 there was a noticeable lack of established riparian vegetation. Therefore, consideration should be given to the establishment of a woody riparian zone upstream of Sta 13,960.

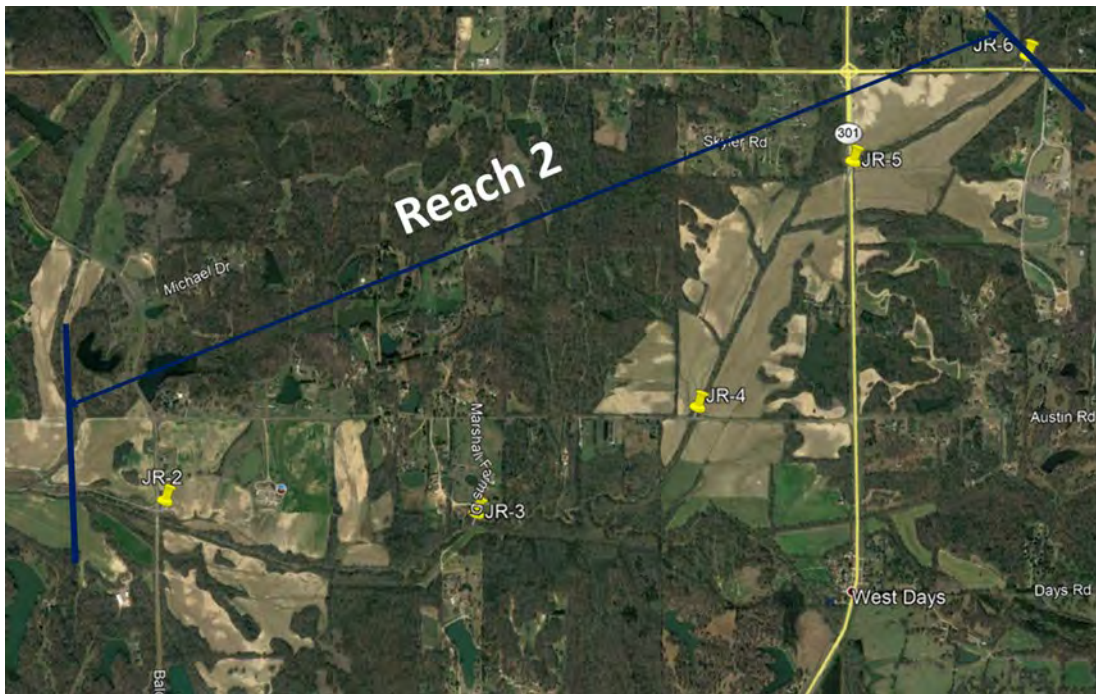
Figure 45. Johnson Creek Reach 2

Reach 2 extends from approximate Sta 20,000 (downstream of Baldwin Rd) to just upstream of Church Rd (approximate Sta 40,000). The limits of this reach are shown in Figure 45. The field investigations confirmed that this entire reach was subject to degradation, albeit, at a relatively slow rate due to the hard clay throughout the bed. Although the degradation rate appears to be relatively slow, this continued incision will contribute to the long-term deterioration of the channel system, inducing accelerated bed and bank erosion and sediment supply to downstream reaches. Therefore, for this preliminary assessment, a conservative plan of a series

With respect to bank instability, the field investigations were too limited to provide a complete assessment of the degree of erosion in this reach. However, the preliminary observations suggest that localized areas of bank erosion exist, but they may be more localized than systematic. Therefore, bank stabilization is only included as needed to protect the proposed grade control structures. Table 1 provides a preliminary and conservative estimate of the linear feet of bank stabilization that will be required for each grade control structure. In total, approximately 6,300 feet of bank stabilization may be required.

of sloping rock grade control structures is recommended. For this plan it was simply assumed that each structure would have a 3.5-foot drop with a flat pool upstream which would provide a tailwater for the next upstream structure. Figures 46 and 47 show the tentative locations of these 11 proposed structures proposed. Again, it must be emphasized that this is a conservative assessment and that the final locations, heights and number of structures could vary considerable after a more thorough analysis.
