Hatchie Loosahatchie Mississippi River Ecosystem Restoration Study

Appendix 1 – Management Measures

February 2023

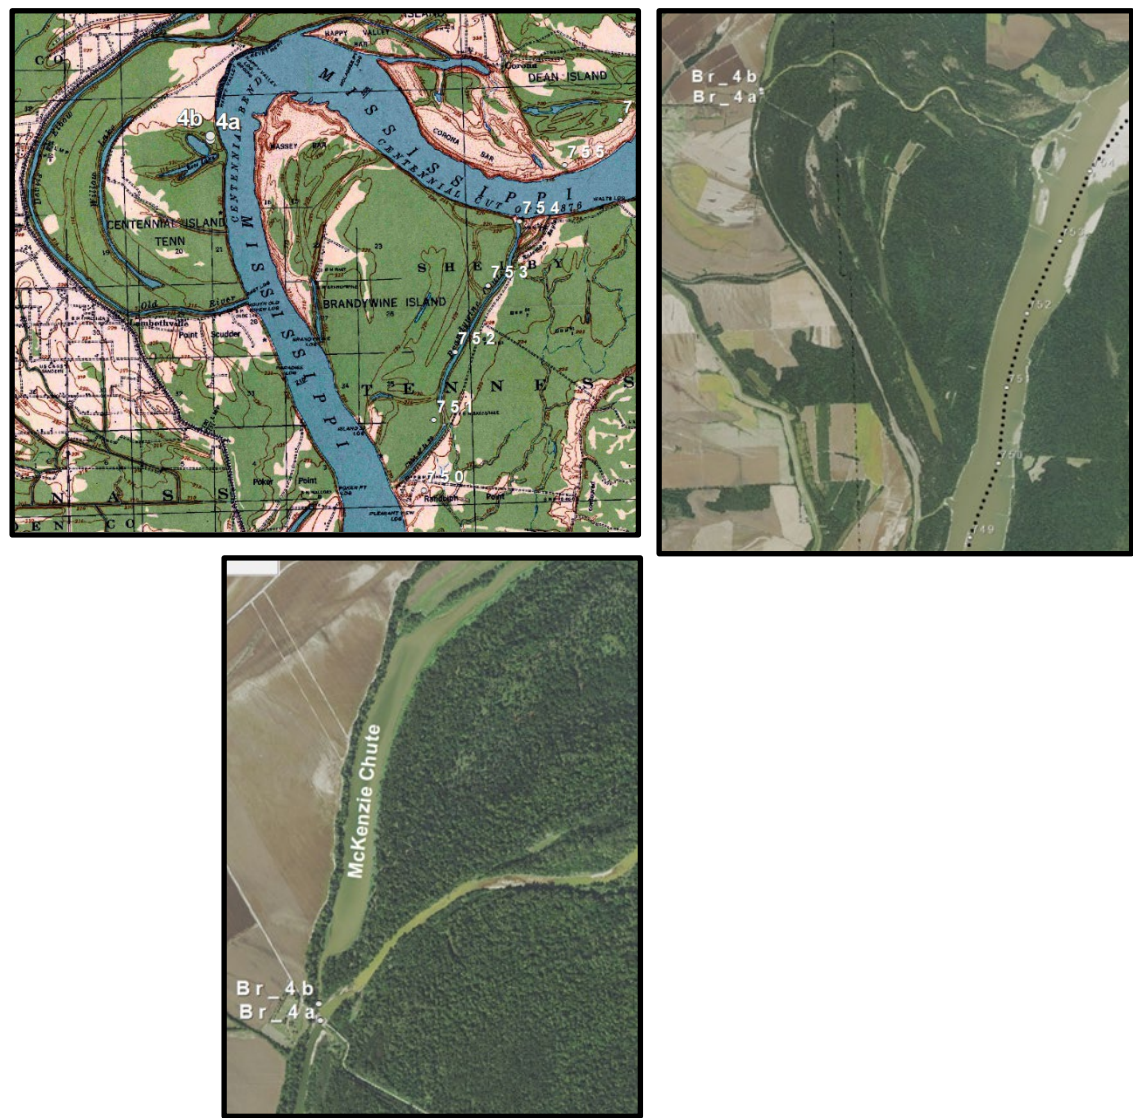
Figure 2-3. BR_4

Even in the lowest water imagery (NAIP 2012, 2017, and 2021), there is a 20 – 30 ft channel connecting McKenzie Chute to Brandywine Chute. Therefore, the channel has a lower elevation bed than the bridge and sediment deposit. Connecting channels do not typically have steeply sloping banks. With a 30' wide channel and the deepest point at the channel's midpoint, a 3 ft deep channel would result in the 1:5 or 20% slope. Thus, the channel's invert may be around 189.5 ft. exceeded 95% of the time

BR_4 proposes to adjust the invert of the bridge (BR_04a) improving connectivity. The lower invert would also promote scouring flows and thus remove the unvegetated sediment throughout Brandywine further improving connectivity and channel longevity. This measure also proposes installation of a weir in McKenzie Chute to maintain connectivity.

Item-Feature	Meets Objective	Notes	Screened
BR_04a	3	Lower bridge invert at the apex of Brandywine Chute to increase connectivity in meander scarp.	No
BR_04b	3	Install weir at the mouth of McKenzie Chute to prevent water levels from falling below existing lows (i.e., maintain this floodplain waterbody while restoring downstream meander scarp activities in Item BR_04a).	No
BR_4 Construction Assumptions			
BR_04a	Bridge Replacement cost based off of AR DOT bridge replacement assuming competitive bid contract, including contingency, same costs as Island 35 Bridge replacement.		
BR_04b	R200 rock weir, 10ft crown, 1:1.5 side slopes, 80ft long.		
BR_4 Real Estate Assumptions			
BR_04a	Assume purchase of 5 aquatic acres of woodlands for construction activities.		
BR_04b			
BR_4 OMRR&R Assumptions			
BR_04a	None		
BR_04b	Control structure O&M at year 30 estimated at 50% of construction cost.		
BR_4 Adaptive Management & Monitoring Assumptions

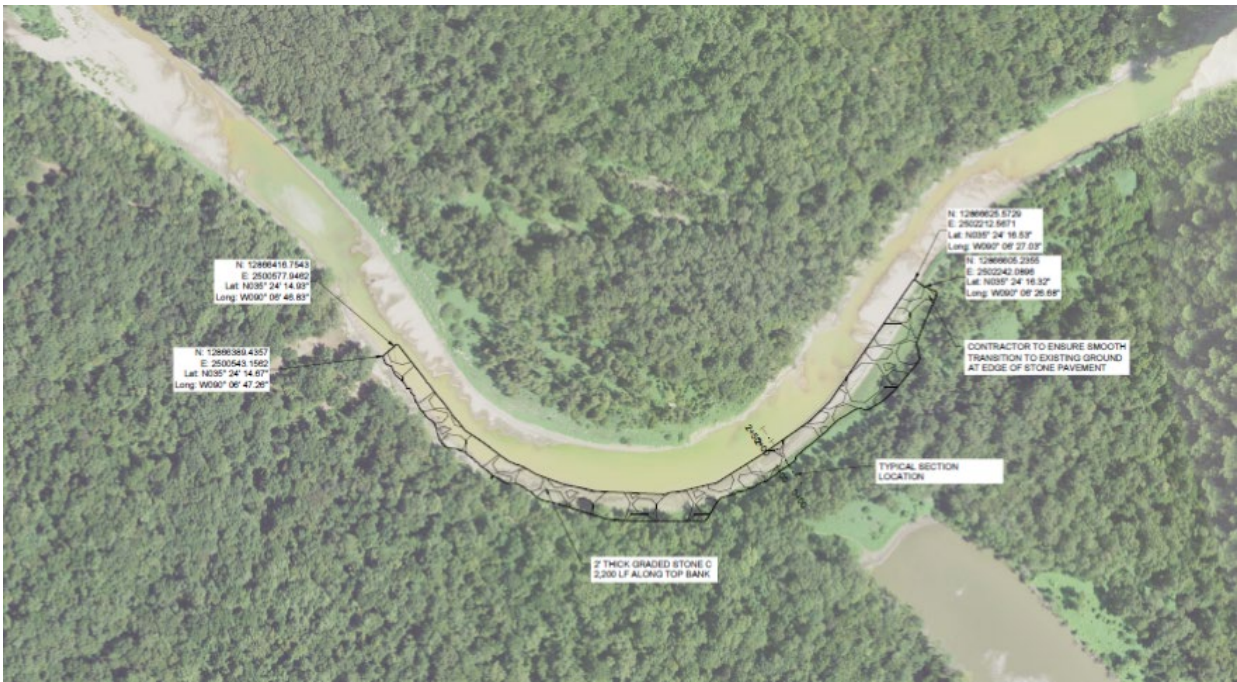
Figure 2-4. BR_5

BR_5a proposes to construct innovative bank protection or river training structures to enhance aquatic diversity while reducing bank erosion and sedimentation. The erosion may be contributing to the sediment deposit downstream in Brandywine Chute. During low water, this sediment can act as a dam preventing flow through the chute. Land managers have noted erosion along the island bank about 2 miles into Brandywine Chute. This erosion reduces the acreage of the large contiguous tract of valuable oak dominated bottomland hardwood forest growing on the island's highest ground by an estimated 0.04 acres per year (G. Earth 1997, 2021). Without the project, an additional 2 acres could erode over the project life. The erosion may also be contributing to the sediment deposit downstream in Brandywine Chute.

Because this measure reduces sedimentation that could impact the chute's flow, the aquatic project acreage includes Brandywine Chute. This effect on connectivity is less certain because the bank protection is a localized measure, therefore there is no supplementary acreage.

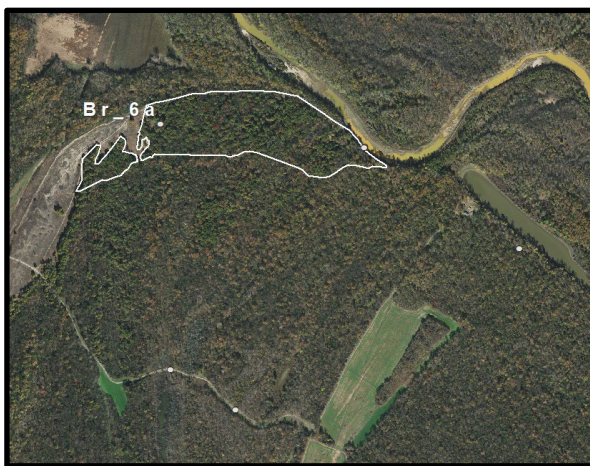
Figure 2-5. BR_6

BR_6 proposes to girdle common floodplain forest trees and monitor seedling development to determine if planting additional oak species is needed (adaptive management). With this forest, other more common floodplain forest species (cottonwood, sweetgum, willow, sycamore) compete with the hardwood trees. The dense forest canopy and competition also reduces and, in some cases eliminates, hardwood seedling growth.

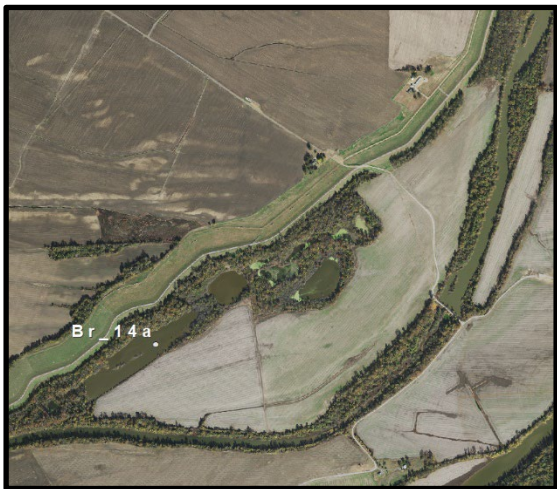
Figure 2-14. BR_14

BR_14 proposes to enhance the aquatic area of borrow pits by increasing depth following environmental design of borrow area recommendations. Levee borrow areas are typically constructed with a flat bottom and gently sloping sides. Overtime, sediment accumulates and the borrow areas become shallower. This would increase habitat complexity to the borrow areas.

BR_14 Construction Assumptions	
BR_14a	Estimate is based on excavating with no haul. Assumed depth of excavation 5ft. Survey is required to determine current borrow pit depth. Full borrow pit analysis will be required to verify the allowable excavation depth based on seepage conditions at each borrow pit. This could lead to the borrow pits not being able to be excavated at all or being able to be excavated more than 5ft. 232,320 CY (75% of the borrow area.)
BR_14 Real Estate Assumptions	
BR_14a	Assume purchase of 47 aquatic acres of woodlands.
BR_14 OMRR&R Assumptions	
BR_14a	Borrow excavation and unwatering O&M at year 30 estimated at 12.5% of initial construction cost.
BR_14 Adaptive Management & Monitoring Assumptions	
BR_14a	Fish Surveys - Borrow Areas at years 0,3,5,7,10 estimated at \$5455/event.

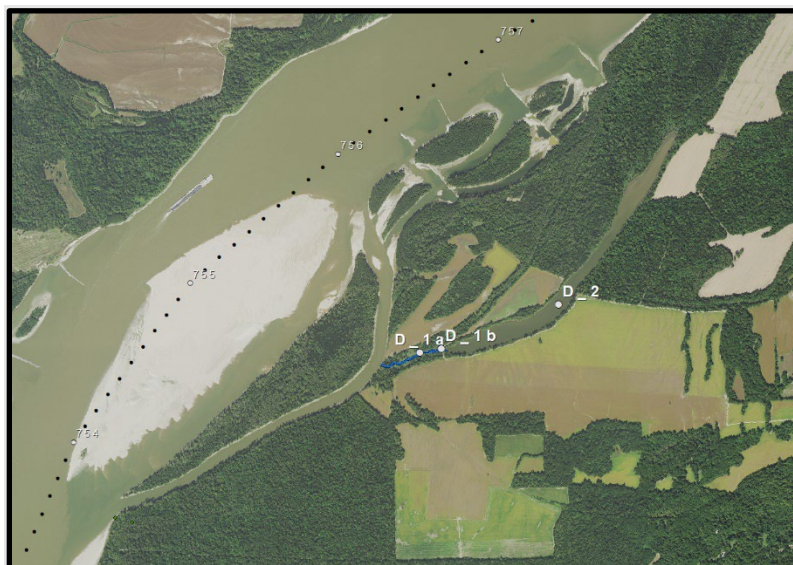
Figure 3-2. D-1

Thweatt Chute has been isolated at its upper end possibly for over a century (USGS 1931, Guntren et al. 2016). The channel at the lower end of the chute passes over two field roads (low water crossings) and connects to Densford secondary channel. Imagery suggests that culverts were replaced with low water crossings after the 2011 flood (G. Earth).

D_1 proposes to degrade the remnant crossing at D_1a which appears to be no longer in use (NAIP 2021) and lower the crossing at D_1b.

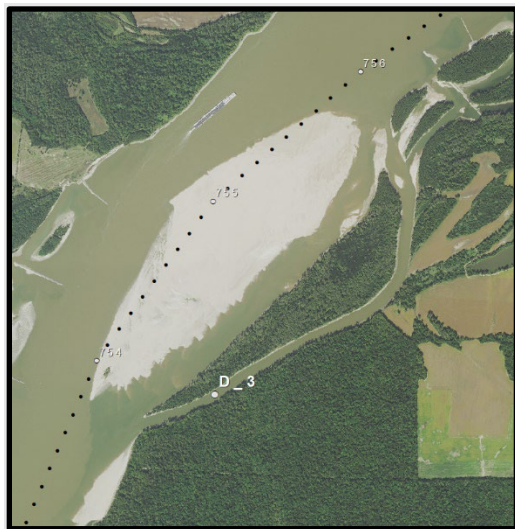
Figure 3-3. D-3

D_3 proposes to add wood to the lower end of Densford secondary channel where the channel maintains a year-round connection to the main channel. The benefits evaluation acreage for this measure is the Densford secondary channel.

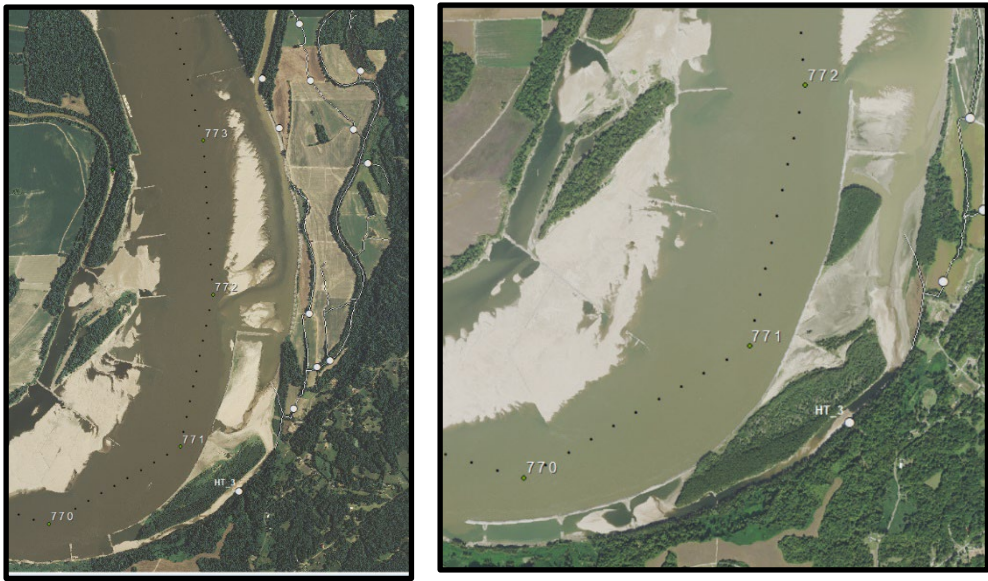
Figure 4-5. HT_3

HT_3 proposes to improve connectivity to Randolph secondary channel by dredging the southern end.

Item-Feature	Meets Objective	Notes	Screened
HT_3 – Channel Cleanout	2	Dredge downstream pilot channel to increase connectivity 500 ft x 160 ft wide to 193.2 ft depth. Enhances bidirectional flow. <i>Screening Criteria: This was attempted several years ago using a dustpan dredge, paid for by LMRCC. It was unsuccessful due to access and the re-sedimentation of material. Likely the same result will occur.</i>	Yes – Pre CEICA
HT_3 Construction Assumptions			
HT_3		Recommend deleting measure. This was attempted several years ago using a dustpan dredge, paid for by LMRCC. It was unsuccessful due to access and the re-sedimentation of material. Likely the same result will occur.	
HT_3 Real Estate Assumptions			
HT_3		None; screened prior to real estate estimation.	
HT_3 OMRR&R Assumptions			
HT_3		None; screened prior to OMRR&R estimation.	
HT_3 Adaptive Management & Monitoring Assumptions			
HT_3		None; screened prior to AMM estimation.

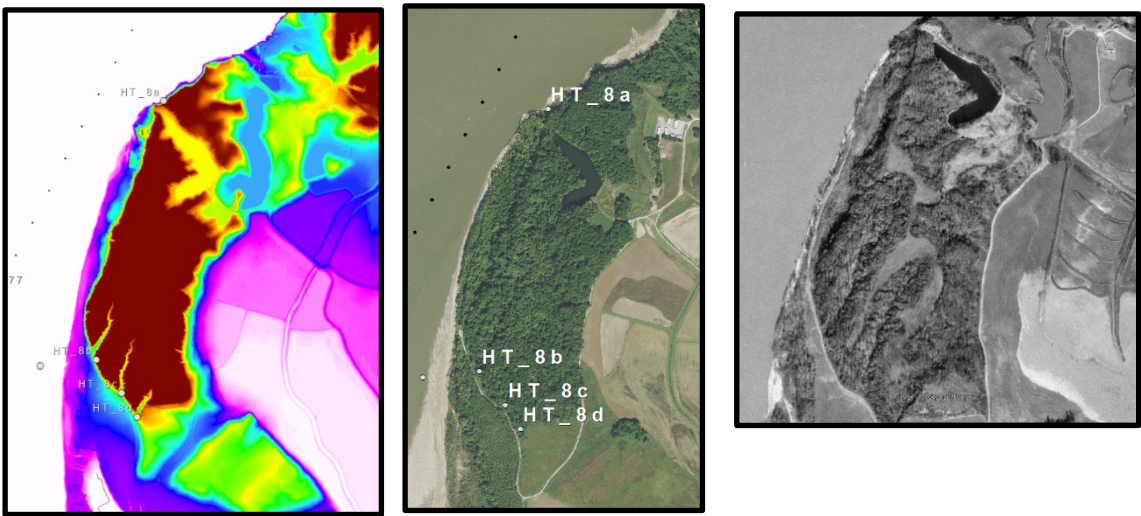
Figure 4-10. HT_8

HT_8 proposes to install river training structures and grade control structures to reduce further erosion and deepening of gullies.

Three gullies have eroded into the natural bluff and are depositing sediment onto the floodplain to the south. The hillside’s soils are Memphis silt loam (SSURGO). It is difficult to tell how the gullies formed. G. Earth imagery from 1997 suggests logging, agriculture, and possibly runoff from the reservoir to the north may have increased runoff into the bluff valleys forming the current gullies. Instream weirs or grade control structures (items HT_8b, 8c, and 8d) are proposed to reduce further erosion and deepening of the gullies. Because the cause of the gully formation was difficult to determine, the PDT proposed a river structure to reduce upstream overbank flooding (item HT_8a). Upon further investigation of the bluff elevation, this item was screened out as being unnecessary. The highest 1m contour denoting the top of the steeply sloped gully area was used to represent the project acreage. The adjacent forest was the supplemental acreage.

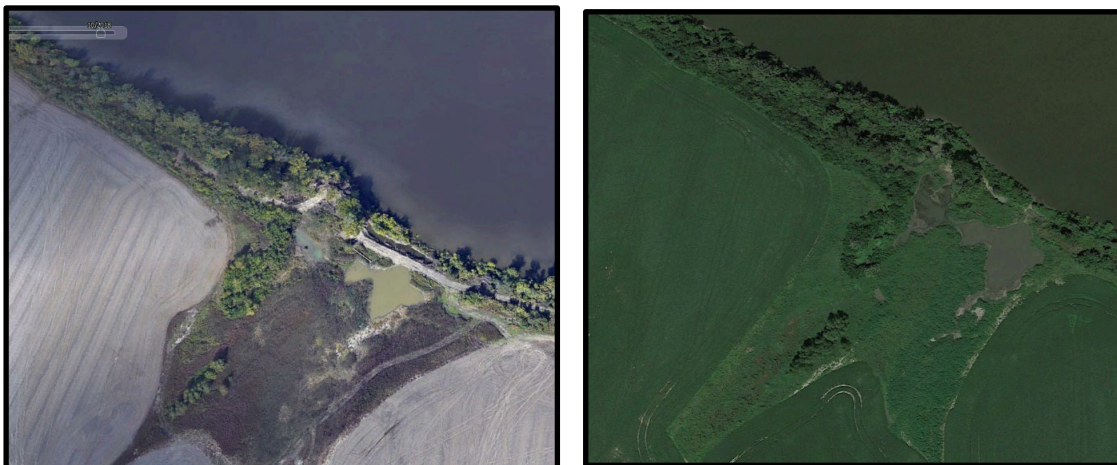
Figure 5-4. HB_2ab Imagery 1

Item HB_2a: The first obstruction is an old roadbed on the bank of Hopefield Chute with an elevation around 208.6 ft in 2014. This road has been eroded and repaired multiple times. 2021 imagery indicates it has eroded again (G. Earth). There are other roads that provide access to all surrounding ground.

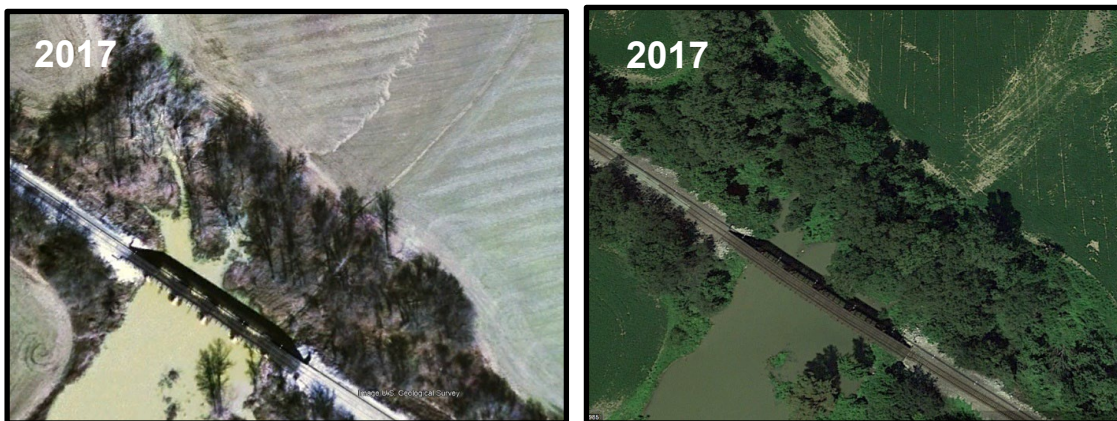
Figure 5-5. HB_2ab Imagery 2

Item HB_2b: The St. Louis San Francisco Railroad crosses over the swale right before it connects to the permanent waterbody and potential spawning area. There is a ~ 100 ft wide higher elevation forested area on the Hopefield Chute side of the crossing. This item proposes to modify the area to improve connectivity.

HB_2ab proposes to modify two obstructions in Hopefield Chute. The two obstructions reduce connectivity of Hopefield Chute and its floodplain.

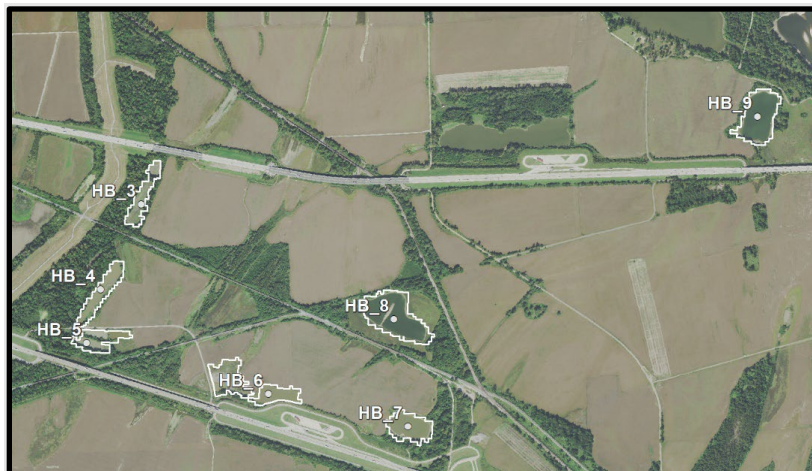
Figure 5-7. HB_3

HB_3 proposes to deepen accessible existing borrow area to improve habitat for slack water species.

Borrow area labeled HB_3 was present in its current configuration with similar surrounding landcover in 1985 (G. Earth). The soils in this area are partially to all hydric and predominantly Commerce silt loam or Sharkey silty clay with pockets of Bowdre silty clay or Tunica clay (NWIS, SSURGO). The project team chose not to alter the connectivity of these sites. Interstate 40, 55, two railroads and numerous local roads cross the area. Additionally numerous drainage ways have been built, creating a complex system of interconnecting channels.

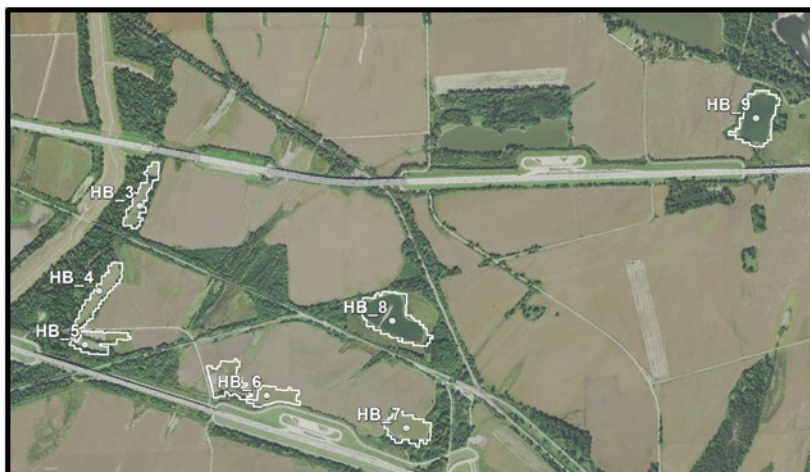
Figure 5-8. HB_4

HB_4 proposes to deepen accessible existing borrow area to improve habitat for slack water species.

Borrow area labeled HB_4 was present in its current configuration with similar surrounding landcover in 1985 (G. Earth). The soils in this area are partially to all hydric and predominantly Commerce silt loam or Sharkey silty clay with pockets of Bowdre silty clay or Tunica clay (NWIS, SSURGO). The project team chose not to alter the connectivity of these sites. Interstate 40, 55, two railroads and numerous local roads cross the area. Additionally numerous drainage ways have been built, creating a complex system of interconnecting channels.

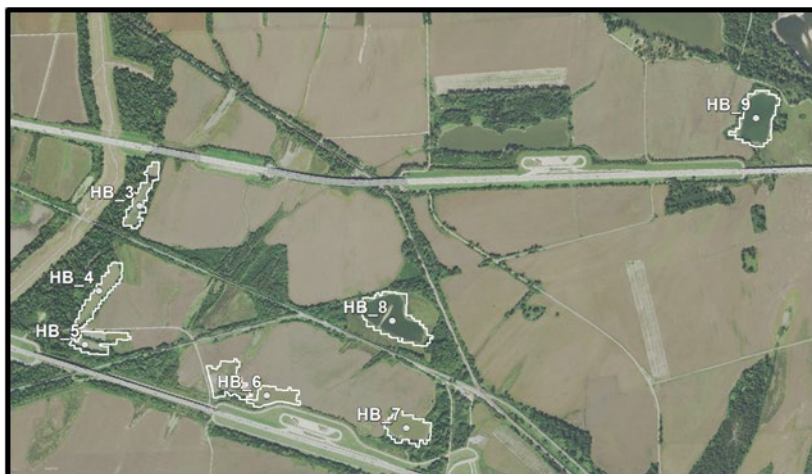
Figure 5-9. HB_5

HB_5 proposes to deepen accessible existing borrow area to improve habitat for slack water species.

Borrow area labeled HB_5 was present in its current configuration with similar surrounding landcover in 1985 (G. Earth). The soils in this area are partially to all hydric and predominantly Commerce silt loam or Sharkey silty clay with pockets of Bowdre silty clay or Tunica clay (NWIS, SSURGO). The project team chose not to alter the connectivity of these sites. Interstate 40, 55, two railroads and numerous local roads cross the area. Additionally numerous drainage ways have been built, creating a complex system of interconnecting channels.

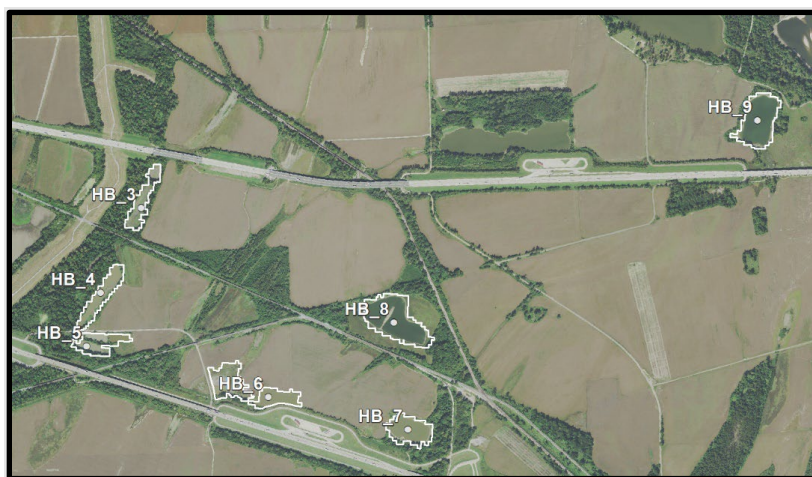
Figure 5-10. HB_6

HB_6 proposes to deepen accessible existing borrow area to improve habitat for slack water species.

Borrow area labeled HB_6 was present in its current configuration with similar surrounding landcover in 1997 (G. Earth). With the upgrades to the interstates, HB_9, and Hb_8 appear in 2001 (G. Earth). The soils in this area are partially to all hydric and predominantly Commerce silt loam or Sharkey silty clay with pockets of Bowdre silty clay or Tunica clay (NWIS, SSURGO). The project team chose not to alter the connectivity of these sites. Interstate 40, 55, two railroads and numerous local roads cross the area. Additionally numerous drainage ways have been built, creating a complex system of interconnecting channels.

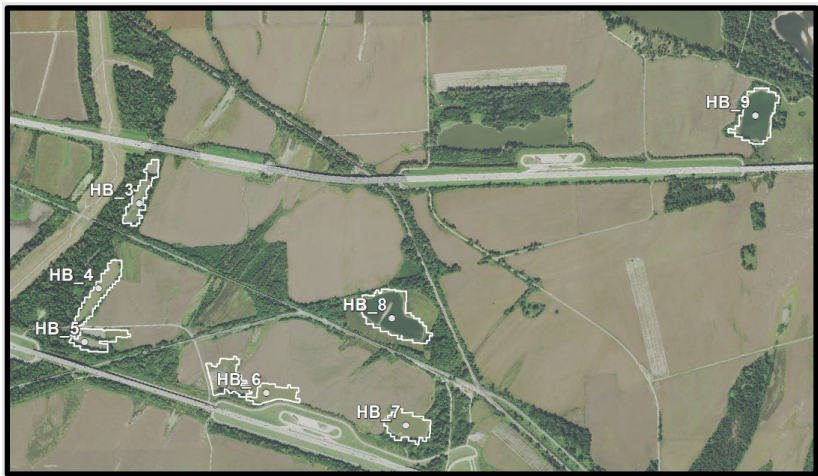
Figure 5-11. HB_7

HB_7 proposes to deepen accessible existing borrow area to improve habitat for slack water species.

Borrow area labeled HB-7 was present in its current configuration with similar surrounding landcover in 1985 (G. Earth). The soils in this area are partially to all hydric and predominantly Commerce silt loam or Sharkey silty clay with pockets of Bowdre silty clay or Tunica clay (NWIS, SSURGO). The project team chose not to alter the connectivity of these sites. Interstate 40, 55, two railroads and numerous local roads cross the area. Additionally numerous drainage ways have been built, creating a complex system of interconnecting channels.

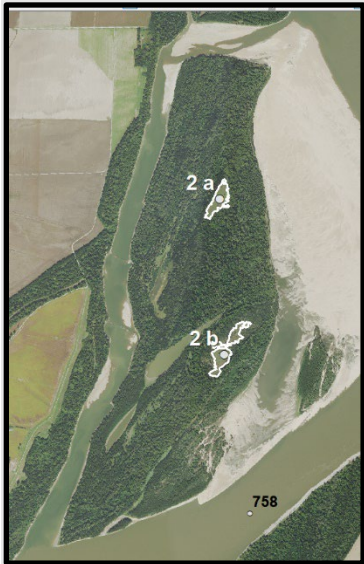
Figure 6-4. I35_2

There are two bare areas (outlined in white on image) on Dean Island with average elevations around 230.5 and 299.4 ft. The inundation period of the bare areas is short making them suitable for reforestation with mast producing trees. Areas 2a and 2b are classified as Entisols crevasse loamy sand (SSURGO) and 1-25% hydric (NWI).

Island 35-Deans Island (I35_2) proposes the reforestation of two bare areas from non-forest to mast producing forest to enhance the composition and size of forest on Dean Island.

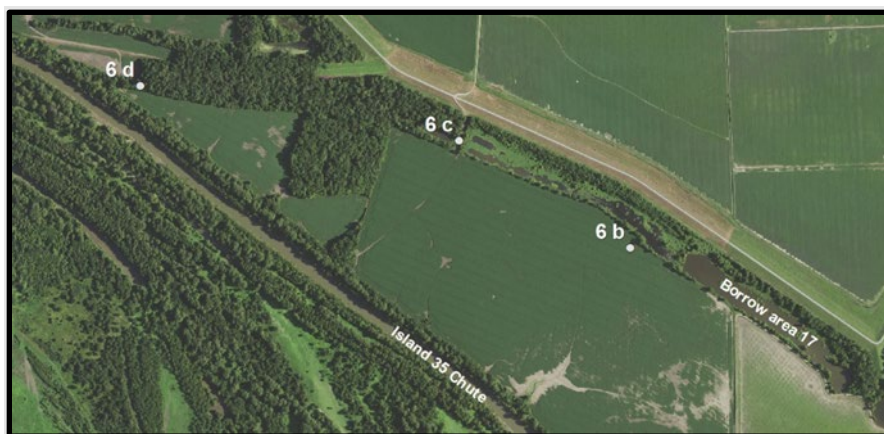
Figure 6-9. I35_6b

Island 35-Deans Island (I35_6b) proposes to reforest the southwestern shore of the borrow areas. Currently this area is farmed to the water's edge which increases sediment runoff, turbidity, and max water temperature. Reforesting the shoreline would reduce these impacts and provide additional habitat.

The soils along the shore are Sharkey silty clay (SSURGO) and 76-95% hydric (NWI). The acreage for this measure is the proposed replanting area supplemented by the adjacent forest.

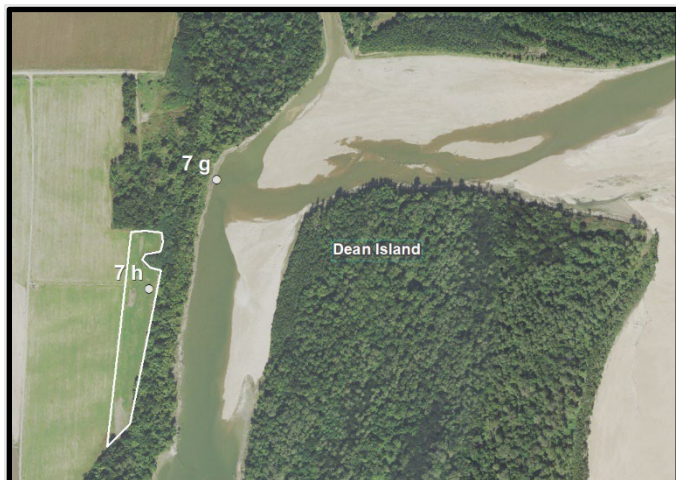
Figure 6-12. I35_7g

Island 35-Deans Island (I35_7g) proposes to protect the shoreline and create aquatic habitat complexity by installing hardpoints along the shoreline creating bathymetric and hydraulic diversity.

Three hardpoints in Duck Island secondary channel within the St. Louis District were used to determine the size of the channel bed area affected by the hardpoints. These hardpoints changed the bathymetry upstream by 1 times their length, downstream by 3.75, and outwards by 1 times their length. Thus, the aquatic acreage was the hardpoint footprint plus the additional area of bathymetric impact.

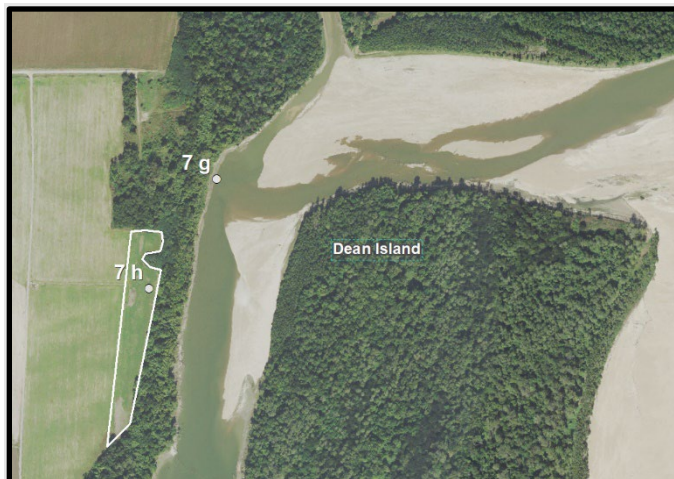
Figure 6-13. I35_7h

Island 35-Deans Island (I35_7h) proposes to reforest the secondary channel's adjacent wet agricultural land (white outlined area) to ensure a 300ft forest buffer to reduce landward bank erosion.

Landward bank erosion has reduced the secondary channel's forest buffer. Soils in this area are partially hydric 1-25, 26-50% (NWI) and Hayti or Convent fine sandy loam, or Steele silty clay loam (SSURGO). The acreage is the reforestation footprint with supplemental benefits to the adjacent forest.

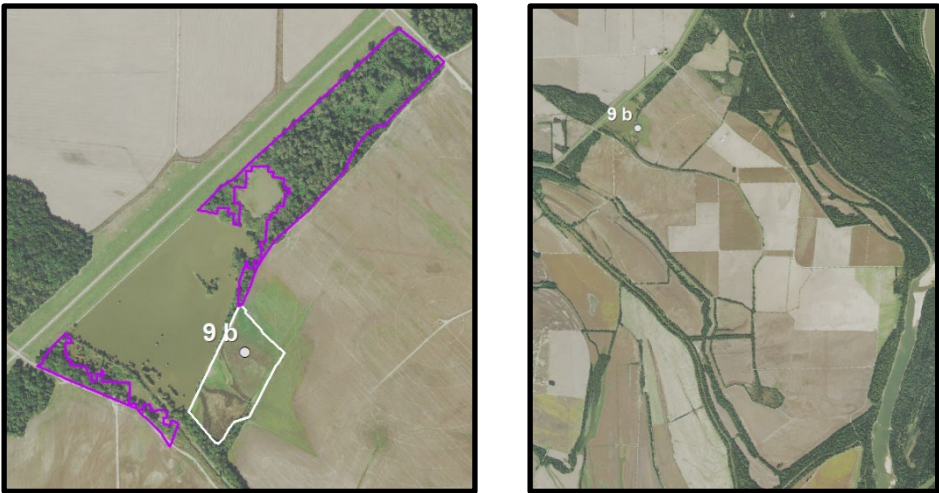
Figure 6-15. I35_9b

Island 35-Deans Island (I35_9b proposes to reforest 12 acres along the southeastern side of the borrow area which currently has minimal forest. The borrow area lies against the mainline levee in an agricultural area protected by a private levee.

The average elevation is 229.6 ft. The soils are Sharkey silty clay (SSURGO) and 76-95% hydric (NWI). The acreage was the area proposed for reforestation (white outline in image). The adjacent forest would receive supplemental benefits (purple outline). The borrow area would also benefit from the wind protection, shade, and plant material though these benefits were no quantified.

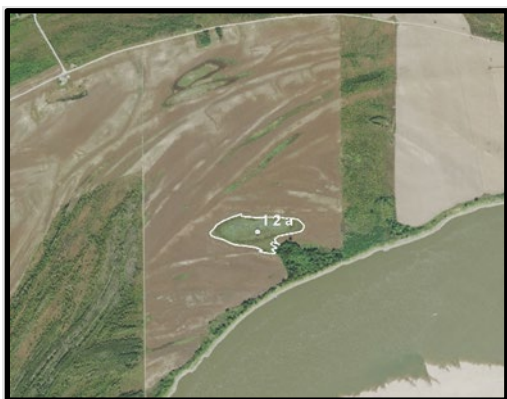
Figure 6-18. I35_12a

Island 35-Deans Island (I35_12a) proposes to plant cypress and tupelo in a low area that ponds water and is rarely farmed (outlined in white). Cypress/tupelo forest communities are relatively rare within the Lower Mississippi River floodplain.

Tunica clay and Commerce Silt Loam (SSURGO) and all hydric (NWI). The project acreage is the planting site, and the supplemental acreage is the adjacent forest.

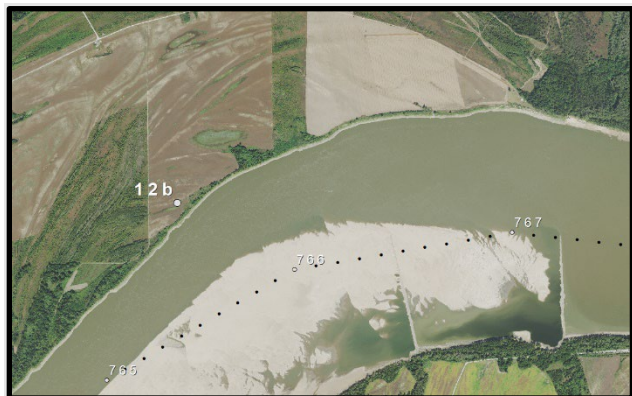
Figure 6-20. I35_12b

Island 35-Deans Island (I35_12b) proposes to plant a 300 ft wide forest strip just above the revetment and bendway weirs to create a continuous forested bank. There is very little forest along the right descending bank of the main channel from river mile 765.5 to

767. Imagery shows this bankline has been farmed since at least the 1960s likely leading to considerable erosion, bank loss, and revetment maintenance.

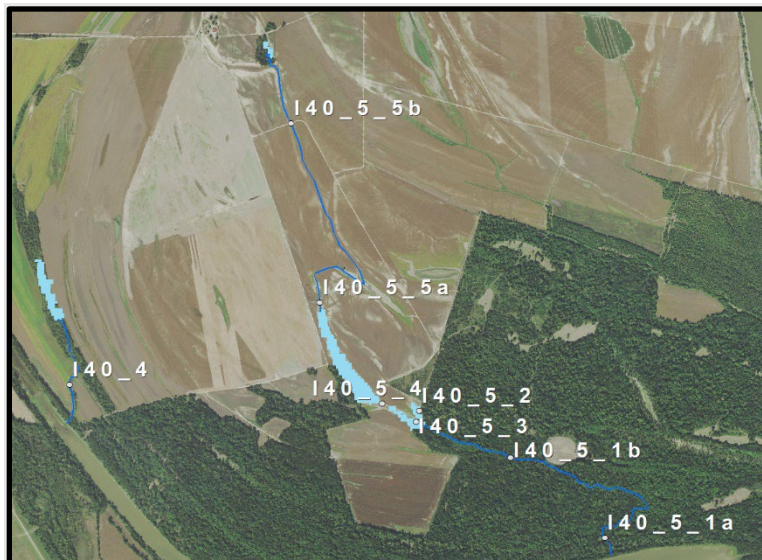
Figure 7-8. I40_4

I40_4 proposes to remove a high spot within the channel that connects to the western lake to improve connectivity to this forested waterbody.

There are few permanent waterbodies in the interior of Island 40 and 41. The remaining four waterbodies, have obstructions that reduce their connectivity to Island 40 Chute. Three of the four waterbodies occur in hydric to mostly hydric soils while the 4th in remnant forest north of I40_5_5b is in non-hydric soil (NWIS). The soils are Tunica silty clay, Sharkey clay, Bowdre silty clay and swamp

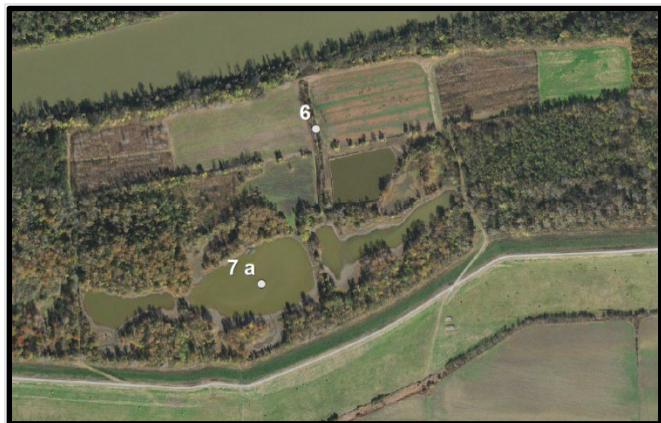
Figure 7-12. I40_7a

I40_7a proposes to alter the borrow areas connectivity by deepening them. The borrow areas maintain a mostly forested and sinuous shoreline by have likely accumulated considerable sediment over more than 50 years.

The borrow areas have been present since at least 1963 and are visible in 8 March 1963 USGS imagery. The measure’s acreage is the aquatic borrow area.

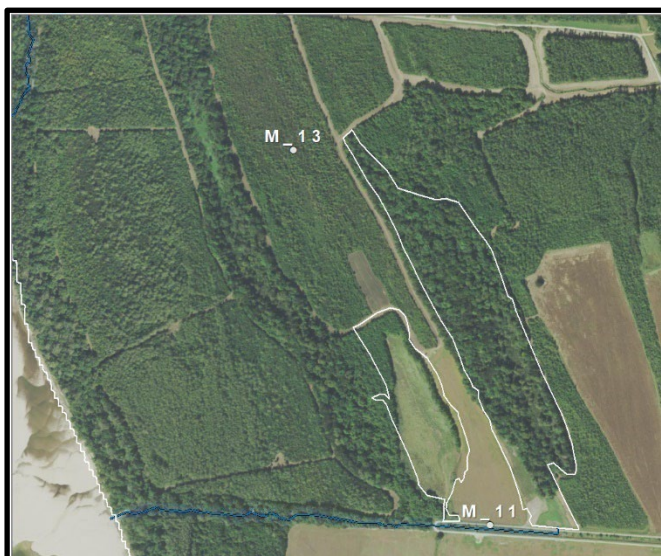
Figure 9-7. M_7

M_11 proposes to provide site managers better control of hydrology on herbaceous and forested wetlands by installation of a well.

This measure proposes a well that site managers can use to move water onto the Lost Unit of Eagle Lake State Refuge during low water years. Currently, two flashboard control structures bring water to the units from the manmade east/west channel when the Memphis gage reaches +21. The river over tops the road which forms the east west channel berm at +28 ft. Without project in a typical water year, the units could be inundated in late winter and spring. In a low water year, like 2012, very little water is available. Both units have elevations ranging from 214.2 – 216.5 ft (65.3 – 65.9 m) with Sharkey clay and Tunica silty clay soils that are 76 – 100% hydric (SSURGO, NWI). The acreage for this measure is the digitized boundary of each forested wetland management unit.

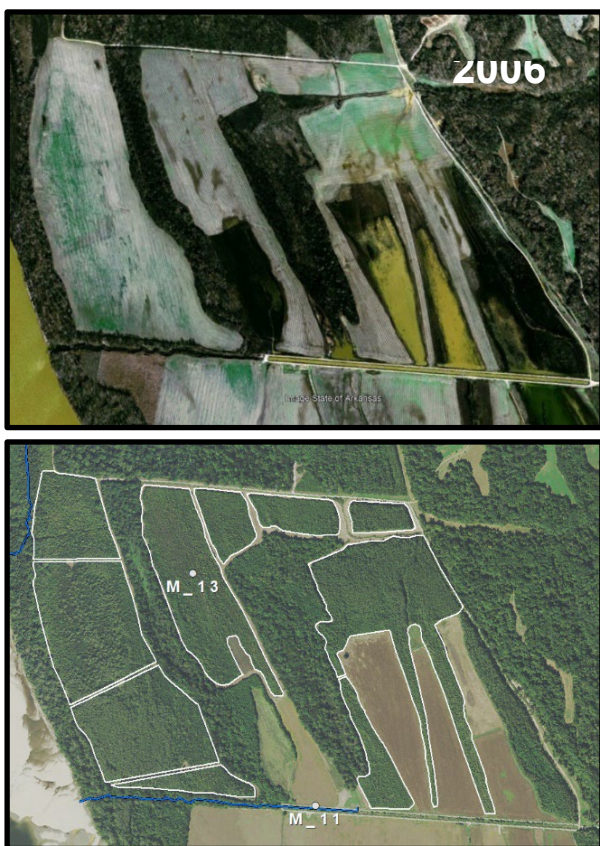
Figure 9-9. M_13

M_13 proposes to girdle unwanted tree species within the Eagle Lake Refuge.

In 2006, higher elevation agricultural areas in Eagle Lake Refuge were planted in a variety of species. As the forest evolved Cottonwood has become the dominant species. There is an opportunity to employ forest enhancement through tree girdling. Tree girdling would create dead standing wood benefiting insects and cavity nesting birds. The reforested areas are non-hydric or 76-95% hydric with Robinsonville and Convent silt loam, Bowdre silty clay, and Sharkey clay. There is no supplemental acreage as all reforestation areas are surrounded by roads or mowed management strips.

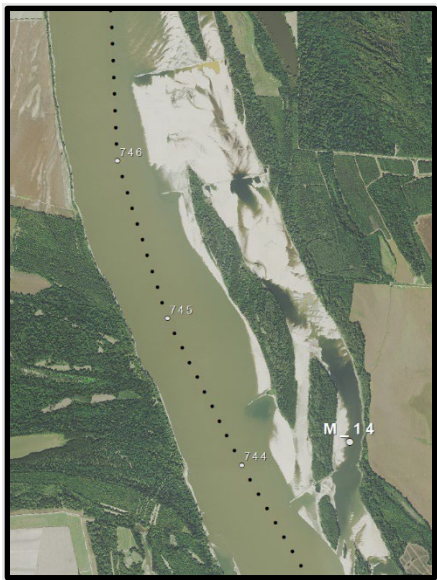
Figure 9-9. M_14

M_14 proposes to add wood to the lower end of Hickman Bar secondary channel where the channel maintains a year-round connection to the main channel. Wood traps would improve the aquatic invertebrate diversity in Hickman Bar secondary channel.

The benefits evaluation acreage for this measure is the secondary channel. The Hickman Bar islands were not captured in the HEC-RAS inundation GIS layer. The Q50 satellite imagery inundation GIS layer was used to remove the islands from the HEC-RAS layer and determine the riverward boundary of the secondary channel.

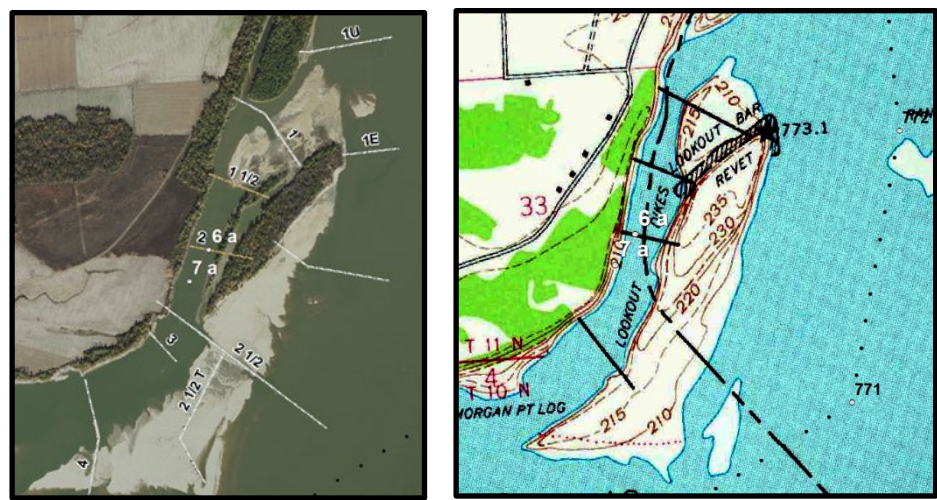
Figure 12-7. S-6

S_6 proposes to notch the wood pile dikes and create a pilot channel in the small interior secondary channel.

which is unnotched in this area. Water enters the channel by flowing along the downstream edge of Dike 1 or when Dike 1 overtops. The position of the secondary channel entrance likely results in sediment deposition and causes the upstream disconnection. The downstream end of the channel is less obstructed and notching the interior dikes would improve downstream connectivity and fish access to the channel’s interior habitat. Pile dikes 1.5 and 2 block the smaller interior channel. Dike 1 is partially submerged in the 8 Oct. 2021 NAIP image suggesting an elevation around 201.7 ft exceeded 91.5%. Dike 2 is above water on 3 Aug 2018 at 208.8 ft and mostly submerged on 14 Aug. 2019 at 213 ft suggesting an elevation of 210.8 ft which would be exceeded 68%. There is considerable sediment built up around Dike 2 and a pilot channel would improve downstream connectivity. Although the upstream end of the channel is likely to stay disconnected, the overall connectivity and downstream connection would be improved by this measure. An elevation of 193.5 ft. would be exceeded 100% of the time. Project acreage is the Lookout Bar secondary channel whose aquatic species would benefit from the increase in accessible protected habitat.
