US Army Corps
of Engineers

OPERATION MAKE SAFE PROJECT UPDATE Nov. 30, 2011

Birds Point - New Madrid Floodway

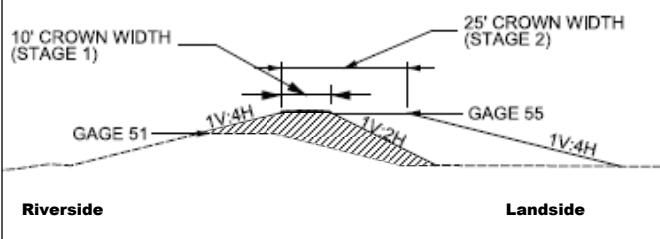
The hatched area is the modified section of the upper crevasse levee. The modified section will be built as weather permits and will provide protection to 55 feet on the Cairo gage. The full levee section will be constructed after spring highwater and will provide additional stability and durability to the levee.

The upper crevasse is located at Birds Point, near the confluence of the Mississippi and Ohio rivers. Repairs are required for 9,000 feet of levee at this location. Work here includes filling five scour holes back to level grade, repairing four levee segments and constructing one segment realignment.

Upper crevasse: A Corps of Engineers crew consisting of 26 personnel and 30 pieces of heavy equipment is on site here, at two nearby borrow sites, and at a maintenance facility. Survey results indicate that the entire 9,000 feet of levee is at or above a (Cairo) gage elevation of 51 feet. Crews had been filling the land side of the levee back to level grade until rain suspended earthwork Sunday morning. Limited work to build the 55-foot levee has begun, with nearly 4,000 feet of foundation in place. Focus now is to complete the landside clay bed so assets can then be shifted fully to constructing the higher 55-foot levee.

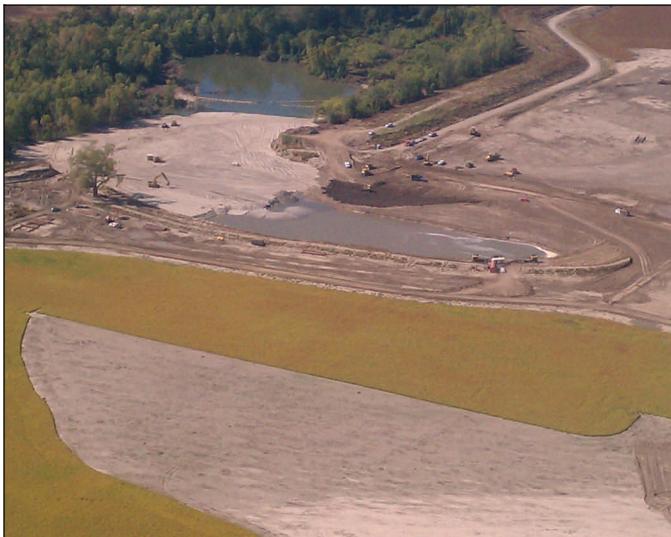
The center crevasse scour hole as seen from the air Oct. 25 during dredging. The area to the right of the levee was filled in after this photo was taken. (Photo by Brad Hahn, courtesy of Great Lakes Dredge & Dock Company)

The center crevasse is located near Seven Island Conservation Area. Repairs are required for 800 feet of levee at this location. A scour hole developed here, connecting with the existing 1937 scour hole. Work here includes separating the two scour holes, filling the new scour hole using sand dredged from the river bottom, and repairing the levee to the interim grade.

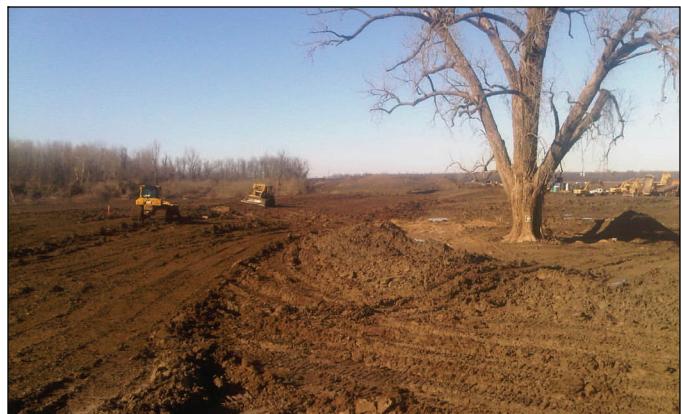
Bulldozers operators remove the top four inches of mud Nov. 30 to allow the levee at the center crevasse to dry faster. Proper moisture content is critical here.

Center crevasse: A Corps of Engineers crew consisting of 27 personnel and 20 pieces of heavy equipment is on site here and at a nearby clay borrow site. Sunshine today allowed the crew to dry the soil in the levee and prepare it for additional construction. Earthwork could resume as soon as Thursday. The Make Safe levee will be 15 feet high above the surrounding ground. Crews have now constructed seven feet.

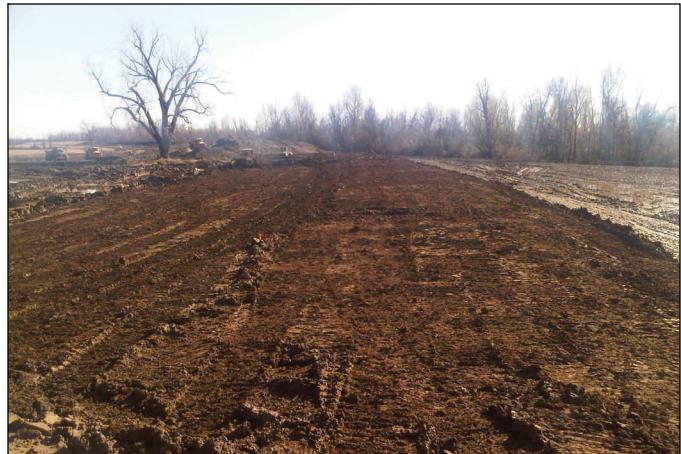
The levee at the center crevasse dries Nov. 30. Once dry, additional clay can be placed and compacted.
