# OPERATION MAKE SAFE PROJECT UPDATE Oct. 26, 2011

## Birds Point - New Madrid Floodway

### Missouri

#### Memphis District

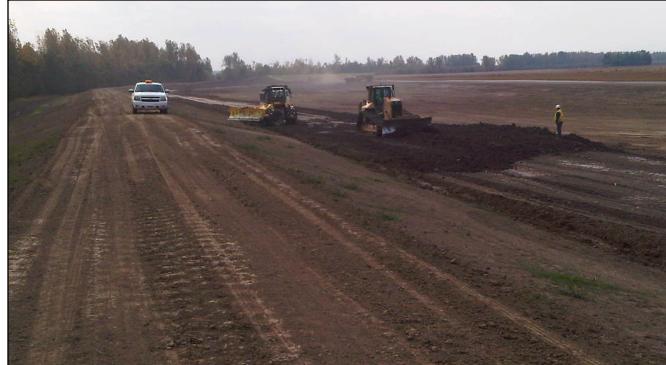
A bulldozer operator spreads clay landside of the levee at the upper crevasse Wednesday.

**Upper crevasse:** A Memphis District crew consisting of 22 personnel and 16 pieces of heavy equipment is on site here, at a nearby borrow site, and at a maintenance facility. Crews are restoring the bed of clay on the land side of the levee to prevent seepage. A total of 6,800 feet of levee meets or exceeds a (Cairo) gage elevation of 51 feet at this location. Low reaches have been raised and await inspection.

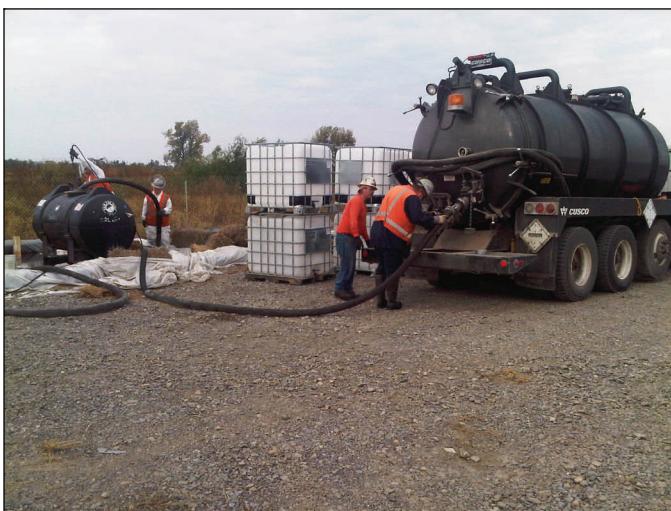
**A contractor at the upper crevasse transfers desensitized blasting agent from the storage containers (at left) to USDOT-authorized shipping containers (at center) Wednesday. Removal will begin later this week.**

**Blasting agent removal:** Desensitized blasting agent remains stored at the upper and lower crevasses. The results of a laboratory characterization confirmed the blasting agent is not an explosive risk. A contractor transferred the blasting agent into shipping containers today at the upper crevasse, and will transfer the material at the lower crevasse tomorrow. Removal will begin later this week.

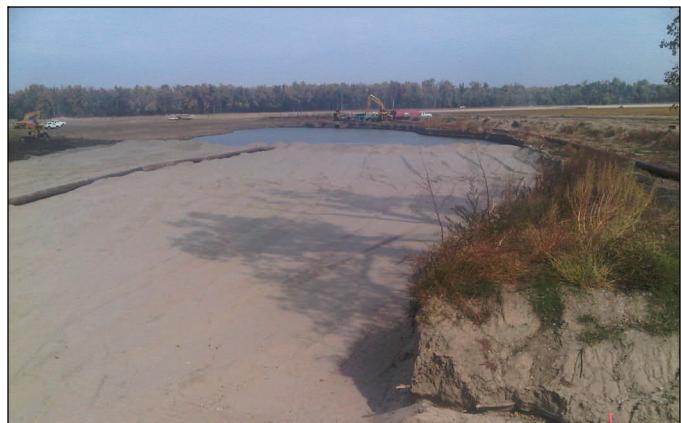
**The dredge contractor pumps sand into the scour hole at the center crevasse Wednesday.**

**Center crevasse:** A Memphis District crew consisting of seven personnel and ten pieces of heavy equipment is on site here and at a nearby clay borrow site. The crew is placing the clay over the dredged sand to prevent seepage and serve as the foundation for the levee segment. The dredge Iowa began pumping sand from the Mississippi River into the scour hole Oct. 8. Pumping will last up to 30 days. The dredge has pumped 290,000 cubic yards of sand into the scour hole to date.

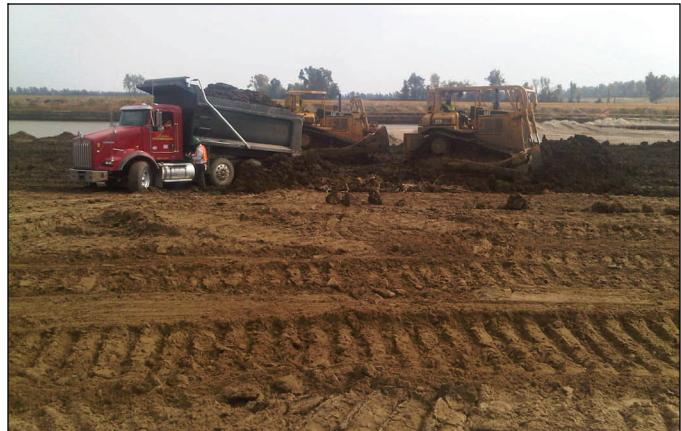
**Clay is delivered to the center crevasse Wednesday to cover the dredge sand that was placed in the scour hole. This clay will form the foundation of the levee and serve as a landside seepage barrier.**
