OPERATION MAKE SAFE PROJECT UPDATE Sept. 21, 2011

Birds Point - New Madrid Floodway

Missouri

Memphis District

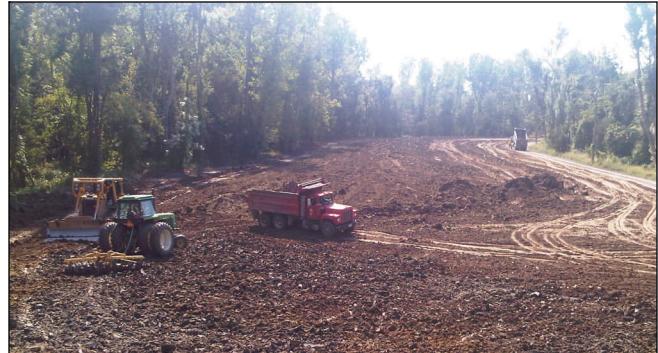
Work at the lower crevasse resumed today after rain delays. Crews are processing material to remove excess water before placing the clay into the levee.

Lower crevasse: A Vicksburg District crew consisting of 14 personnel and 18 pieces of heavy equipment is on site. The crew is awaiting inspection of a 2,000-foot levee segment, and is again making progress on a 1,500-foot segment of levee. The crew is also processing material for the foundation of the last 1,200 feet of levee.

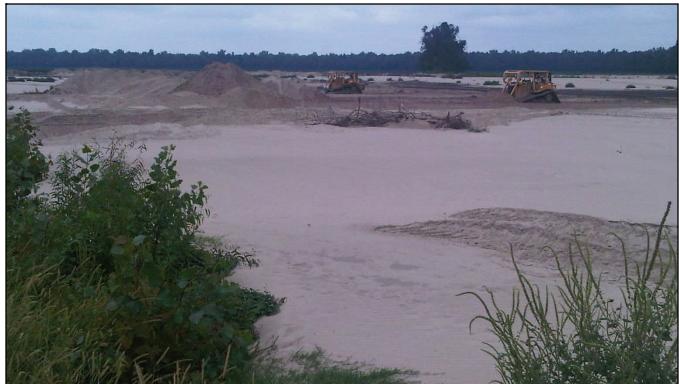
Crews at the center crevasse harvest sand from the surrounding fields Tuesday. The sand is being transported to fill the single large scour hole here.

Center crevasse: A Memphis District crew consisting of seven personnel and six pieces of heavy equipment is preparing the ground for construction at this site. The crew is initially harvesting sand deposited during the flood for use as fill material. An active dredge contract was modified to include dredging at the center crevasse. The dredge contractor received the modified notice to proceed Sept. 13.

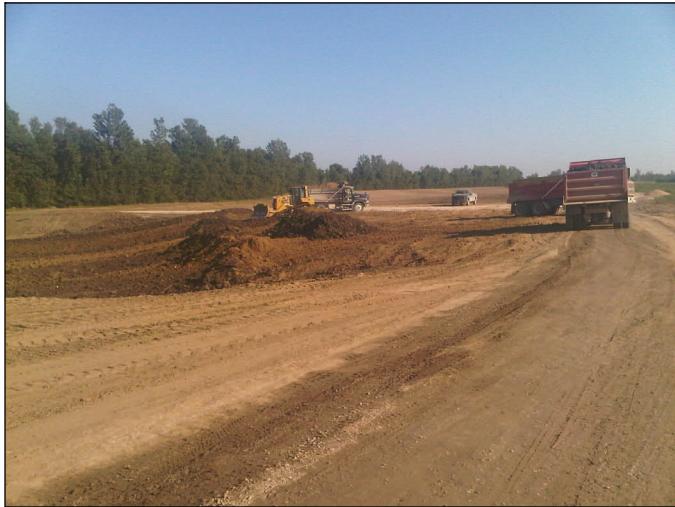
Placing clay into the third of five scour holes Sept. 12.
Crews previously filled the hole to the water table with sand, and are now placing clay in the hole to provide a stable base for the levee and to resist seepage.

Upper crevasse: A Memphis District crew consisting of 30 personnel and 20 pieces of heavy equipment are on site. All five scour holes are filled with sand to the required depth. Crews continue to apply a clay cap to the third and fourth of five scour holes. A 2,000-foot segment across the first two scour holes is ready for inspection, and crews continue work on an 1,800-foot realigned segment. A total of 1,800 feet of levee have been built to a (Cairo) gage elevation of 51 feet at this location.

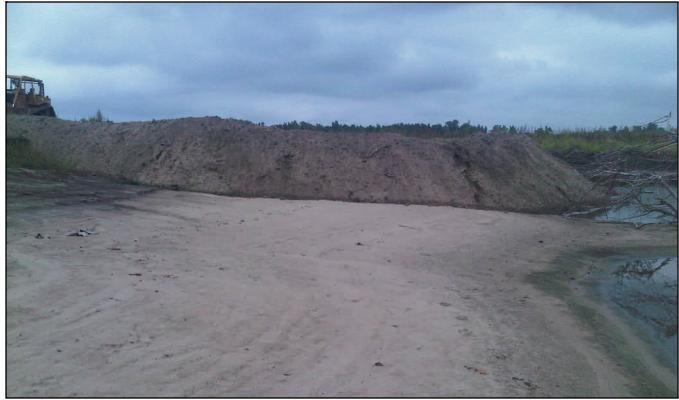
Sand from surrounding fields is being used to fill the scour hole at the center crevasse. As of Tuesday, crews had placed a sand shelf approx. 50 feet long by 75 feet wide in the scour hole.

The center crevasse is located near Seven Island Conservation Area. Repairs are required for 800 feet of levee at this location. A scour hole developed here, connecting with the existing 1937 scour hole. Work here includes separating the two scour holes, filling the new scour hole using sand dredged from the river bottom, and repairing the levee to the interim grade.
