US Army Corps
of Engineers

OPERATION MAKE SAFE PROJECT UPDATE Sept. 16, 2011

Birds Point - New Madrid Floodway Missouri

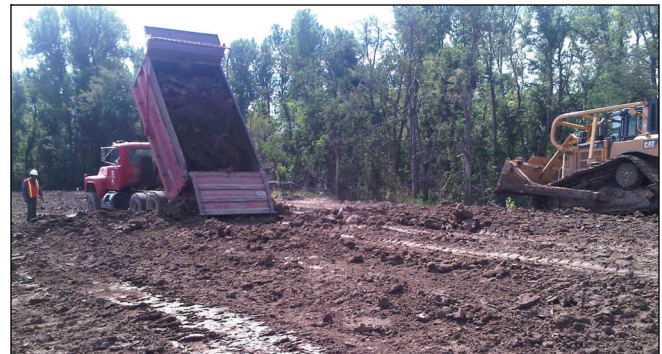
Crews resumed work at the lower crevasse yesterday evening after heavy rain and lightning Wednesday caused a temporary work stoppage.

The lower crevasse is located near Donaldson Point Conservation Area. Repairs are required for 4,700 feet of levee at this location. Work here includes removing excess water at the foundation, and repairing the levee to the interim grade.

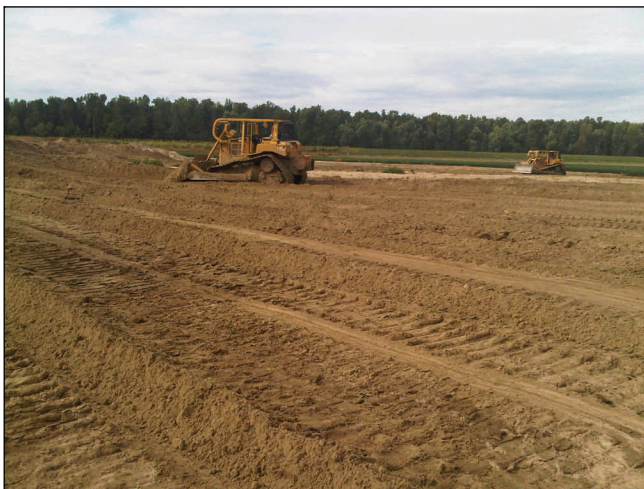
Harvesting sand from the surrounding land at the center crevasse today. Crews are harvesting sand deposited on the land during the flood for use as fill material.

Center crevasse: A Memphis District crew consisting of seven personnel and three pieces of heavy equipment were moved to this site Tuesday to begin preparing the ground for construction. The crew is initially harvesting sand deposited during the flood for use as fill material. An active dredge contract was modified to include dredging at the center crevasse. The dredge contractor received the modified notice to proceed Tuesday.

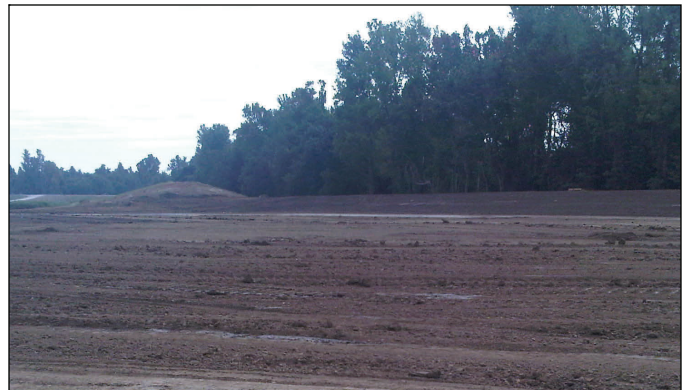
A nearly-complete levee segment at the upper crevasse. This weekend, quality assurance inspectors will verify that this segment complies with our requirements for interim elevation and cross section.

Upper crevasse: A Memphis District crew consisting of 30 personnel and 20 pieces of heavy equipment are on site. All five scour holes are filled with sand to the required depth. Crews continue to apply a clay cap to the third and fourth of five scour holes. A 2,000-foot segment across the first two scour holes is ready for inspection, and crews continue work on an 1,800-foot realigned segment. A total of 1,800 feet of levee have been built to a (Cairo) gage elevation of 51 feet at this location.

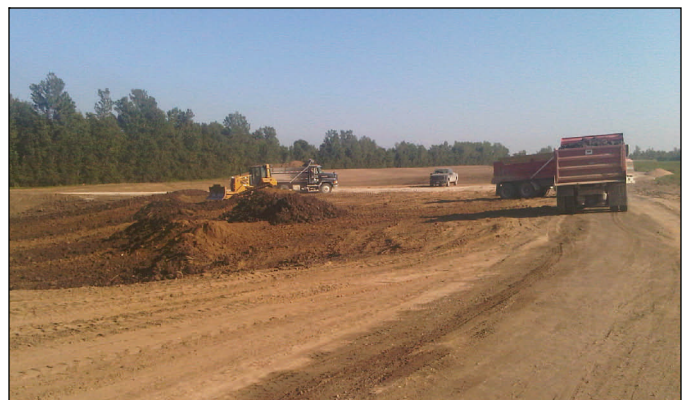
Placing clay into the third of five scour holes Monday. Crews previously filled the holes to the water table with sand, and are now placing clay in the hole to provide a stable base for the levee and to resist seepage.
