US Army Corps
of Engineers

OPERATION MAKE SAFE PROJECT UPDATE Sept. 19, 2011

Birds Point - New Madrid Floodway Missouri

Memphis District

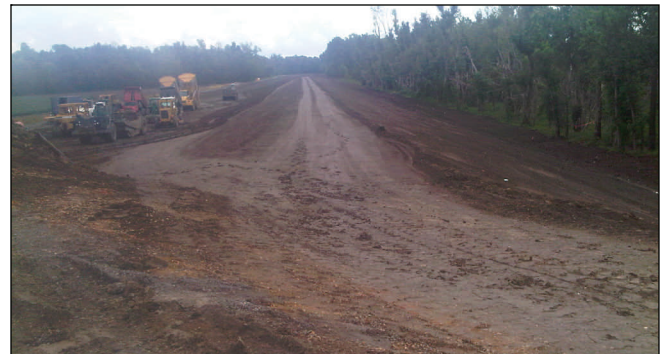
Today was wet and muddy at the lower crevasse. Crews halted earthwork due to the wet conditions, focusing on road and equipment maintenance instead.

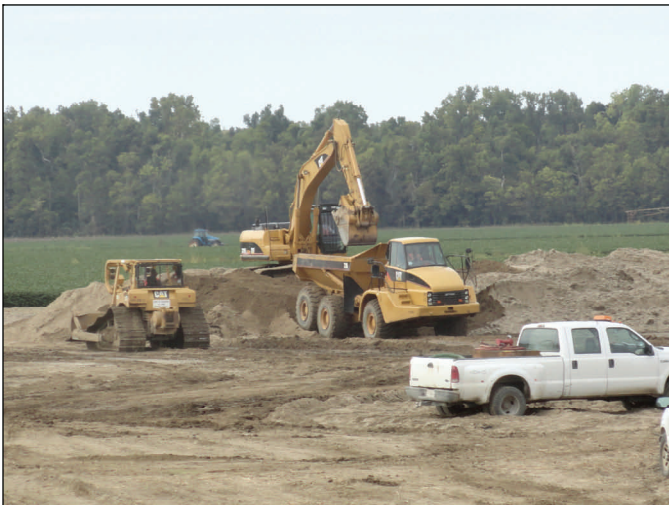
Harvesting sand at the center crevasse Friday. Crews are harvesting sand deposited on the surrounding land during the flood for use as fill material.

Center crevasse: A Memphis District crew consisting of seven personnel and six pieces of heavy equipment is preparing the ground for construction at this site. The crew is initially harvesting sand deposited during the flood for use as fill material. An active dredge contract was modified to include dredging at the center crevasse. The dredge contractor received the modified notice to proceed Sept. 13.

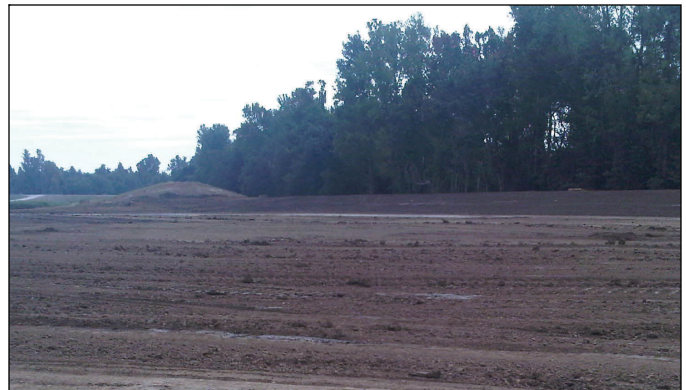
A nearly-complete levee segment at the upper crevasse. Quality-Assurance inspectors will verify that this segment complies with our requirements for interim elevation and cross section.

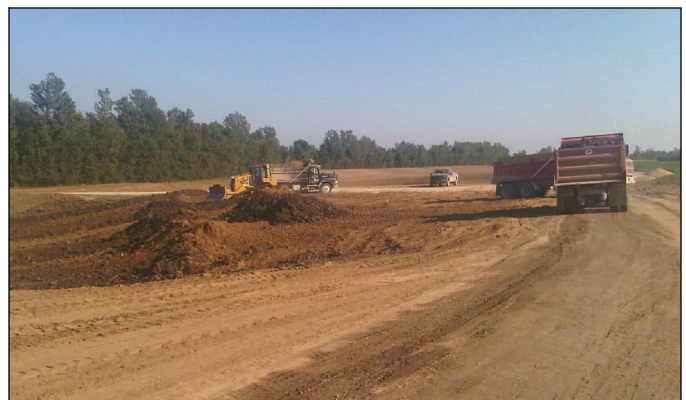
Placing clay into the third of five scour holes Sept. 12. Crews previously filled the hole to the water table with sand, and are now placing clay in the hole to provide a stable base for the levee and to resist seepage.

Upper crevasse: A Memphis District crew consisting of 30 personnel and 20 pieces of heavy equipment are on site. All five scour holes are filled with sand to the required depth. Crews continue to apply a clay cap to the third and fourth of five scour holes. A 2,000-foot segment across the first two scour holes is ready for inspection, and crews continue work on an 1,800-foot realigned segment. A total of 1,800 feet of levee have been built to a (Cairo) gage elevation of 51 feet at this location.
