OPERATION MAKE SAFE PROJECT UPDATE Aug. 24, 2011

Birds Point - New Madrid Floodway

New Madrid Project Office

Memphis District

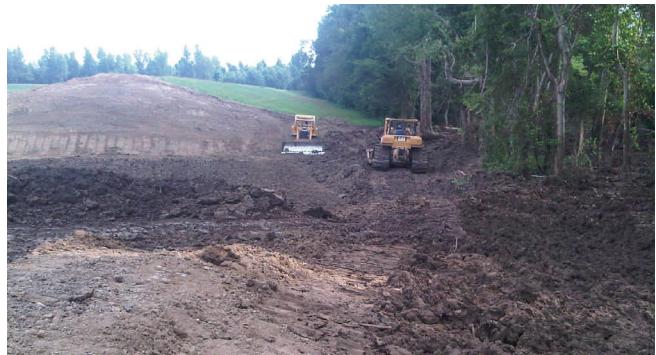
A crew places clay over the first scour hole. The hole had been filled with sand and is being capped with clay to prevent seepage.

Upper crevasse: Two Memphis District crews consisting of 27 personnel and 24 pieces of heavy equipment are on site. One crew is reshaping levee segments at the southern end of the site, while the second crew is filling scour holes with sand at the northern end. Two scour holes are filled with sand to the required depth, a third is filled to 95% and a fourth is filled to 50% of the required depth. Crews continue to apply a clay cap to the first scour hole. A contract for haul services was awarded today to transport additional clay embankment. Delivery is scheduled to begin later this week. Current priorities are filling scour holes and shaping two levee segments. A total of 1,800 feet of levee has been built to a (Cairo) gage elevation of 51 feet at this location.

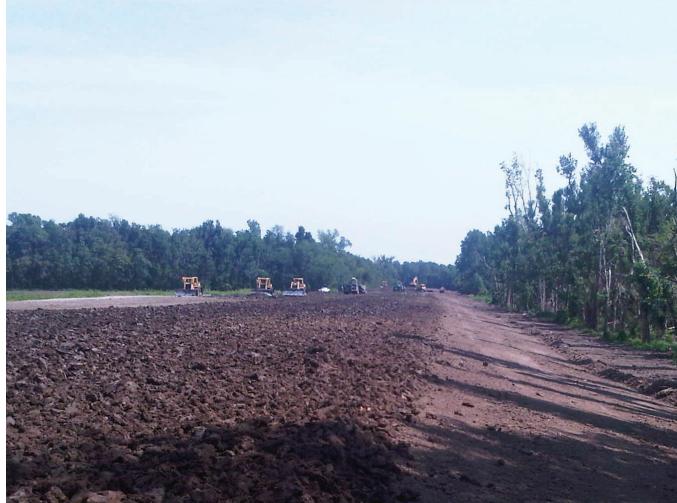
The levee takes shape at the lower crevasse. The river-side slope is now clearly visible.

Lower crevasse: A Vicksburg District crew consisting of 13 personnel and 13 pieces of heavy equipment is on site at this location. Excess water has been removed from the soil and the crew continued to shape a 2,000-foot segment at the western end to tie in with the existing levee.

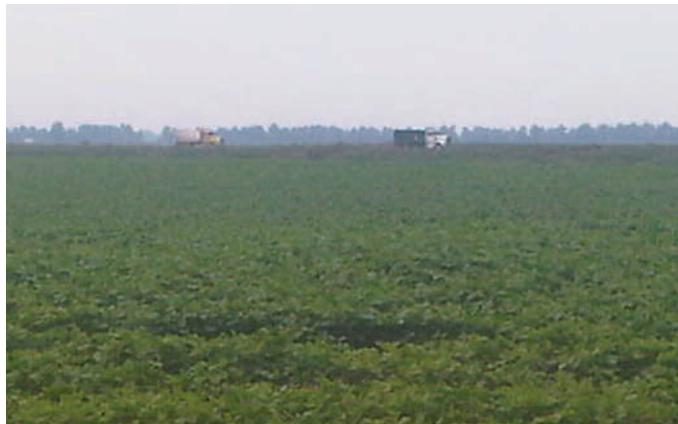
Dump trucks leave the site after delivering sand at the upper crevasse. More than 84,350 tons of sand have been delivered to date.

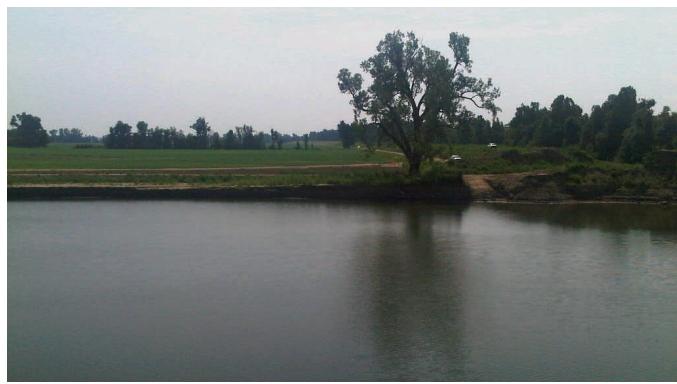
Center crevasse near Seven Island Conservation Area. The existing levee is visible behind the tree.

The center crevasse is located near Seven Island Conservation Area. Repairs are required for 800 feet of levee at this location. A scour hole developed here, connecting with the existing 1937 scour hole. The scope of work and construction schedule will be determined following completion of an environmental assessment in mid-September.

Center crevasse: A detailed elevation survey continued at this site. The data gathered will be used to analyze design options in the forthcoming environmental assessment. The environmental assessment (EA), scheduled for completion by mid-September, will address multiple options for interim protection at the center crevasse, as well as repair of all three crevasses to the final authorized grade.
