US Army Corps
of Engineers

OPERATION MAKE SAFE PROJECT UPDATE Dec. 14, 2011

Birds Point - New Madrid Floodway
Missouri

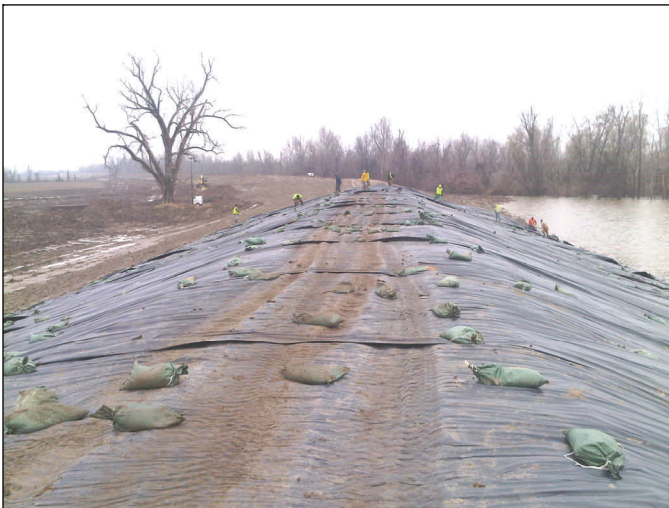
Crews cover the newly-constructed levee segment at the center crevasse with heavy plastic sheeting Dec. 6. The plastic sheeting will help protect the levee against erosion caused by wave action and rainfall. This view looks east along the levee.

Center crevasse: Interim repairs were completed Dec. 3. The interim levee stands 15 feet high above the surrounding ground and provides flood protection to approximately 55 feet on the Cairo gage. The crew also completed covering the levee in heavy plastic sheeting to resist against erosion by rain and wave wash. The crew is currently demobilizing equipment from the site.

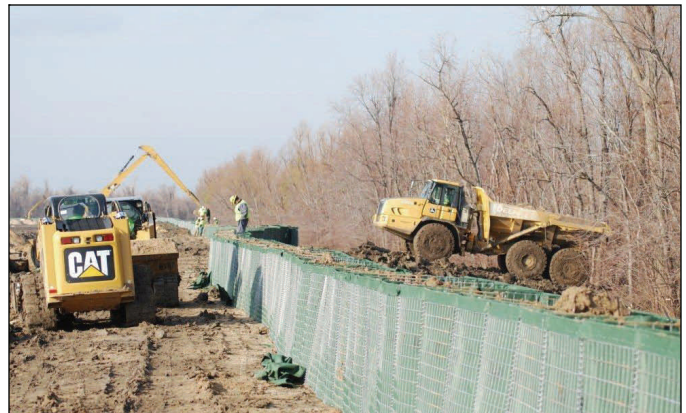
Crews fill HESCO barriers with sand at the upper crevasse Dec. 11. The temporary HESCO structure was completed Tuesday evening.

Upper crevasse: The crew has completed permanent levee repairs to a (Cairo) gage elevation of 51 feet as of Oct. 28, and temporary protection to 55 feet as of Dec. 13. HESCO barrier installation was completed Tuesday. Crews began demobilizing equipment from the site today. The HESCOs are fastened together with wire, filled with sand, and lined with heavy plastic sheeting to provide temporary flood protection. This work is part of an orderly shutdown of the project for winter. Permanent repairs will resume after spring highwater recedes.

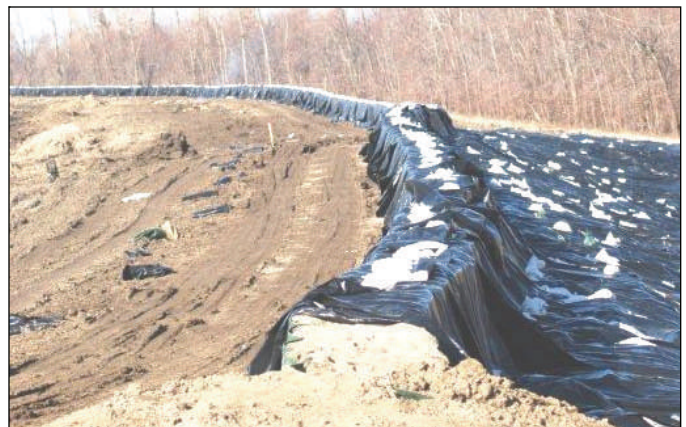
A completed section of levee at the upper crevasse Dec. 11. The plastic sheeting protects against erosion and provides a water-resistant barrier over the HESCOs.
