OPERATION MAKE SAFE PROJECT UPDATE

Dec. 9, 2011

Birds Point - New Madrid Floodway
Missouri

Memphis District

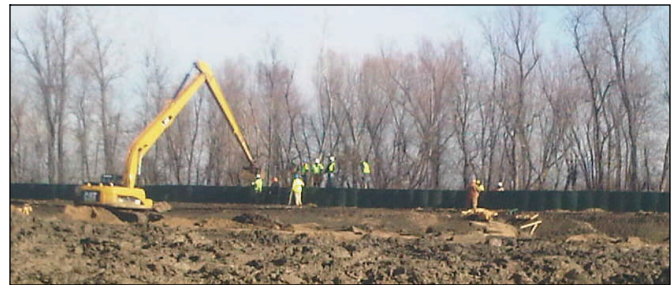
A crew fills HESCO barriers at the upper crevasse Friday. The barriers are a temporary measure to raise the level of protection at Birds Point from 51 to 55 feet on the Cairo gage. Permanent repairs to the levee will resume after spring highwater recedes.

Upper crevasse: The earthen levee meets or exceeds a (Cairo) gage elevation of 51 feet as of Oct. 28. Weather conditions are no longer favorable for earthwork. The District was directed Tuesday to proceed with installing a temporary structure of HESCO barriers to increase flood protection to 55 feet on the Cairo gage. Installation began Wednesday. To date, all 9,000 linear feet of HESCO barriers have been deployed, and 1,500 feet have been filled with sand. The HESCO barriers are wire mesh baskets lined with heavy fabric. The HESCOs are fastened together with wire, filled with sand, and lined with heavy plastic sheeting to provide temporary flood protection. This work is part of an orderly shutdown of the project for winter. Permanent repairs will resume after spring highwater recedes.

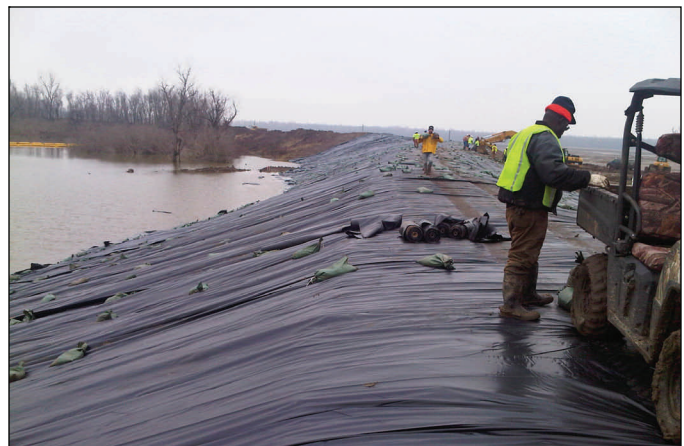
Newly-installed heavy plastic sheeting covers the levee at the center crevasse Tuesday. This view looks west.

Center crevasse: The Memphis- and Vicksburg-based crews reached the required Make Safe elevation Dec. 3. The interim levee stands 15 feet high above the surrounding ground and provides flood protection to approximately 55 feet on the Cairo gage. The crew also completed covering the levee in heavy plastic sheeting to resist against erosion by rain and wave wash. The crews moved to Birds Point Wednesday to assist in the installation of HESCO barriers.

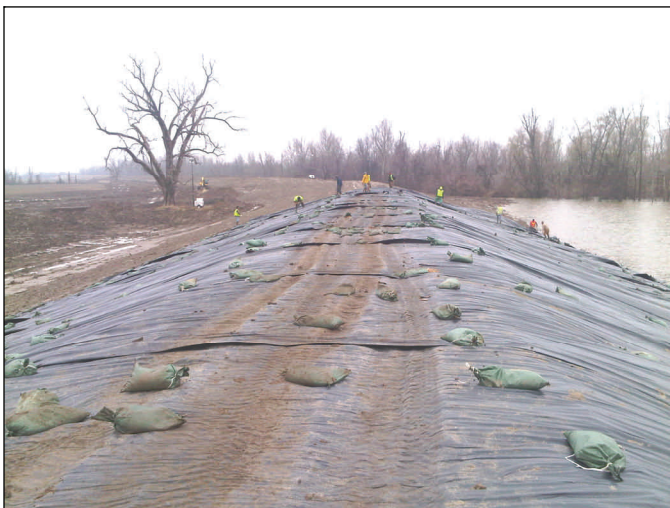
Crews cover the newly-constructed levee segment at the center crevasse with heavy plastic sheeting Tuesday. The plastic sheeting will help protect the levee against erosion caused by wave action and rainfall. This view looks east along the levee.

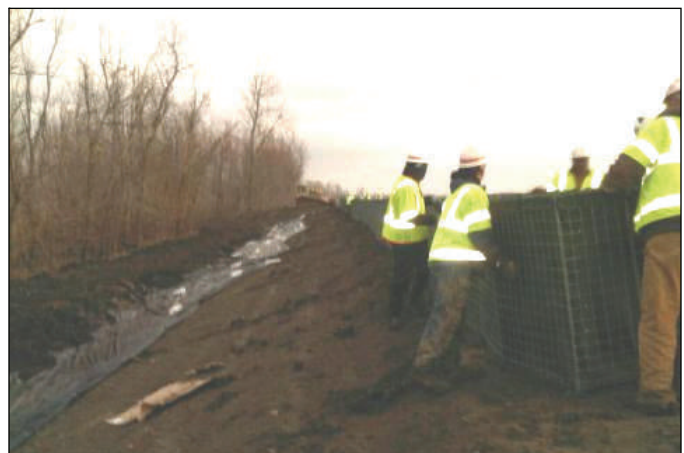
Crews install HESCO barriers at the upper crevasse Wednesday evening.
