# OPERATION MAKE SAFE PROJECT UPDATE Oct. 14, 2011

Birds Point - New Madrid Floodway  
Missouri

**New Madrid Project Office**

**Memphis District**

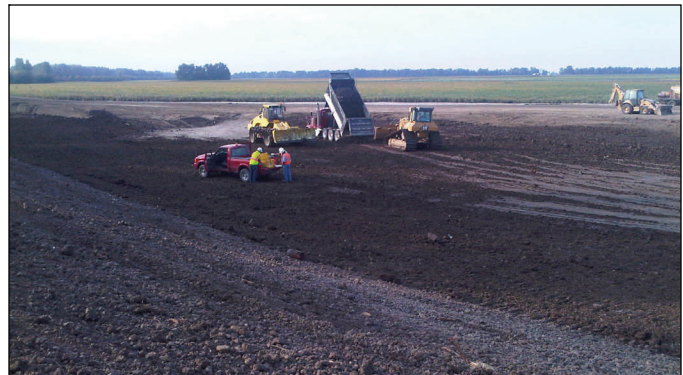
**Clay embankment is placed in the final scour hole at the upper crevasse Wednesday to prevent seepage.**

**Upper crevasse:** A Memphis District crew consisting of 22 personnel and 16 pieces of heavy equipment is on site. Crews will continue filling the final of five scour holes when the ground has dried, as well as restoring the bed of clay on the land side of the levee to prevent seepage. There is continuous levee now the entire length of the crevasse. A total of 6,800 feet of levee meets or exceeds a (Cairo) gage elevation of 51 feet at this location. No point of the remaining 2,200 feet is less than three feet below the interim grade, and most of the levee is within one foot. Low spots will be raised in the next week to bring the levee fully up to the interim grade.

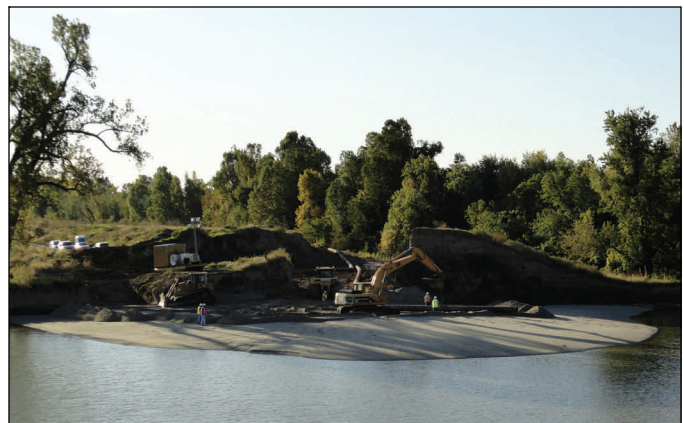
**The dredge contractor adds discharge pipe Friday to continue pumping sand into the center crevasse.**

**Center crevasse:** A Memphis District crew consisting of seven personnel and ten pieces of heavy equipment is on site. The crew continued harvesting sand for use as fill material in the scour hole. The dredge contractor began pumping sand from the Mississippi River into the scour hole Oct. 8. Pumping will last up to 30 days.

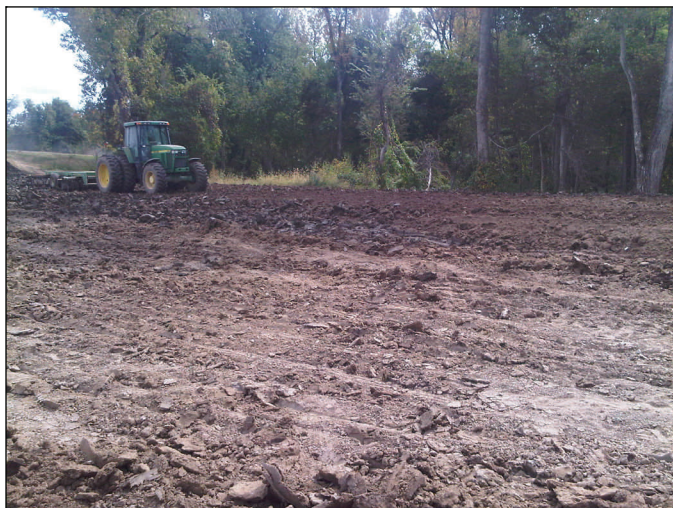
**A Vicksburg-based operator prepares a 300-foot-long washout for repair near the lower crevasse Wednesday.**

**Lower crevasse:** A Vicksburg District crew consisting of 14 personnel and 16 pieces of heavy equipment is on site. The crew will continue dressing and finish-grading the levee when the ground has dried, as well as continue repairs to two washed-out segments that were not part of the original scope of work.

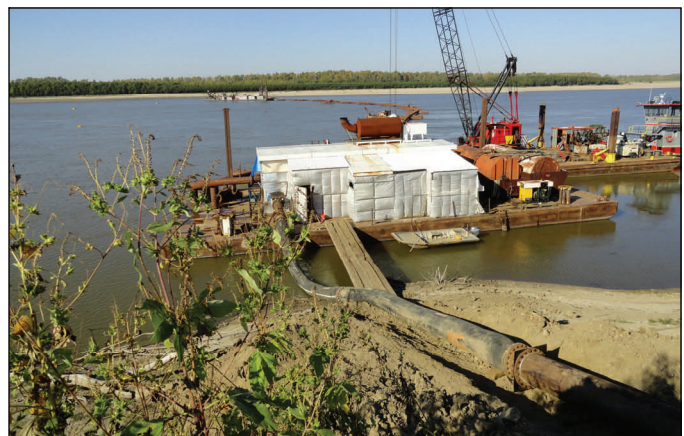
**The dredge (background) pumps sand to a booster pump (on barge, center), to the shore pipeline via a section of flexible pipe (foreground), and then to the scour hole at the center crevasse.**
