# OPERATION MAKE SAFE PROJECT UPDATE

Oct. 17, 2011

Birds Point - New Madrid Floodway  
Missouri

Memphis District

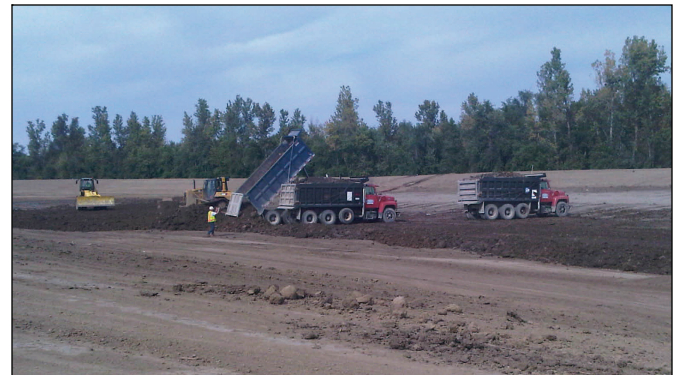
**Clay embankment is placed landside of the levee at the upper crevasse Monday to prevent seepage.**

**Upper crevasse:** A Memphis District crew consisting of 22 personnel and 16 pieces of heavy equipment is on site here, at a nearby borrow site, and at a maintenance facility. Crews are restoring the bed of clay on the land side of the levee to prevent seepage. Restoring landside clay represents the majority of the remaining work effort at Birds Point. There is continuous levee the entire length of the crevasse. A total of 6,800 feet of levee meets or exceeds a (Cairo) gage elevation of 51 feet at this location. No point of the remaining 2,200 feet is less than three feet below the interim grade, and most of the levee is within one foot. Low spots will be raised this week to bring the levee fully up to the interim grade.

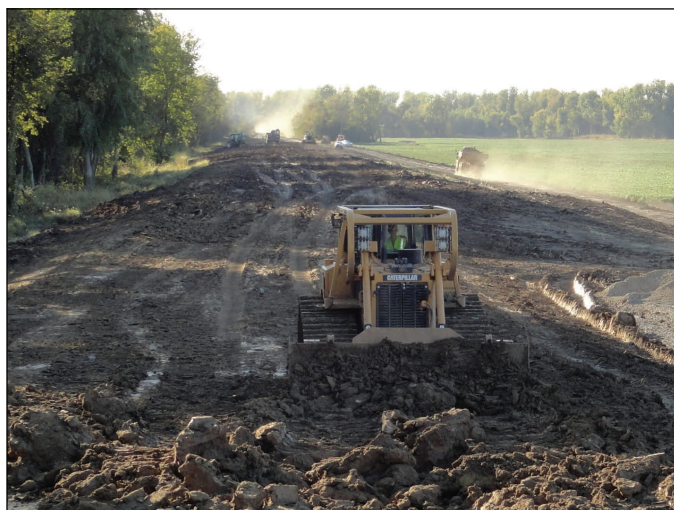
**A Vicksburg-based crew repairs a 300-foot-long washout near the lower crevasse Sunday.**

**Lower crevasse:** A Vicksburg District crew consisting of 14 personnel and 16 pieces of heavy equipment is on site here and at a nearby borrow site. The crew continued dressing and finish-grading the levee, and continued repairs to two washed-out segments that were not part of the original scope of work. Repair of the washout areas are 20 percent complete.

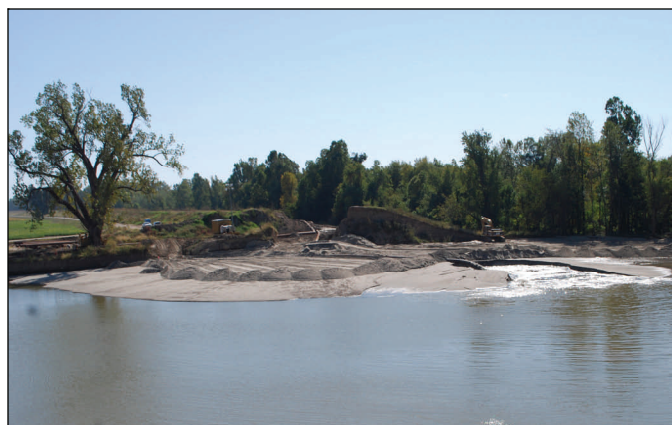
**The dredge contractor pumps sand from the Mississippi River into the scour hole at the center crevasse Sunday.**

**Center crevasse:** A Memphis District crew consisting of seven personnel and ten pieces of heavy equipment is on site here and at a nearby borrow site. The crew has ceased harvesting sand from the surrounding fields and is now preparing to extract clay from a borrow site near Ten Mile Pond Conservation Area. The dredge contractor began pumping sand from the Mississippi River into the scour hole Oct. 8. Pumping will last up to 30 days. Dredge production is averaging approximately 1,100 cubic yards per hour.

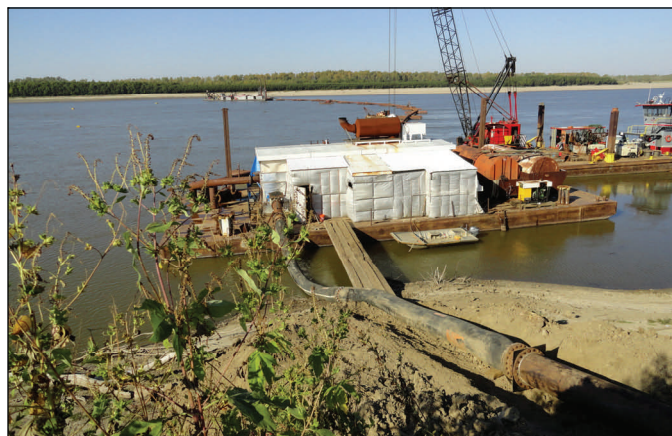
**The dredge (background) pumps sand to a booster pump (on barge, center), to the shore pipeline via a section of flexible pipe (foreground), and then to the scour hole at the center crevasse.**
