US Army Corps
of Engineers

OPERATION MAKE SAFE PROJECT UPDATE Oct. 19, 2011

Birds Point - New Madrid Floodway
Missouri

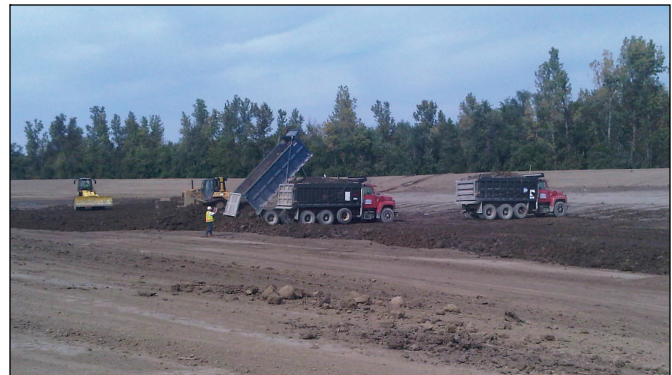
Clay embankment is placed landside of the levee at the upper crevasse Monday to prevent seepage.

Upper crevasse: A Memphis District crew consisting of 22 personnel and 16 pieces of heavy equipment is on site here, at a nearby borrow site, and at a maintenance facility. Crews are restoring the bed of clay on the land side of the levee to prevent seepage. Restoring landside clay represents the majority of the remaining work effort at Birds Point. There is continuous levee the entire length of the crevasse. A total of 6,800 feet of levee meets or exceeds a (Cairo) gage elevation of 51 feet at this location. Low reaches have been raised and await inspection.

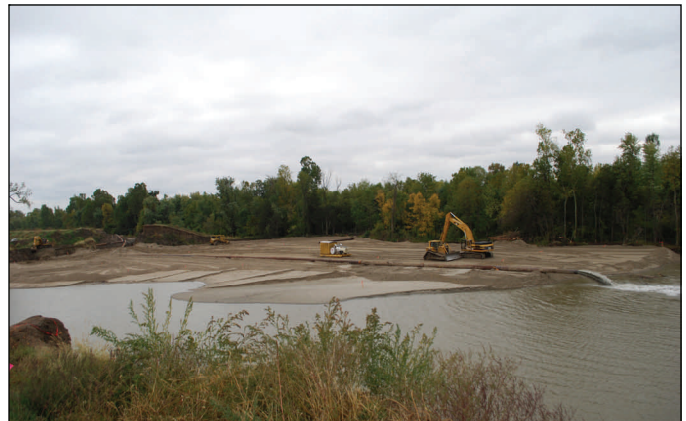
The dredge contractor pumps sand into the scour hole at the center crevasse Wednesday.

Center crevasse: A Memphis District crew consisting of seven personnel and ten pieces of heavy equipment is on site here and at a nearby borrow site. The crew has ceased harvesting sand from the surrounding fields and is now preparing to extract clay from a borrow site near Ten Mile Pond Conservation Area. The dredge contractor began pumping sand from the Mississippi River into the scour hole Oct. 8. Pumping will last up to 30 days. The dredge has pumped nearly 150,000 cubic yards of sand into the scour hole to date.

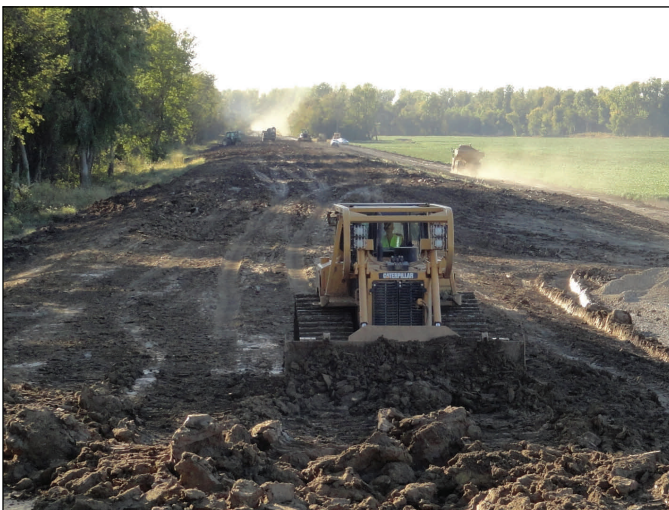
A Vicksburg-based crew repairs a 300-foot-long washout near the lower crevasse Sunday.

Lower crevasse: A Vicksburg District crew consisting of 14 personnel and 16 pieces of heavy equipment is on site here and at a nearby borrow site. Approximately two days of dressing and finish-grading remain to be completed, as well as repairs to two washed-out segments that were not part of the original scope of work. Repair of the washout areas are 20 percent complete.

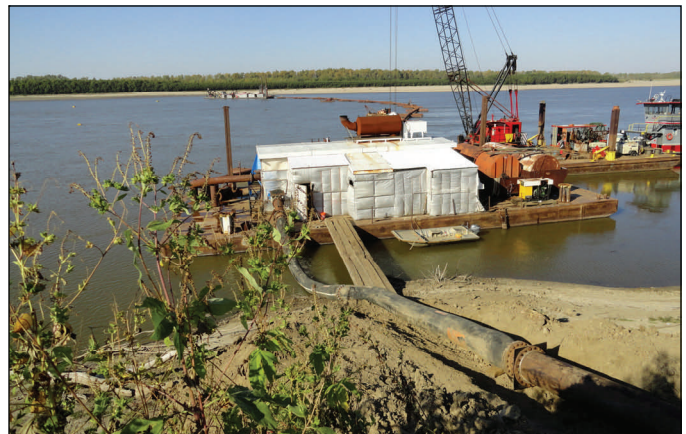
The dredge (background) pumps sand to a booster pump (on barge, center), to the shore pipeline via a section of flexible pipe (foreground), and then to the scour hole at the center crevasse.

The center crevasse is located near Seven Island Conservation Area. Repairs are required for 800 feet of levee at this location. A scour hole developed here, connecting with the existing 1937 scour hole. Work here includes separating the two scour holes, filling the new scour hole using sand dredged from the river bottom, and repairing the levee to the interim grade.
