# OPERATION MAKE SAFE PROJECT UPDATE Oct. 21, 2011

Birds Point - New Madrid Floodway  
Missouri

**New Madrid Project Office**

**Memphis District**

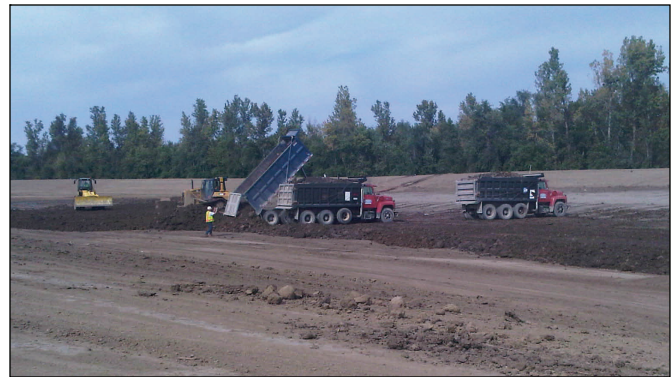
**Clay embankment is placed landside of the levee at the upper crevasse Monday to prevent seepage.**

**Upper crevasse:** A Memphis District crew consisting of 22 personnel and 16 pieces of heavy equipment is on site here, at a nearby borrow site, and at a maintenance facility. Crews are restoring the bed of clay on the land side of the levee to prevent seepage. A total of 6,800 feet of levee meets or exceeds a (Cairo) gage elevation of 51 feet at this location. Low reaches have been raised and await inspection.

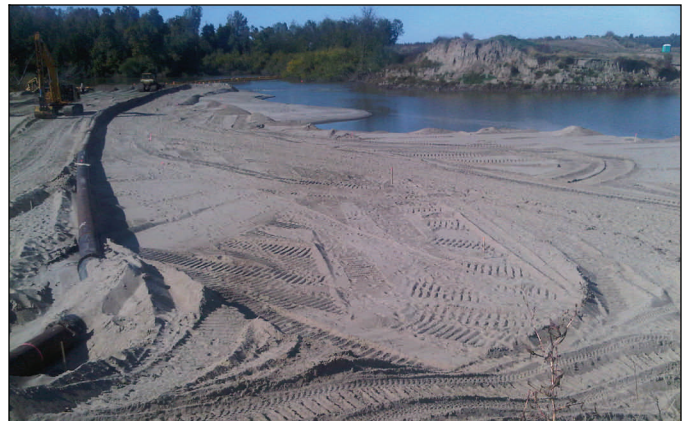
**The dredge contractor pumps sand into the scour hole at the center crevasse Friday.**

**Center crevasse:** A Memphis District crew consisting of seven personnel and ten pieces of heavy equipment is on site here and at a nearby borrow site. The crew has ceased harvesting sand from the surrounding fields and is now preparing to extract clay from a borrow site near Ten Mile Pond Conservation Area. The dredge lowa began pumping sand from the Mississippi River into the scour hole Oct. 8. Pumping will last up to 30 days. The dredge has pumped 165,000 cubic yards of sand into the scour hole to date.

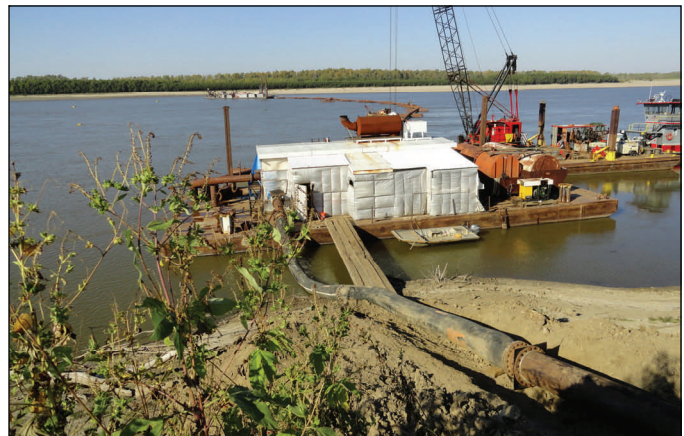
**The dredge (background) pumps sand to a booster pump (on barge, center), to the shore pipeline via a section of flexible pipe (foreground), and then to the scour hole at the center crevasse.**
