# OPERATION MAKE SAFE PROJECT UPDATE Oct. 7, 2011

Birds Point - New Madrid Floodway  
Missouri

**New Madrid Project Office**

**Memphis District**

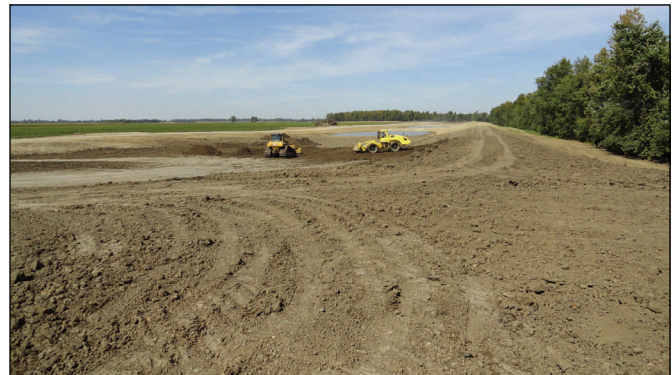
**Clay embankment is placed behind the levee at the upper crevasse Thursday to prevent seepage.**

**Upper crevasse:** A Memphis District crew consisting of 22 personnel and 16 pieces of heavy equipment is on site. Crews are currently filling the final of five scour holes, as well as reconstructing the levee over the top of the previously-filled scour holes. Responses to a new haul service contract were due 2 p.m. today. The District will review responses and award the contract shortly. Nearly 7,000 feet of levee is awaiting inspection. A total of 1,800 feet of levee have been built to a (Cairo) gage elevation of 51 feet at this location.

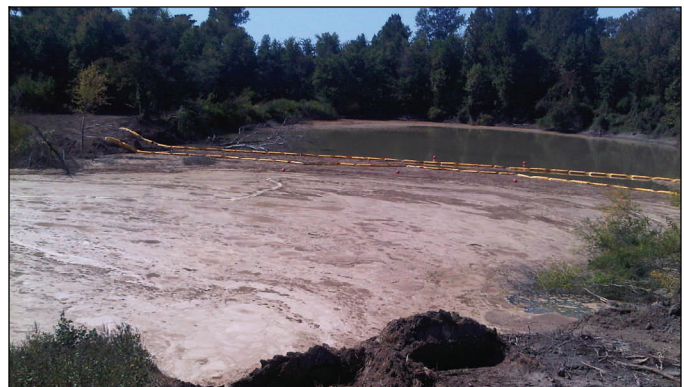
**Engineers installed a silt curtain at the center crevasse this week. The silt curtain will prevent silt plumes from entering the existing scour hole (visible in background).**

**Center crevasse:** A Memphis District crew consisting of seven personnel and ten pieces of heavy equipment is on site. The crew continued harvesting sand for use as fill material in the scour hole. The dredge contractor is currently constructing a pipeline that will be used to pump sand from the Mississippi River to the scour hole. Testing of the pipe is anticipated for this weekend and production will begin afterwards.

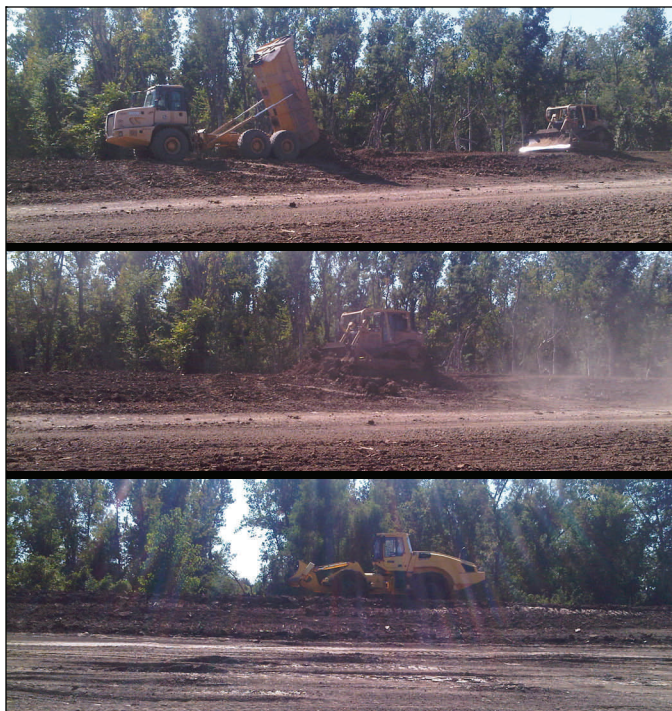
**Constructing levee at the lower crevasse. Clay is first dumped (top), then spread to a depth of one foot or less (middle), and finally compacted (bottom). The process is repeated until the levee is at the proper elevation.**

**Lower crevasse:** A Vicksburg District crew consisting of 14 personnel and 16 pieces of heavy equipment is on site. The crew is constructing the remaining 1,200 feet of levee at this site. The levee is expected to reach the interim elevation as scheduled Oct. 9, but additional work will continue after this date. Work includes dressing, finish-grading, applying turf, and repairing two washed-out segments nearby that were not part of the original scope of work.

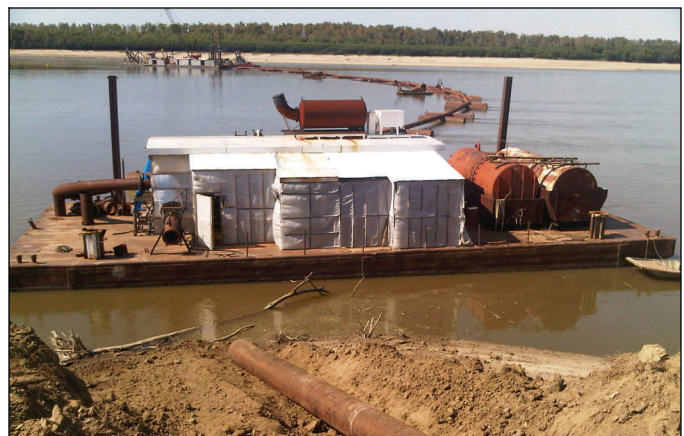
**The dredge (background) will pump sand to a booster pump (on barge, center), then to the scour hole at the center crevasse. A flexible pipe section will connect the booster pump to the shore pipeline (foreground).**
