US Army Corps
of Engineers

OPERATION MAKE SAFE PROJECT UPDATE Sept. 23, 2011

Birds Point - New Madrid Floodway Missouri

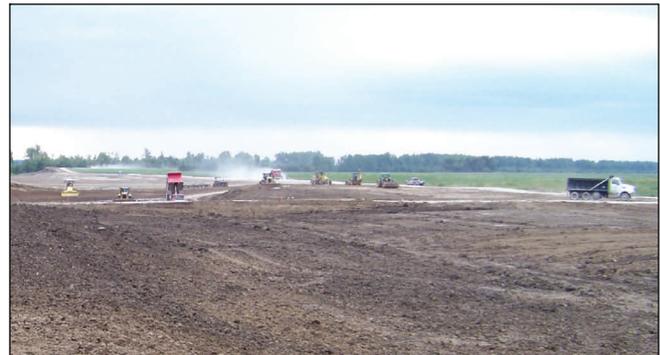
The third of five scour holes at the upper crevasse was restored to level grade Thursday. The fourth scour hole is being filled in the background.

Upper crevasse: A Memphis District crew consisting of 22 personnel and 16 pieces of heavy equipment is on site. All five scour holes are filled with sand to the required depth. Crews continue to apply a clay cap to the fourth of five scour holes. A 2,000-foot segment across the first two scour holes is ready for inspection, and crews continue work on an 1,800-foot realigned segment. A total of 1,800 feet of levee have been built to a (Cairo) gage elevation of 51 feet at this location. Rain Thursday night limited work Friday to road and equipment maintenance.

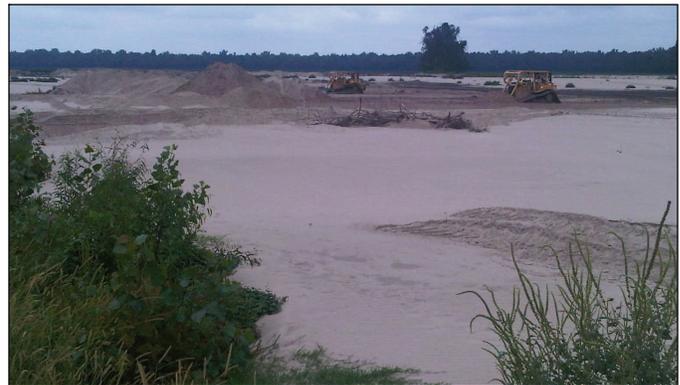
Crews at the center crevasse harvest sand from the surrounding fields Tuesday. The sand is being transported to fill the single large scour hole here.

Center crevasse: A Memphis District crew consisting of seven personnel and nine pieces of heavy equipment is preparing the ground for construction at this site. The crew is initially harvesting sand deposited during the flood for use as fill material. The dredge contractor began mobilizing shore assets Thursday.

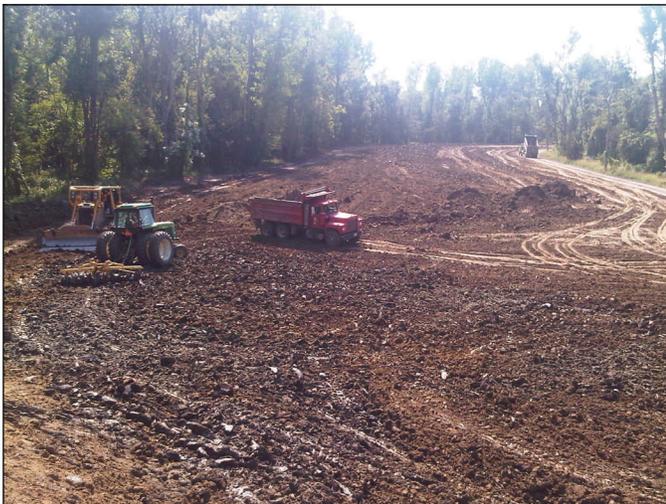
Crews process material Wednesday at the lower crevasse to remove excess water. The soil here is poorly drained and extra effort is required to reduce the moisture content to a workable level.

Lower crevasse: A Vicksburg District crew consisting of 14 personnel and 16 pieces of heavy equipment is on site. A 2,000-foot levee segment is ready for inspection, and the crew is continuing to make progress on a 1,500-foot levee segment. The crew is also processing material for the foundation of the last 1,200 feet of levee.

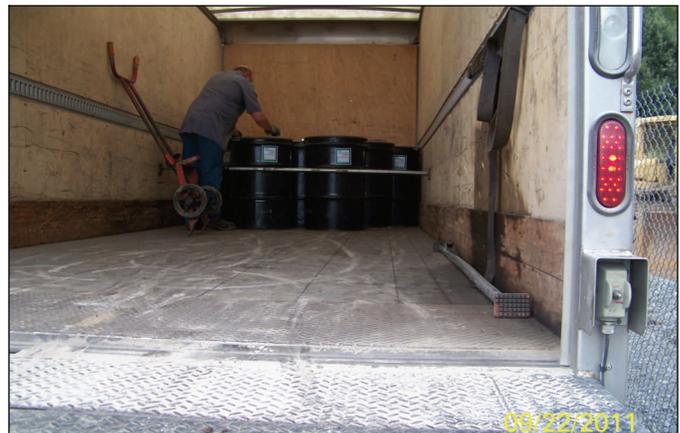
Soil contaminated by the blasting agent is loaded onto a truck Thursday for removal from the project site. All contaminated soil and waste pipes were removed.

Blasting agent removal: All waste pipes and contaminated soil were removed Thursday. Desensitized blasting agent remains stored at the upper and lower crevasses. The results of a laboratory characterization confirmed the blasting agent is not an explosive risk. The Corps has requested and is awaiting permits from the US Department of Transportation to remove the blasting agent, estimated by Sept. 30. The blasting agent will remain secured inside a fenced perimeter at each site until removed.
