MAKE SAFE AND RESTORE PROJECT UPDATE March 30, 2012

**Birds Point - New Madrid Floodway
Missouri**

New Madrid Project Office

Memphis District

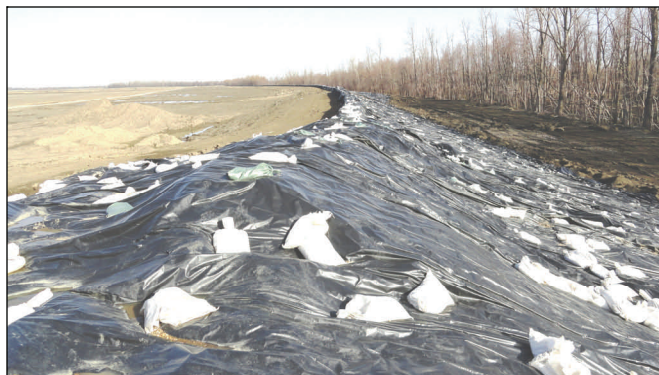
Plastic sheeting to protect the levee and HESCO barriers is shown in this March 1 view.

Upper crevasse: The crew has completed permanent levee repairs to a (Cairo) gage elevation of 51 feet as of Oct. 28, and temporary protection with HESCO barriers to 55 feet as of Dec. 13. Remaining earthwork to complete the restoration of the clay bed on the landside of the levee as well as seeding the levee with grass, will be rolled over to Restore.

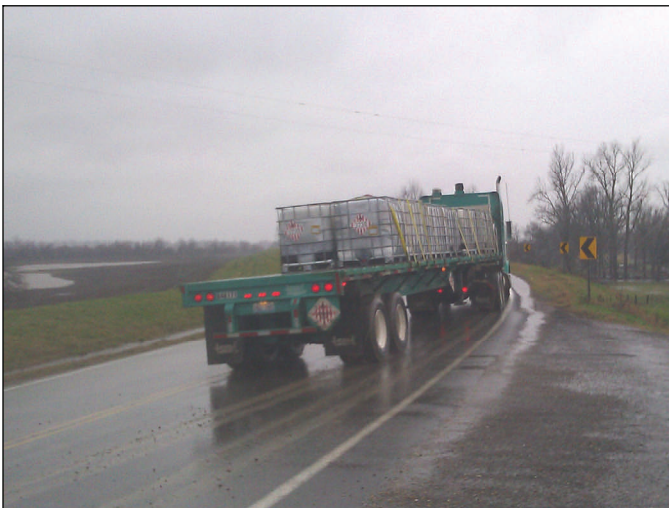
A tractor-trailer transporting desensitized blasting agent leaves the upper crevasse March 8. All blasting agent has now been removed from the Floodway and has been transferred to a disposal site in Illinois.

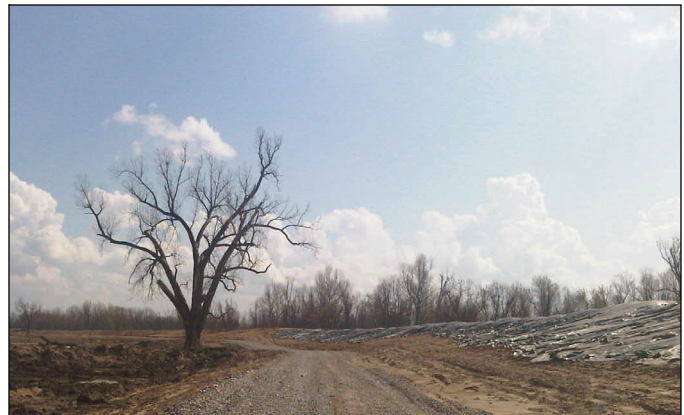
The repair team completed the center crevasse access road in late February. The road provides all-weather access to the levee. March 15 photo.

The project is currently in maintenance status. Scheduled maintenance to repair access roads began Jan. 25 and was completed March 2. A District crew remains on call to perform any future repairs within the Floodway. Earthwork to further expand the levee and reconstruct it to the full authorized level of protection will resume after award of a Multiple-Award Task Order Contract (MATOC), and when field conditions and river stages allow. Plans and specifications are complete for the first Task Order, which will expand the levee at the upper crevasse to the full width, and raise the levee to a gage height of 55 feet. Plans and specifications for the remaining task orders are in development. Contracting and construction schedules are in development.

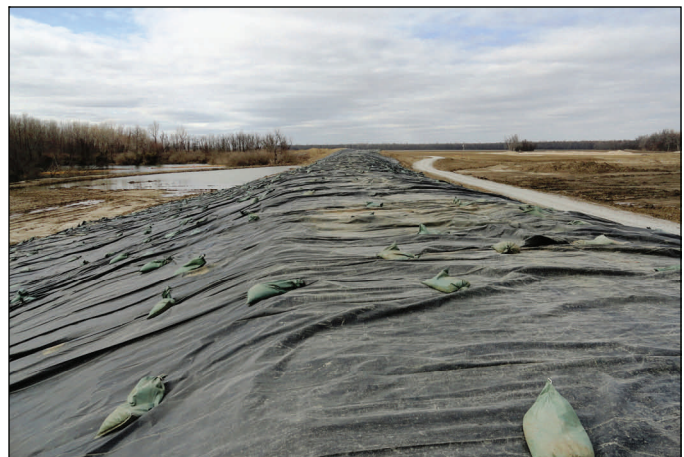
A March 1 view of the repaired levee at the center crevasse. The access road is visible at right.

Center crevasse: Interim repairs were completed Dec. 3. Remaining earthwork to thicken the landside clay bed to better prevent against seepage, as well as seeding the levee with grass, will be rolled over to Restore.
