US Army Corps
of Engineers

OPERATION MAKE SAFE PROJECT UPDATE

Feb. 3, 2012

Birds Point - New Madrid Floodway
Missouri

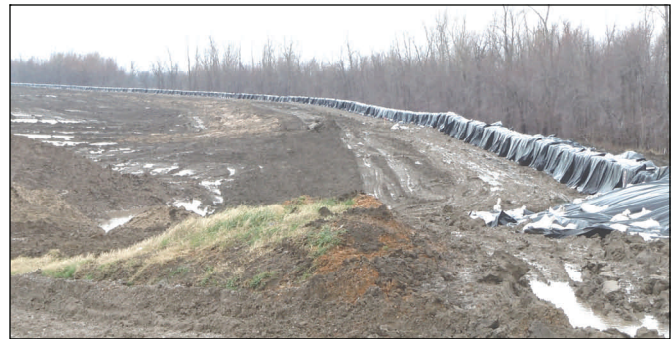
HESCO barriers span the length of the upper crevasse Dec. 15. The plastic sheeting protects against erosion and provides a water-resistant barrier.

Upper crevasse: The crew has completed permanent levee repairs to a (Cairo) gage elevation of 51 feet as of Oct. 28, and temporary protection with HESCO barriers to 55 feet as of Dec. 13. A small amount of earthwork remains to complete the restoration of the clay bed on the landside of the levee, as well as seeding the levee with grass.

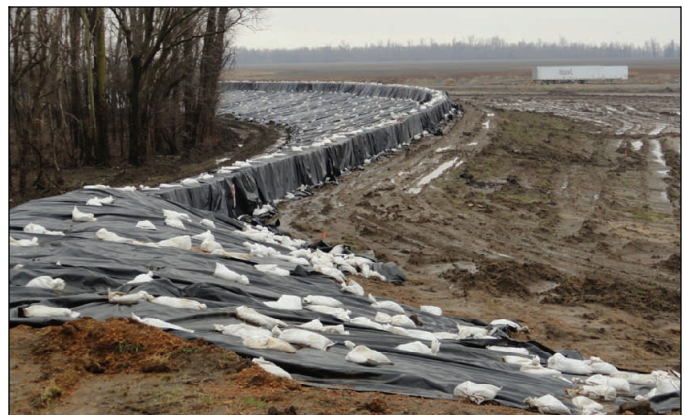
The District team completed repairs to the plastic at the upper crevasse Thursday. The team added additional sandbags to better hold the plastic in place.

An eight-man team arrived Jan. 25 to repair roads at the upper and center crevasses. The team reported Thursday that the plastic sheeting at Birds Point has been repaired, and they have moved to the center crevasse to repair plastic and perform road maintenance there.

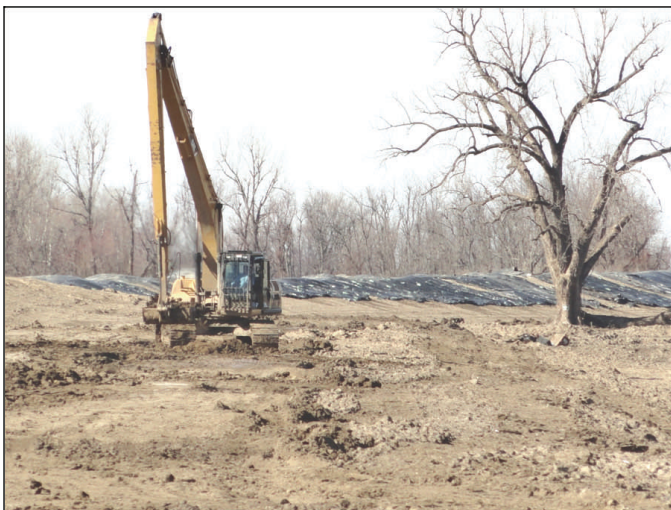
The team performs road maintenance at the center crevasse Friday. Here, an excavator removes soft spots in the road. The excavated hole will be filled with rock that will better support heavy equipment during the reconstruction of the levee.

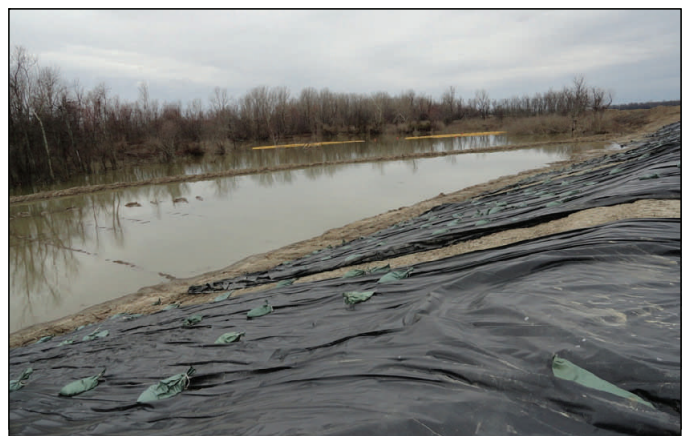
River water rises against the levee at the center crevasse Friday. With the crest passing, this segment will see 1-3 feet of water at the toe of the levee.
