# OPERATION MAKE SAFE PROJECT UPDATE Sept. 14, 2011

## Birds Point - New Madrid Floodway Missouri

**New Madrid Project Office**

**Memphis District**

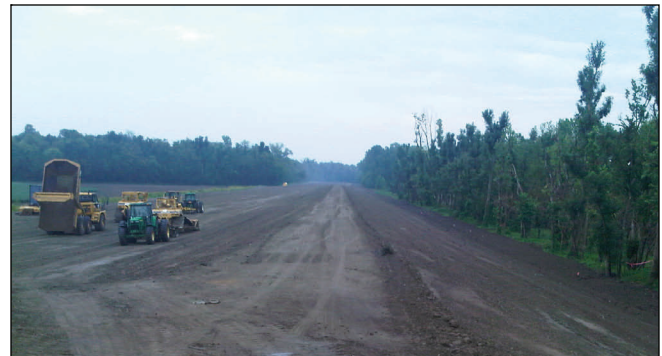
**Light rain falls at the lower crevasse today. Lightning earlier in the day, and heavy rains later, temporary stopped work at this site.**

**Lower crevasse:** A Vicksburg District crew consisting of 14 personnel and 16 pieces of heavy equipment is on site. The crew is nearly complete with a 2,000-foot levee segment, and is making great progress on an additional 1,500-foot segment. The crew had to temporarily stop work due to lightning and heavy rain.

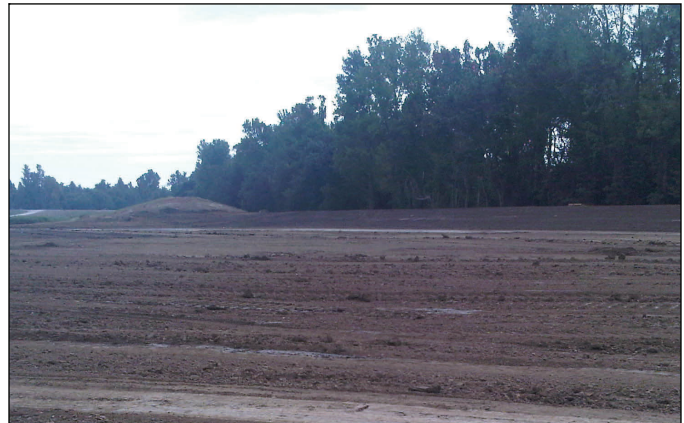
**A nearly-complete levee segment at the upper crevasse. Later this week, quality assurance inspectors will verify that this segment complies with our requirements for interim elevation and cross section.**

**Upper crevasse:** A Memphis District crew consisting of 30 personnel and 20 pieces of heavy equipment are on site. All five scour holes are filled with sand to the required depth. Crews continue to apply a clay cap to the third and fourth of five scour holes. Crews continue to construct a 1,600-foot levee realignment and a 2,000-foot segment across the first two scour holes. A total of 1,800 feet of levee have been built to a (Cairo) gage elevation of 51 feet at this location.

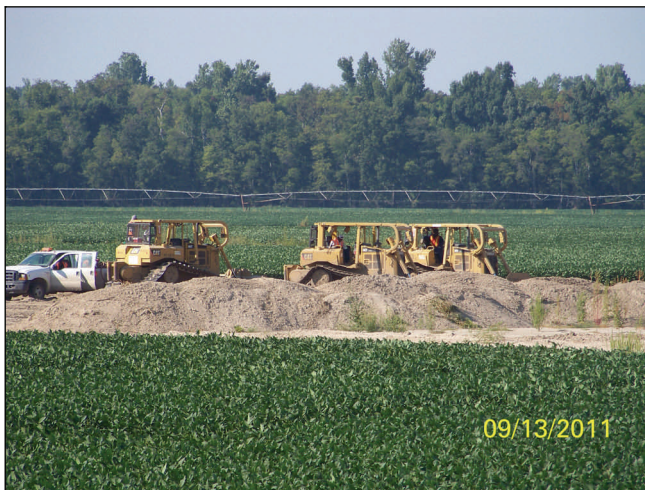
**Harvesting sand from the surrounding land at the center crevasse Tuesday. Crews were mobilized here to begin preparing the ground for construction.**

**Center crevasse:** A Memphis District crew consisting of seven personnel and three pieces of heavy equipment were moved to this site Tuesday to begin preparing the ground for construction. The crews will initially harvest sand deposited on the surrounding lands for use as fill material. An active dredge contract was modified to include dredging at the center crevasse. The dredge contractor received the modified notice to proceed Tuesday.

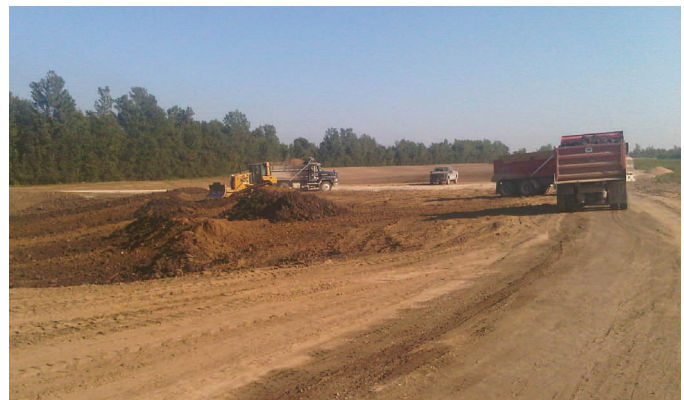
**Placing clay into the third of five scour holes Monday. Crews previously filled the holes to the water table with sand, and are now placing clay in the hole to provide a stable base for the levee and to resist seepage.**
