# OPERATION MAKE SAFE PROJECT UPDATE Aug. 12, 2011

## Birds Point - New Madrid Floodway Missouri

**New Madrid Project Office**

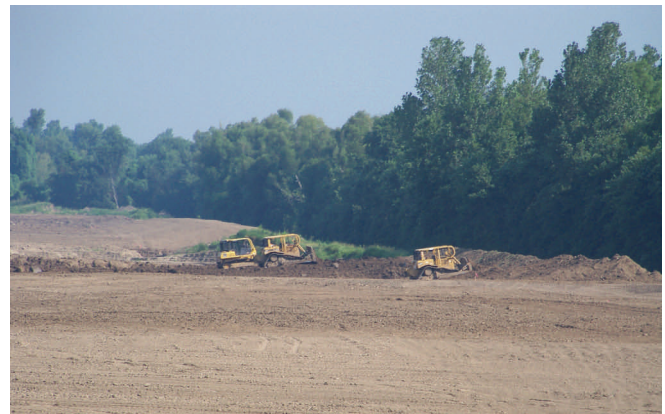
**Repairing the levee at the upper crevasse.**

The upper crevasse is located at Birds Point, near the confluence of the Mississippi and Ohio rivers. Repairs are required for 9,000 feet of levee at this location. Work here includes filling five scour holes back to level grade, repairing four levee segments and constructing one segment realignment.

**Upper crevasse:** Two Memphis District crews consisting of 27 personnel and 24 pieces of heavy equipment are on site. One crew is reshaping levee segments at the southern end of the site, while the second crew is filling scour holes at the northern end. A contract for sand delivery was awarded Aug. 3 and the contractor began delivery Aug. 4. The sand will be used to fill five scour holes at this site. A clay cap over the sand fill will prevent seepage. A request for proposal to provide haul services for clay embankment is under review. This week's priorities are filling two scour holes and shaping two levee segments. A total of 1,500 feet of levee has been built to a (Cairo) gage elevation of 51 feet at this location.

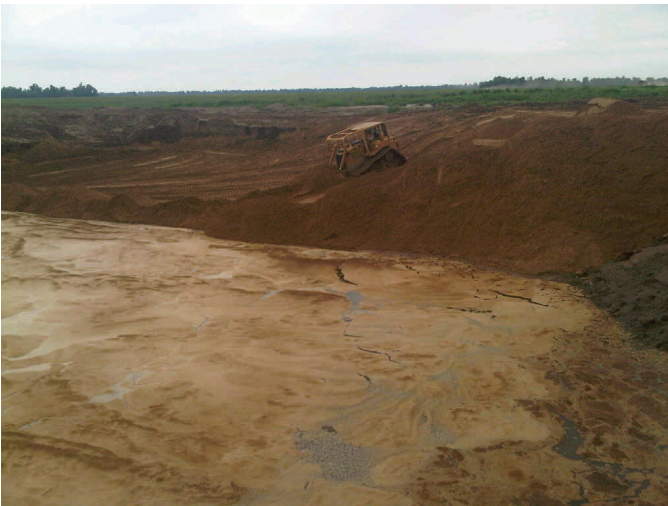
**Sand is used to fill a scour hole at the upper crevasse. Clay will be placed over the sand, capping the scour hole and preventing seepage.**

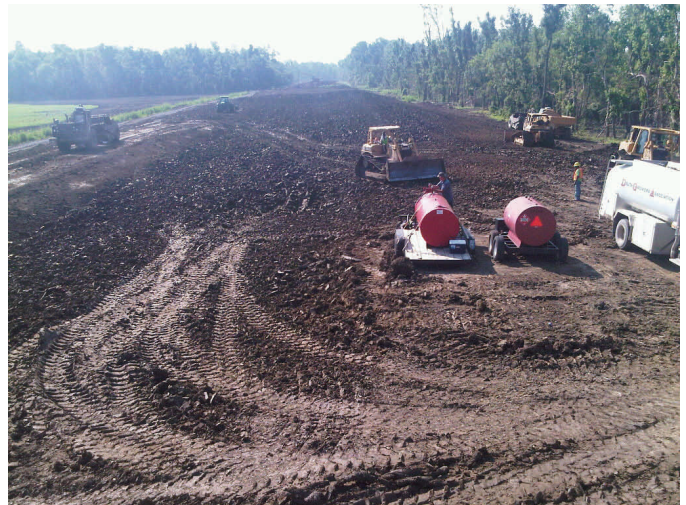
**A Vicksburg-based crew prepares the ground at the lower crevasse. The excess water in the soil must be removed before it can be used in the levee.**

The lower crevasse is located near Donaldson Point Conservation Area. Repairs are required for 4,700 feet of levee at this location. Work here includes removing excess water at the foundation, and repairing the levee to the interim grade.

**Lower crevasse:** A Vicksburg District crew consisting of 13 personnel and 13 pieces of heavy equipment is removing standing water, drying oversaturated soil, and reshaping the levee. This week's priority is removing excess water and leveling the ground under the levee foundation.

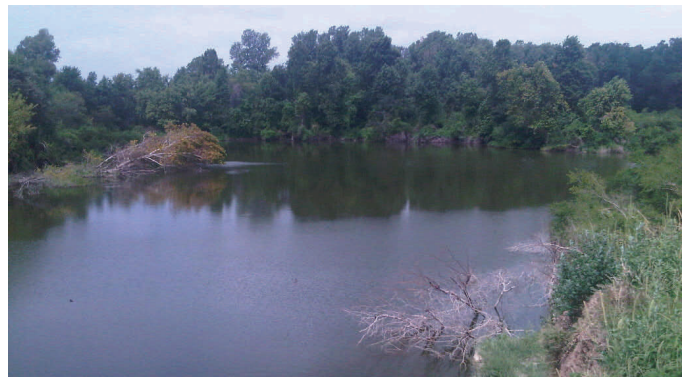
**Center crevasse near Seven Island Conservation Area.**

The center crevasse is located near Seven Island Conservation Area. Repairs are required for 800 feet of levee at this location. A scour hole developed here, connecting with the existing 1937 scour hole. The scope of work and construction schedule will be determined following completion of an environmental assessment in mid-September.

**Center crevasse:** Least terns continue to nest in the vicinity of this site. These endangered birds are expected to finish nesting and depart the area by early September. An environmental assessment (EA) is in development and is scheduled for completion by mid-September. The EA will address multiple options for interim protection at the center crevasse, as well as repair of all three crevasses to the final authorized grade.
