**US Army Corps
of Engineers**

OPERATION MAKE SAFE PROJECT UPDATE Aug. 15, 2011

Birds Point - New Madrid Floodway

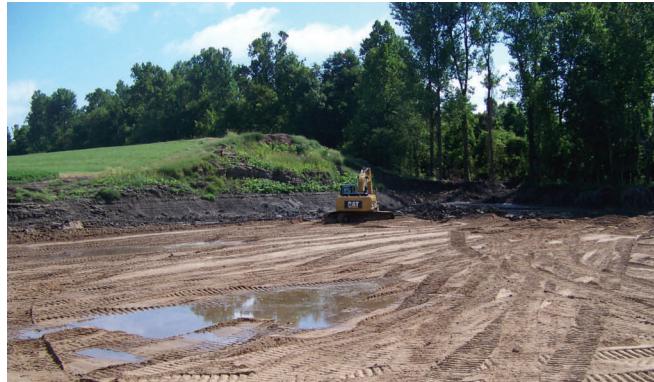
Sand is used to fill the scour holds near Birds Point. Clay will later be used to cap the hole.

The upper crevasse is located at Birds Point, near the confluence of the Mississippi and Ohio rivers. Repairs are required for 9,000 feet of levee at this location. Work here includes filling five scour holes back to level grade, repairing four levee segments and constructing one segment realignment.

Upper crevasse: Two Memphis District crews consisting of 27 personnel and 24 pieces of heavy equipment are on site. One crew is reshaping levee segments at the southern end of the site, while the second crew is filling scour holes with sand at the northern end. One scour hole is filled with sand to the required depth, a second is filled approx. 80%, and crews began filling a third hole Friday. A clay cap over the sand fill will prevent seepage. Current priorities are filling scour holes and shaping two levee segments. A total of 1,500 feet of levee has been built to a (Cairo) gage elevation of 51 feet at this location.

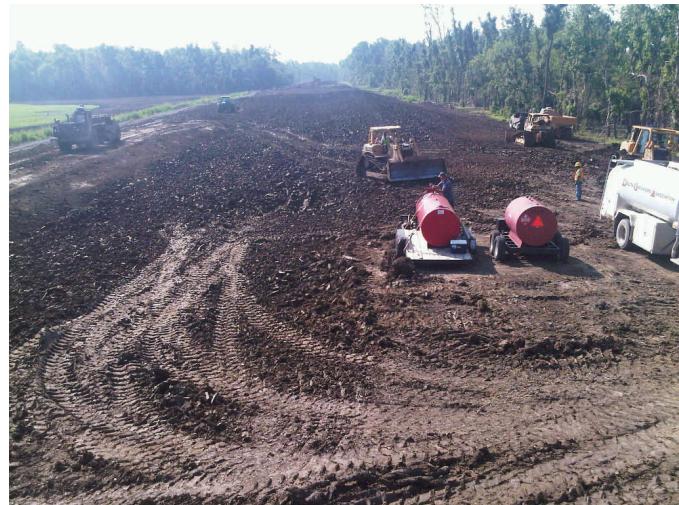
A Vicksburg-based crew prepares the ground at the lower crevasse. The excess water in the soil must be removed before it can be used in the levee.

The lower crevasse is located near Donaldson Point Conservation Area. Repairs are required for 4,700 feet of levee at this location. Work here includes removing excess water at the foundation, and repairing the levee to the interim grade.

Lower crevasse: A Vicksburg District crew consisting of 13 personnel and 13 pieces of heavy equipment is removing standing water, drying oversaturated soil, and reshaping the levee. Some limited shaping of the levee has begun at the western end, but the priorities here continue to be removing excess water and leveling the ground under the levee foundation.

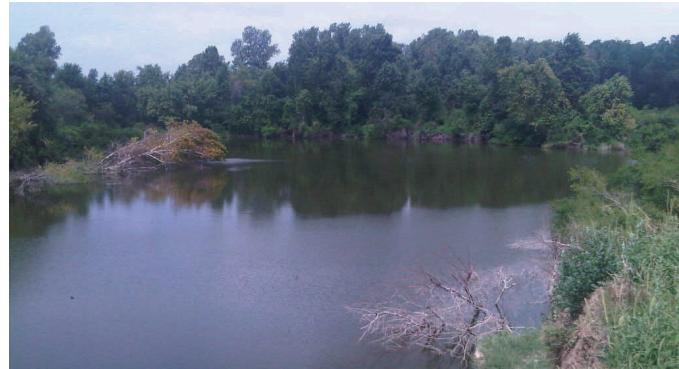
Center crevasse near Seven Island Conservation Area.

The center crevasse is located near Seven Island Conservation Area. Repairs are required for 800 feet of levee at this location. A scour hole developed here, connecting with the existing 1937 scour hole. The scope of work and construction schedule will be determined following completion of an environmental assessment in mid-September.

Center crevasse: The District has confirmed from the Missouri Department of Conservation that the endangered least terns at this location have completed nesting and departed the area. An environmental assessment (EA) is in development and is scheduled for completion by mid-September. The EA will address multiple options for interim protection at the center crevasse, as well as repair of all three crevasses to the final authorized grade.
