US Army Corps
of Engineers

OPERATION MAKE SAFE PROJECT UPDATE Aug. 17, 2011

Birds Point - New Madrid Floodway Missouri

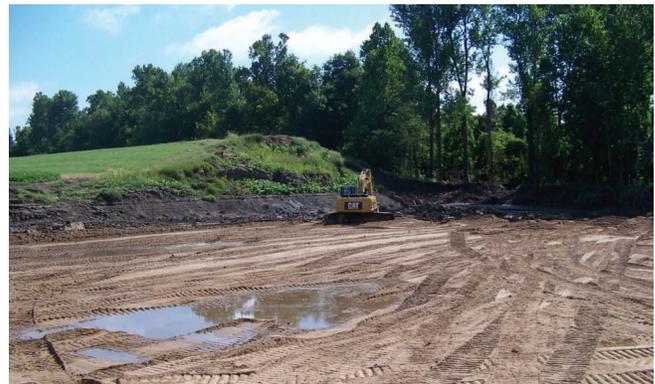
Sand is used to fill the scour holds near Birds Point. Clay will later be used to cap the hole.

Upper crevasse: Two Memphis District crews consisting of 27 personnel and 24 pieces of heavy equipment are on site. One crew is reshaping levee segments at the southern end of the site, while the second crew is filling scour holes with sand at the northern end. Two scour holes are filled with sand to the required depth, and a third is filled to 60% of the required depth. A clay cap over the sand fill will prevent seepage. A solicitation for haul services was posted today to transport additional clay embankment (see below for link). Current priorities are filling scour holes and shaping two levee segments. A total of 1,800 feet of levee has been built to a (Cairo) gage elevation of 51 feet at this location.

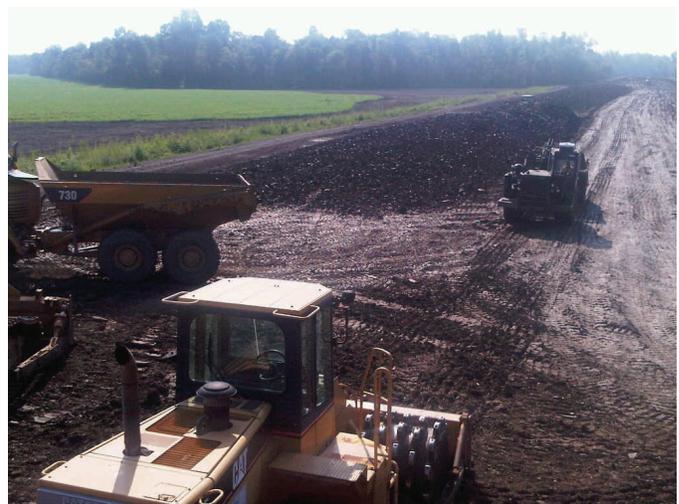
A Vicksburg-based crew removes excess water in the soil at the lower crevasse. Once at the proper moisture content, the material will be compacted into the levee.

Lower crevasse: A Vicksburg District crew consisting of 13 personnel and 13 pieces of heavy equipment is removing standing water, drying oversaturated soil, and reshaping the levee. Standing water has all been removed but soil at the east end is still too wet to compact properly. Some limited shaping of the levee has begun at the western end, but the priorities here continue to be removing excess water and leveling the ground under the levee foundation.

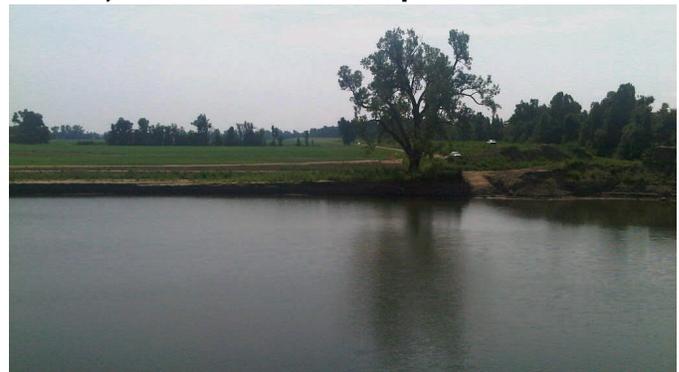
Center crevasse near Seven Island Conservation Area. The existing levee is visible behind the oak tree.

The center crevasse is located near Seven Island Conservation Area. Repairs are required for 800 feet of levee at this location. A scour hole developed here, connecting with the existing 1937 scour hole. The scope of work and construction schedule will be determined following completion of an environmental assessment in mid-September.
