# OPERATION MAKE SAFE PROJECT UPDATE Aug. 19, 2011

Birds Point - New Madrid Floodway  
Missouri

**New Madrid Project Office**

**Memphis District**

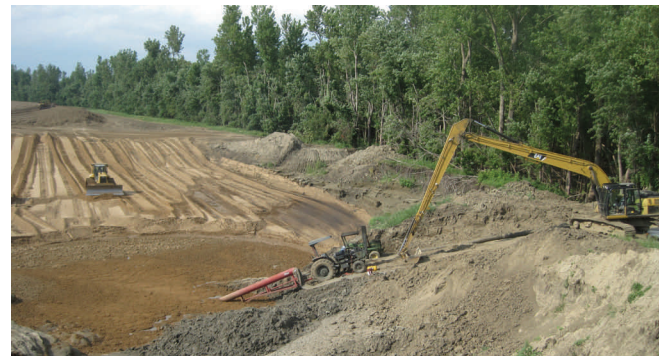
**Crews fill a scour hole with sand at the upper crevasse. Clay will be placed over the sand to prevent seepage and bring the hole to level grade.**

**Upper crevasse:** Two Memphis District crews consisting of 27 personnel and 24 pieces of heavy equipment are on site. One crew is reshaping levee segments at the southern end of the site, while the second crew is filling scour holes with sand at the northern end. Two scour holes are filled with sand to the required depth, and a third is filled to 80% of the required depth. Clay will be used to cap the sand and prevent seepage. Crews began applying the first clay cap Thursday. A solicitation for haul services was posted Wednesday to transport additional clay embankment (see below for link). Current priorities are filling scour holes and shaping two levee segments. A total of 1,800 feet of levee has been built to a (Cairo) gage elevation of 51 feet at this location.

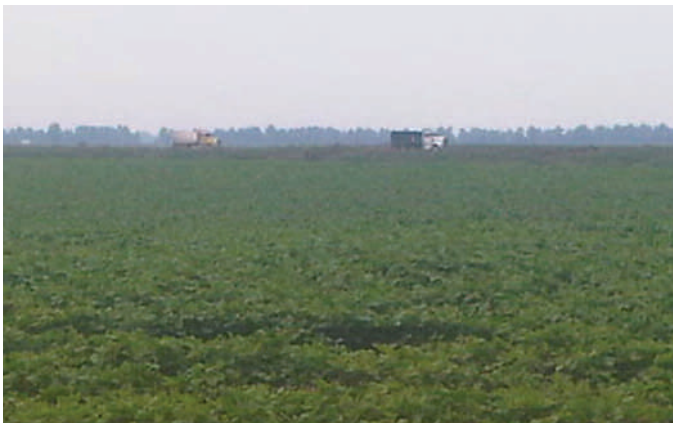
**Dump trucks leave the site after delivering sand at the upper crevasse. More than 58,000 tons of sand has been delivered to date.**

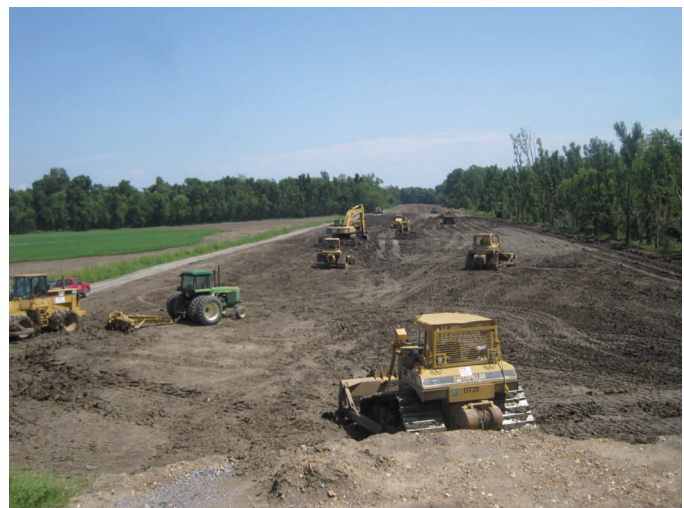
**A Vicksburg-based crew removes excess water in the soil at the lower crevasse. Once at the proper moisture content, the material will be compacted into the levee.**

**Lower crevasse:** A Vicksburg District crew consisting of 13 personnel and 13 pieces of heavy equipment is drying oversaturated soil and reshaping the levee. Standing water has been removed but soil in many locations, particularly the east end, are still too wet to compact properly. Some limited shaping of the levee has begun at the western end, but the priorities here continue to be processing material and preparing the levee foundation.

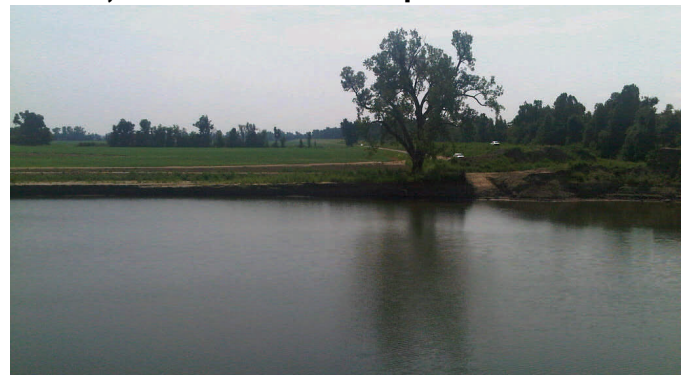
**Center crevasse near Seven Island Conservation Area. The existing levee is visible behind the oak tree.**

The center crevasse is located near Seven Island Conservation Area. Repairs are required for 800 feet of levee at this location. A scour hole developed here, connecting with the existing 1937 scour hole. The scope of work and construction schedule will be determined following completion of an environmental assessment in mid-September.

**Center crevasse:** An environmental survey concluded and a detailed elevation survey continued this week. The data gathered will be used to analyze design options in the forthcoming environmental assessment. The environmental assessment (EA), scheduled for completion by mid-September, will address multiple options for interim protection at the center crevasse, as well as repair of all three crevasses to the final authorized grade.
