US Army Corps
of Engineers

OPERATION MAKE SAFE PROJECT UPDATE Aug. 22, 2011

Birds Point - New Madrid Floodway Missouri

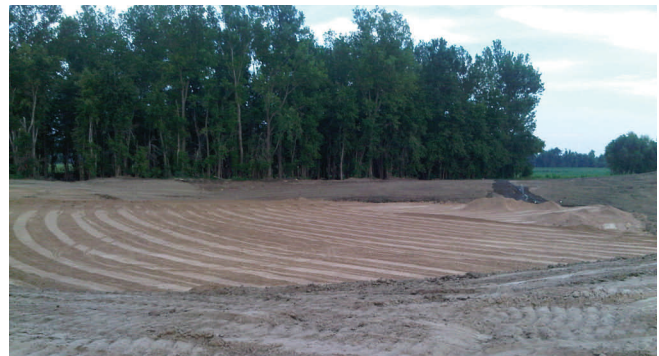
A third scour hole is nearly filled with sand at the upper crevasse. Clay embankment will be placed over the sand up to level grade to prevent seepage.

Upper crevasse: Two Memphis District crews consisting of 27 personnel and 24 pieces of heavy equipment are on site. One crew is reshaping levee segments at the southern end of the site, while the second crew is filling scour holes with sand at the northern end. Two scour holes are filled with sand to the required depth, and a third is filled to 90% of the required depth. Clay will be used to cap the sand and prevent seepage. Crews continue to apply the first clay cap. A solicitation for haul services was posted Wednesday to transport additional clay embankment (see below for link). Current priorities are filling scour holes and shaping two levee segments. A total of 1,800 feet of levee has been built to a (Cairo) gage elevation of 51 feet at this location.

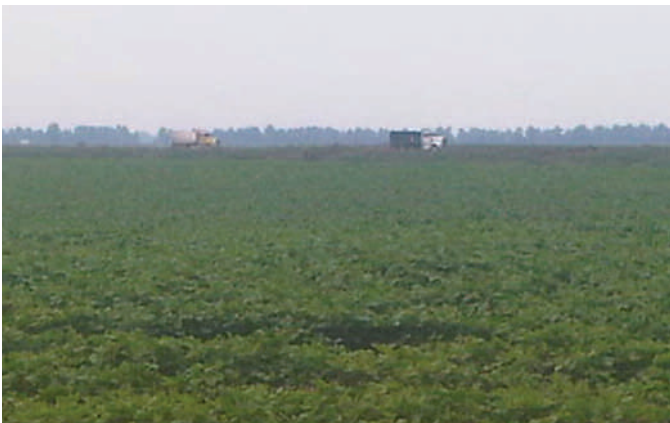
Dump trucks leave the site after delivering sand at the upper crevasse. More than 70,600 tons of sand has been delivered to date.

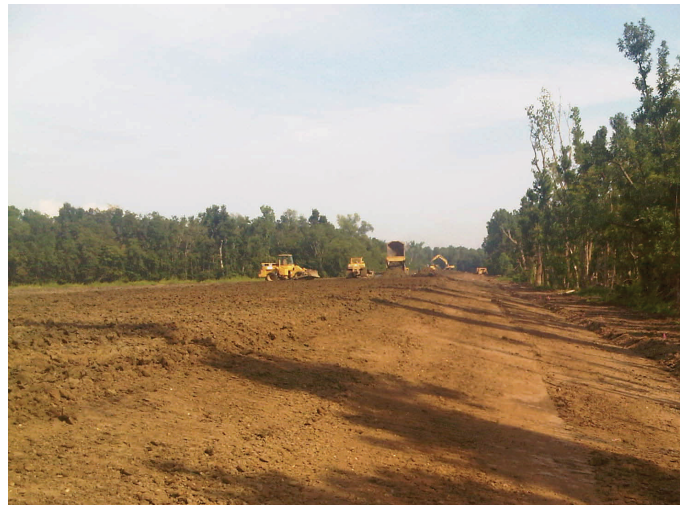
The levee takes shape at the lower crevasse. The river-side slope is now clearly visible.

Lower crevasse: A Vicksburg District crew consisting of 13 personnel and 13 pieces of heavy equipment is on site at this location. Excess water has been removed from the soil and the crew has shifted its focus to shaping a 2,000-foot segment at the western end to tie in with the existing levee.

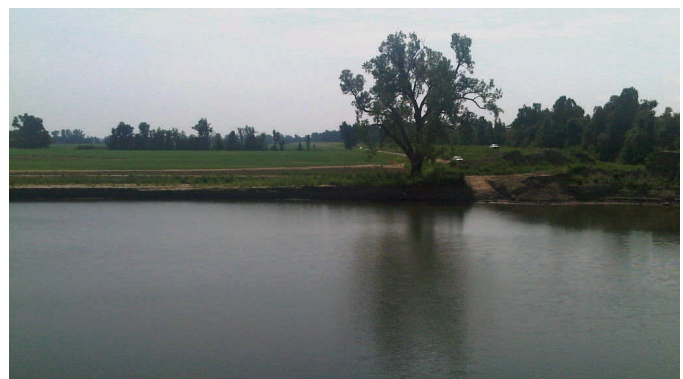
Center crevasse near Seven Island Conservation Area. The existing levee is visible behind the oak tree.

The center crevasse is located near Seven Island Conservation Area. Repairs are required for 800 feet of levee at this location. A scour hole developed here, connecting with the existing 1937 scour hole. The scope of work and construction schedule will be determined following completion of an environmental assessment in mid-September.
