OPERATION MAKE SAFE PROJECT UPDATE Aug. 26, 2011

Birds Point - New Madrid Floodway Missouri

New Madrid Project Office

Memphis District

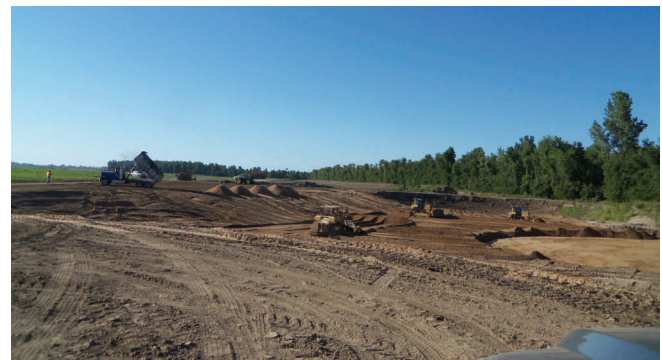
Filling the fourth of five scour holes at the upper crevasse. This hole has been filled 67 percent of the required depth of sand and will be capped with clay.

Upper crevasse: Two Memphis District crews consisting of 27 personnel and 24 pieces of heavy equipment are on site. One crew is reshaping levee segments at the southern end of the site, while the second crew is filling scour holes with sand at the northern end. Three scour holes are filled with sand to the required depth, and a fourth is filled to 67 percent of the required depth. Crews continue to apply a clay cap to the first scour hole. Delivery of additional clay embankment began this morning. Current priorities are filling scour holes and shaping two levee segments. A total of 1,800 feet of levee has been built to a (Cairo) gage elevation of 51 feet at this location. More than 100,700 tons of sand have been delivered here to date.

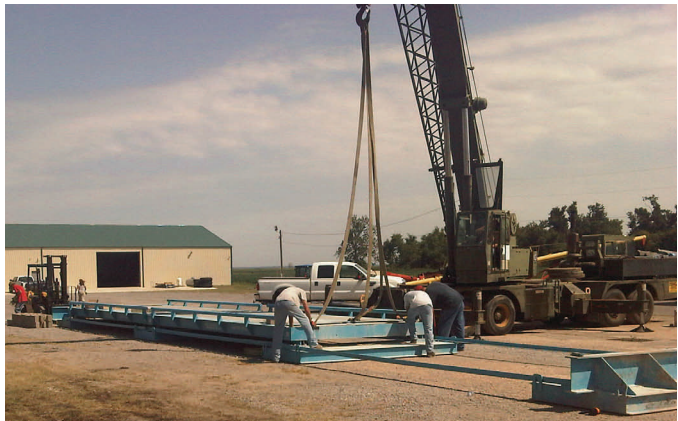
A contractor sets up temporary scales in preparation for clay hauling Thursday. Delivery of clay embankment began Friday.

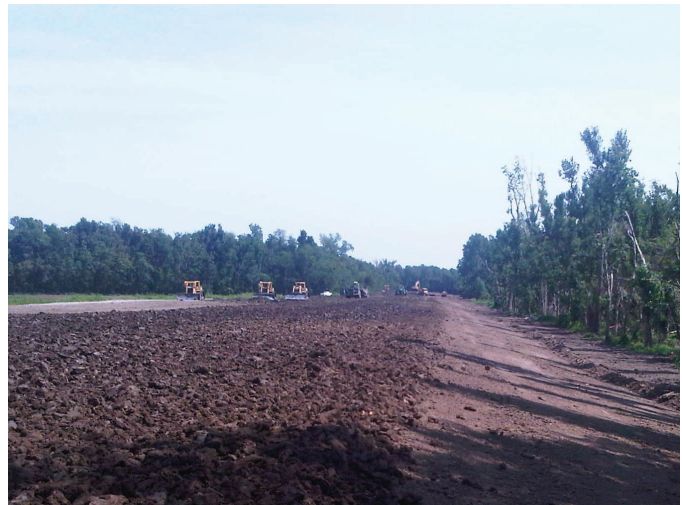
The levee takes shape at the lower crevasse. The river-side slope is now clearly visible.

Lower crevasse: A Vicksburg District crew consisting of 13 personnel and 13 pieces of heavy equipment is on site at this location. Work uncovered more oversaturated soil which required additional processing. This material will be placed into the levee when it is reduced to the proper moisture content.

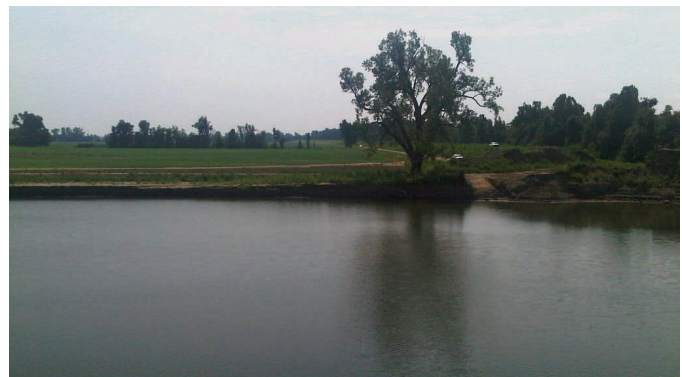
Center crevasse near Seven Island Conservation Area. The existing levee is visible behind the tree.

The center crevasse is located near Seven Island Conservation Area. Repairs are required for 800 feet of levee at this location. A scour hole developed here, connecting with the existing 1937 scour hole. The scope of work and construction schedule will be determined following completion of an environmental assessment in mid-September.

Center crevasse: A detailed elevation survey continued at this site. The environmental assessment (EA) was released for public review and comment Aug. 25, and comments are due by Sept. 6 (see link below). The EA is scheduled for completion in mid-September, and addresses multiple options for interim protection at the center crevasse, as well as repair of all three crevasses to the final authorized grade.
