OPERATION MAKE SAFE PROJECT UPDATE Dec. 12, 2011

Birds Point - New Madrid Floodway

Missouri

Memphis District

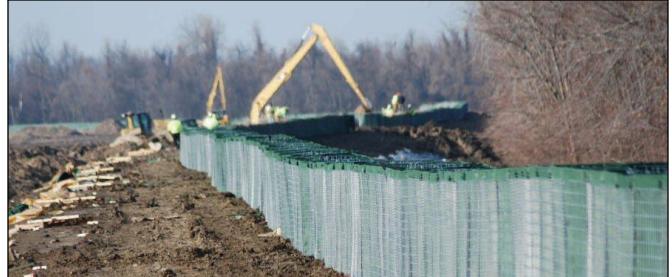
A crew fills HESCO barriers at the upper crevasse Sunday. The barriers are a temporary measure to raise the level of protection at Birds Point from 51 to 55 feet on the Cairo gage. Permanent repairs to the levee will resume after spring highwater recedes.

Upper crevasse: The earthen levee meets or exceeds a (Cairo) gage elevation of 51 feet as of Oct. 28. Weather conditions are no longer favorable for earthwork. The District was directed Dec. 6 to proceed with installation of a temporary structure of HESCO barriers to increase flood protection to 55 feet on the Cairo gage. Installation began Dec. 7. To date, all 9,000 linear feet of HESCO barriers have been deployed, 8,200 feet have been filled with sand, and 4,900 feet have been covered with plastic for protection. The HESCO barriers are wire mesh baskets lined with heavy fabric. The HESCOs are fastened together with wire, filled with sand, and lined with heavy plastic sheeting to provide temporary flood protection. This work is part of an orderly shutdown of the project for winter. Permanent repairs will resume after spring highwater recedes.

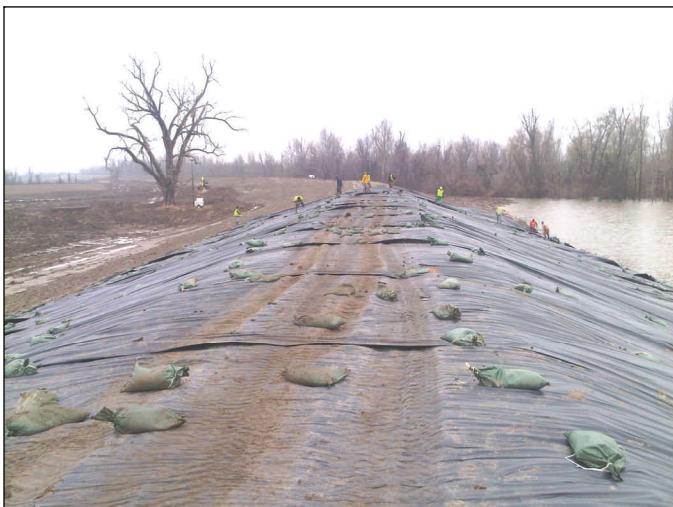
Crews cover the newly-constructed levee segment at the center crevasse with heavy plastic sheeting Dec. 6. The plastic sheeting will help protect the levee against erosion caused by wave action and rainfall. This view looks east along the levee.

Center crevasse: The Memphis- and Vicksburg-based crews reached the required Make Safe elevation Dec. 3. The interim levee stands 15 feet high above the surrounding ground and provides flood protection to approximately 55 feet on the Cairo gage. The crew also completed covering the levee in heavy plastic sheeting to resist against erosion by rain and wave wash. A crew is demobilizing from the site.

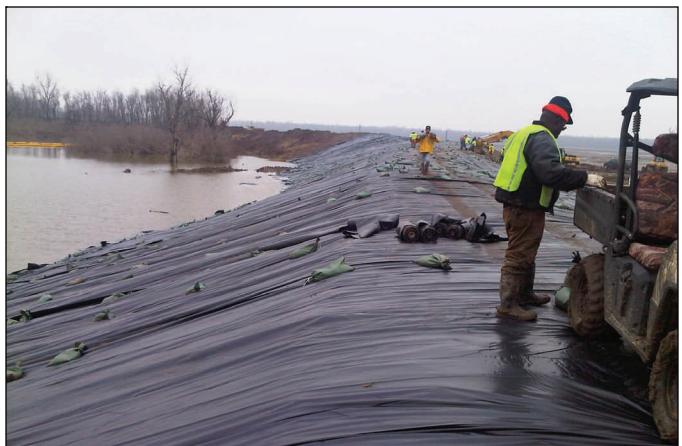
Newly-installed heavy plastic sheeting covers the levee at the center crevasse Dec. 6. This view looks west.

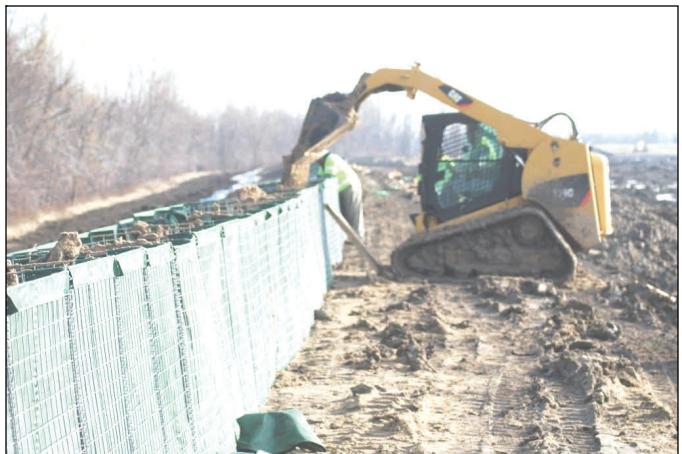
An equipment operator fills HESCO barriers with sand at the upper crevasse Sunday.
