OPERATION MAKE SAFE PROJECT UPDATE

Dec. 5, 2011

Birds Point - New Madrid Floodway
Missouri

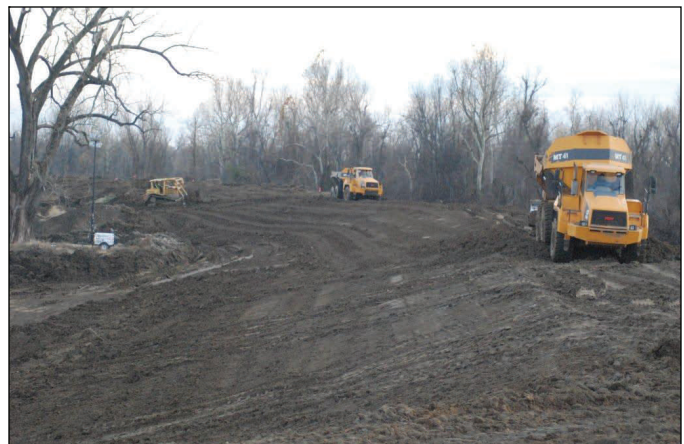
Crews reconstruct the levee at the center crevasse Dec. 3.

Center crevasse: A Corps of Engineers crew consisting of 27 personnel and 20 pieces of heavy equipment is on site here and at a nearby clay borrow site. The crew reached the required Make Safe elevation Saturday evening. The interim levee stands 15 feet high above the surrounding ground and will provide flood protection to approximately 55 feet on the Cairo gage. Work remains to backfill the landside clay bed to prevent against seepage. Additionally, the levee will be covered in heavy plastic sheeting this week to protect it against erosion by rain or wave wash.

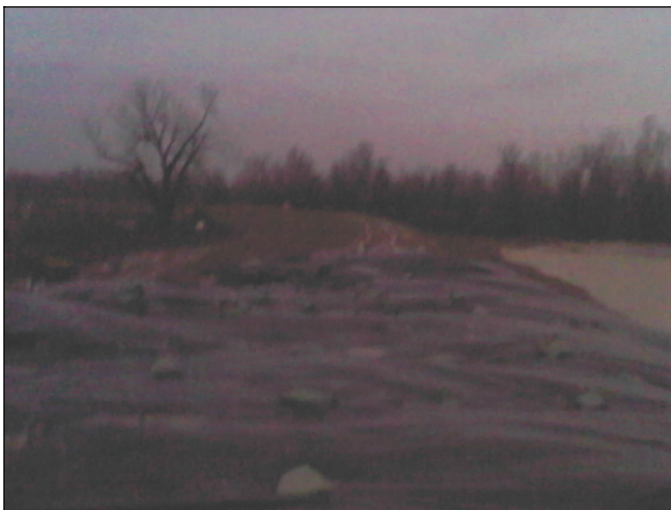
Water creeps up the toe of the levee at the center crevasse Monday evening (river is on right side). The forecasted crest is expected to put about five feet of water on the 15-foot-high levee.

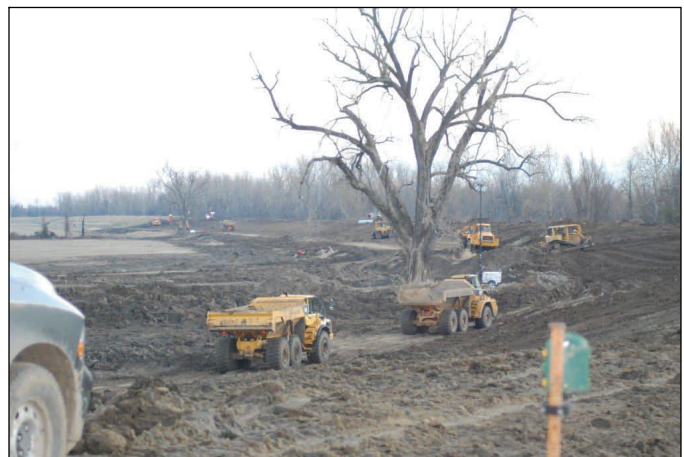
Crews reconstruct levee at the center crevasse Dec. 3 to close an 800-foot gap here.

The center crevasse is located near Seven Island Conservation Area. Repairs are required for 800 feet of levee at this location. A scour hole developed here, connecting with the existing 1937 scour hole. Work here includes separating the two scour holes, filling the new scour hole using sand dredged from the river bottom, and repairing the levee to the interim grade.
