# OPERATION MAKE SAFE PROJECT UPDATE Nov. 14, 2011

Birds Point - New Madrid Floodway  
Missouri

**New Madrid Project Office**

**Memphis District**

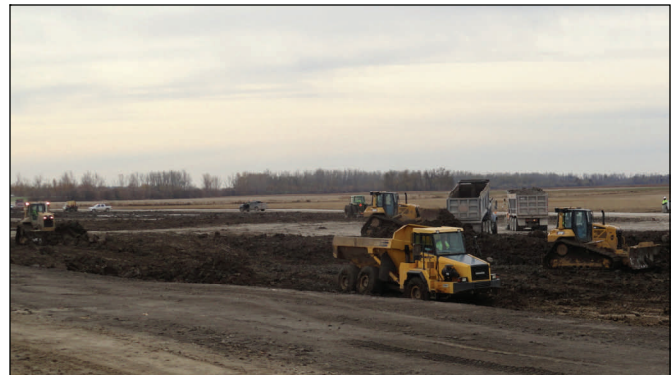
**Crews spread clay landside of the levee at the upper crevasse Saturday.**

**Upper crevasse:** A Corps of Engineers crew consisting of 26 personnel and 30 pieces of heavy equipment is on site here, at two nearby borrow sites, and at a maintenance facility. Survey results indicate that the entire 9,000 feet of levee is at or above a (Cairo) gage elevation of 51 feet. Before Monday night’s rain, crews had made excellent progress filling the land side of the levee back to level grade. Limited work to 55 feet has begun, with nearly 4,000 feet of foundation in place. Work will resume as the weather and ground conditions allow.

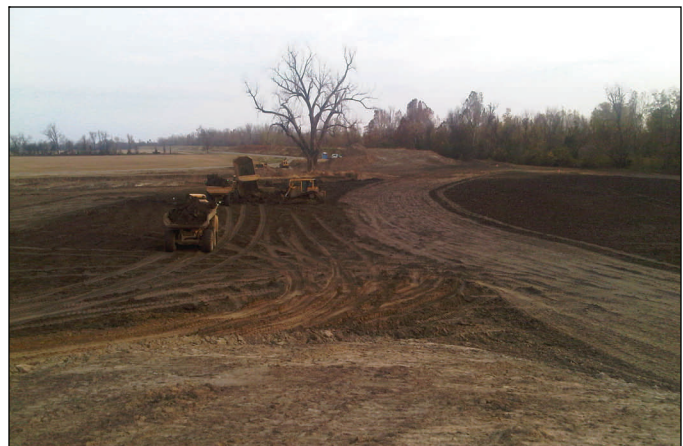
**Crews deliver and spread clay Monday at the center crevasse.**

**Center crevasse:** A Corps of Engineers crew consisting of 27 personnel and 20 pieces of heavy equipment is on site here and at a nearby clay borrow site. Four additional 25-ton off-road dump trucks were delivered last week, bringing the total number of trucks to eight. The 10-man night shift moved here Nov. 11. Work will resume as the weather and ground conditions allow.

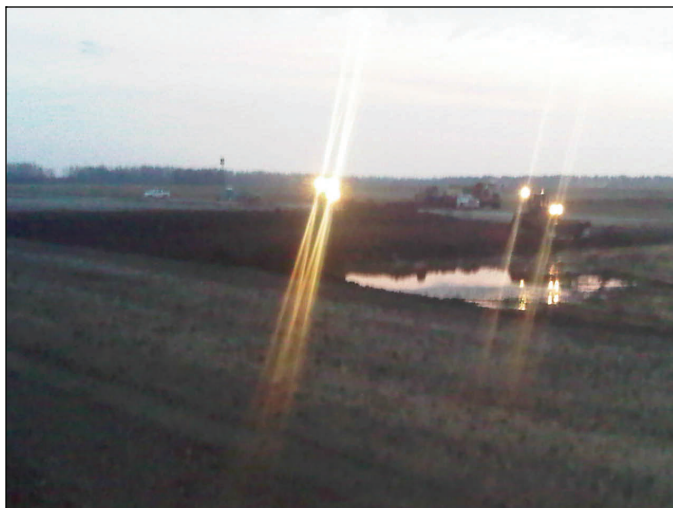
**Two bulldozer operators spread clay at dusk Monday at the upper crevasse.**

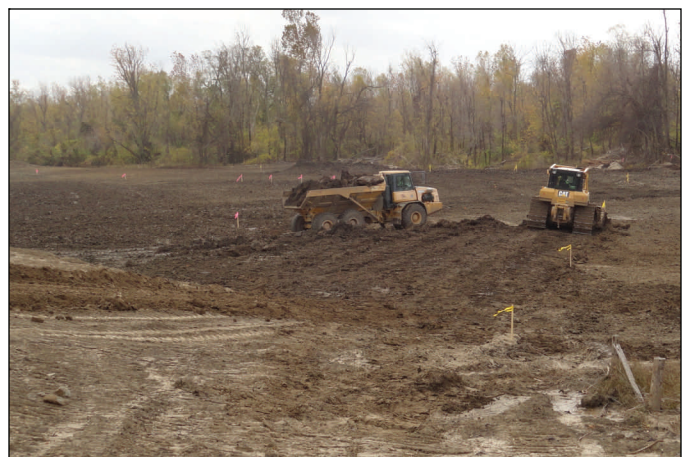
**Crews deliver and spread clay Sunday at the center crevasse.**
