OPERATION MAKE SAFE PROJECT UPDATE Nov. 18, 2011

Birds Point - New Madrid Floodway
Missouri

New Madrid Project Office

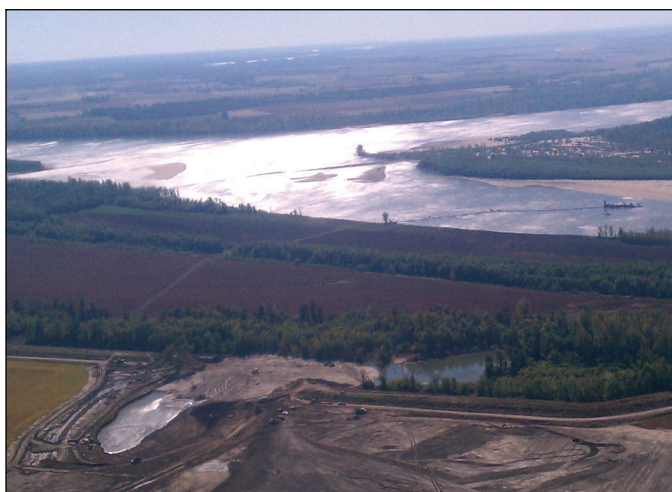
The center crevasse scour hole as seen from the air Oct. 25. The dredge Iowa is visible in the channel at top right. (Photo by Brad Hahn, courtesy of Great Lakes Dredge & Dock Company)

The center crevasse is located near Seven Island Conservation Area. Repairs are required for 800 feet of levee at this location. A scour hole developed here, connecting with the existing 1937 scour hole. Work here includes separating the two scour holes, filling the new scour hole using sand dredged from the river bottom, and repairing the levee to the interim grade.

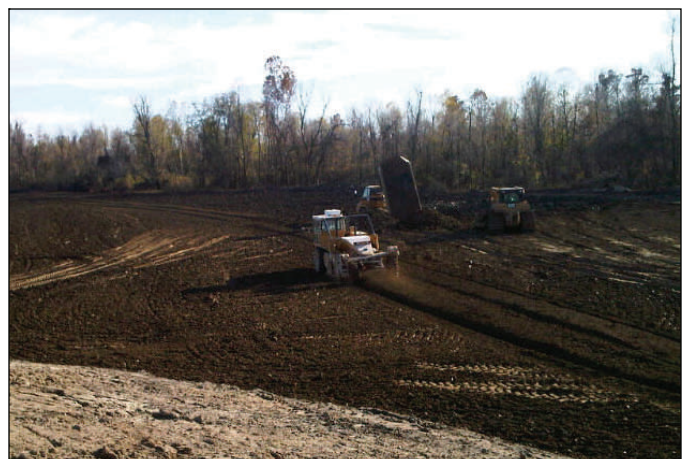
Crews deliver and spread clay Friday at the center crevasse to begin levee reconstruction.

Center crevasse: A Corps of Engineers crew consisting of 27 personnel and 20 pieces of heavy equipment is on site here and at a nearby clay borrow site. The District began running a 10-man night shift Nov. 11. Crews are currently reconstructing the levee to close the 800-foot gap.
