# OPERATION MAKE SAFE PROJECT UPDATE

Nov. 2, 2011

## Birds Point - New Madrid Floodway Missouri

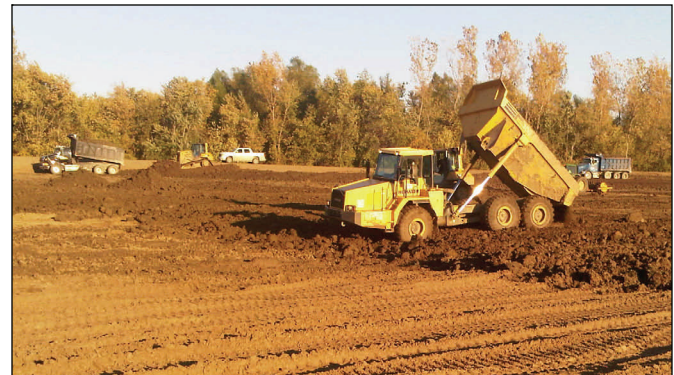
**Crews spread clay landside of the levee at the upper crevasse Wednesday.**

**Upper crevasse:** A Corps of Engineers crew consisting of 29 personnel and 24 pieces of heavy equipment is on site here, at two nearby borrow sites, and at a maintenance facility. Survey results indicate that the entire 9,000 feet of levee is at or above a (Cairo) gage elevation of 51 feet. Crews continue restoring the bed of clay on the land side of the levee in order to prevent seepage. The District, with assistance from Levee District No. 3 of Mississippi County, Missouri, acquired additional borrow material at Birds Point. The crew began utilizing this borrow site earlier this week, greatly increasing production.

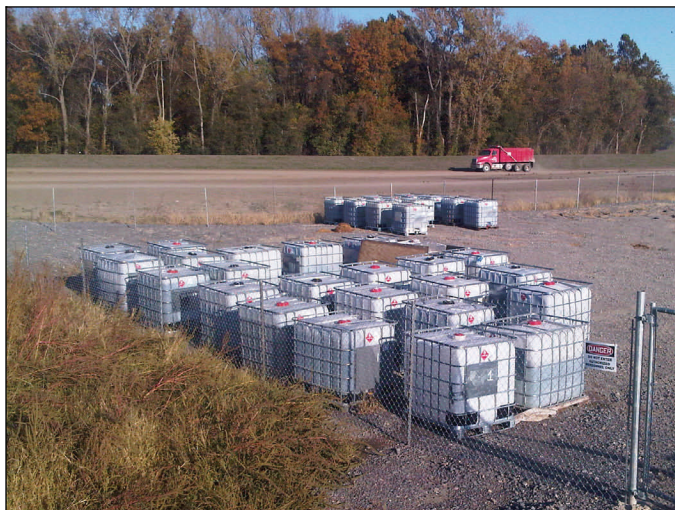
**Desensitized blasting agent awaits transport at the upper crevasse. The material will be transported to a disposal site in Illinois.**

**Blasting agent removal:** Desensitized blasting agent is packaged and awaiting shipment. A contractor is making final preparations for shipping before removing the material to a disposal site in central Illinois.

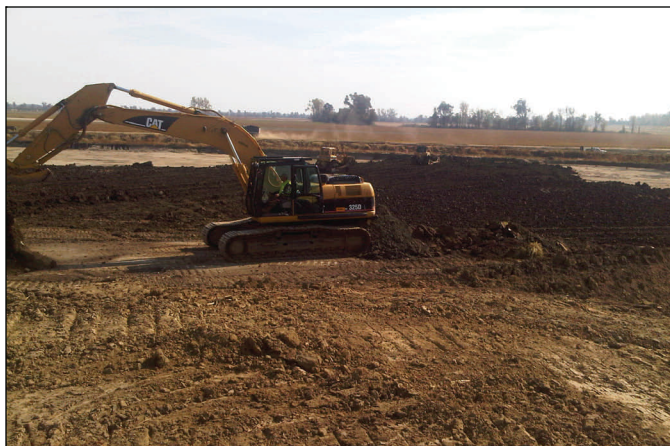
**Crews spread and compact clay at the center crevasse Wednesday. The excavator is removing asphalt.**

**Center crevasse:** A Corps of Engineers crew consisting of 14 personnel and 18 pieces of heavy equipment is on site here and at a nearby clay borrow site. The crew continued placing clay over the dredged sand to prevent seepage and serve as the foundation for the repaired levee segment. The scour hole is filled with sand. Dredging ended Monday at 8:30 a.m. The dredge Iowa pumped a total of 301,000 cubic yards of sand into the scour hole in 24 days of dredging.

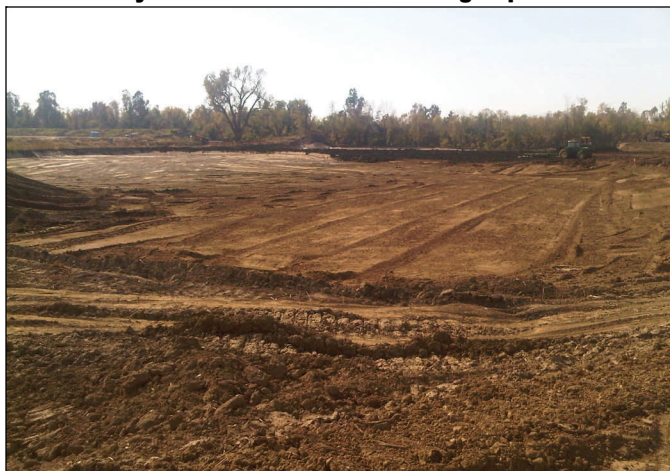
**The scour hole at the center crevasse is filled with sand. Dredging ended Monday morning.**

The center crevasse is located near Seven Island Conservation Area. Repairs are required for 800 feet of levee at this location. A scour hole developed here, connecting with the existing 1937 scour hole. Work here includes separating the two scour holes, filling the new scour hole using sand dredged from the river bottom, and repairing the levee to the interim grade.
