# OPERATION MAKE SAFE PROJECT UPDATE

Nov. 21, 2011

Birds Point - New Madrid Floodway  
Missouri

Memphis District

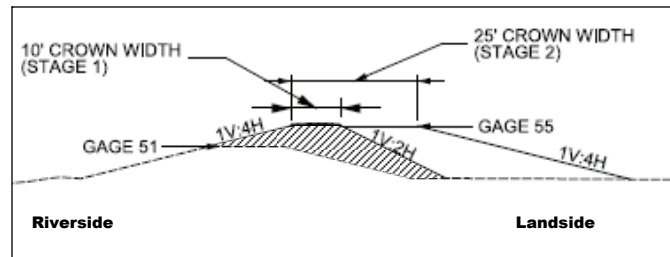
The hatched area is the modified section of the upper crevasse (Birds Point) levee. The modified section will be constructed as weather permits and will provide protection to 55 feet on the Cairo gage. The full levee section will be constructed Spring 2012 and will provide additional stability and durability to the levee.

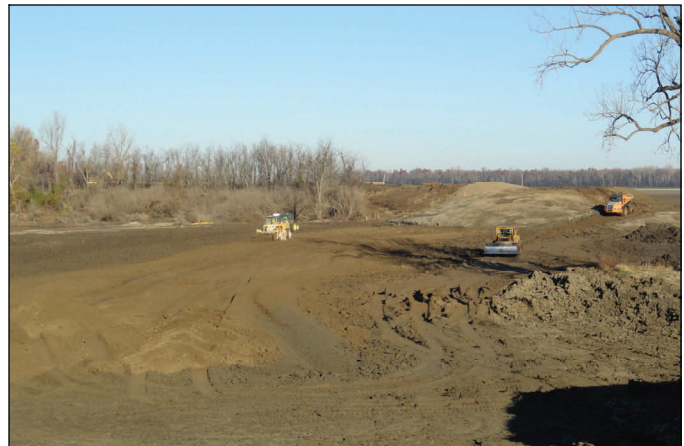
**Crews deliver and spread clay Nov. 18 at the center crevasse to begin levee construction.**

**Center crevasse:** A Corps of Engineers crew consisting of 27 personnel and 20 pieces of heavy equipment is on site here and at a nearby clay borrow site. The District began running a 10-man night shift Nov. 11. Crews will resume levee reconstruction to close the 800-foot gap as the weather permits.

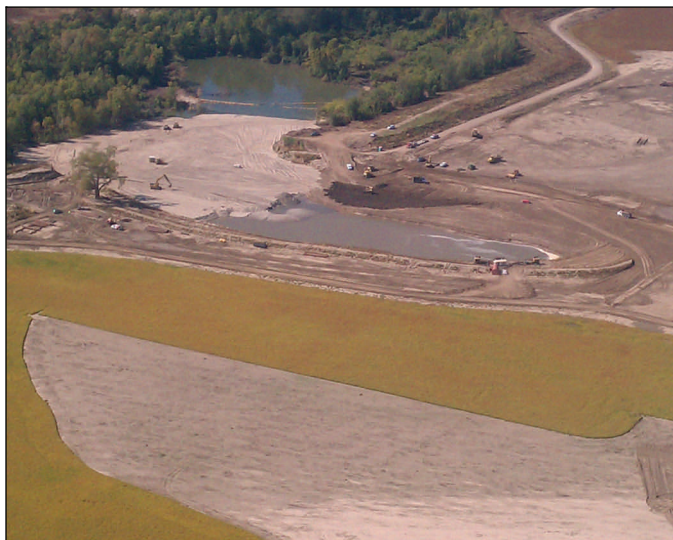
**The center crevasse scour hole as seen from the air Oct. 25 during dredging. The area to the right of the levee was filled in after this photo was taken. (Photo by Brad Hahn, courtesy of Great Lakes Dredge & Dock Company)**

The center crevasse is located near Seven Island Conservation Area. Repairs are required for 800 feet of levee at this location. A scour hole developed here, connecting with the existing 1937 scour hole. Work here includes separating the two scour holes, filling the new scour hole using sand dredged from the river bottom, and repairing the levee to the interim grade.

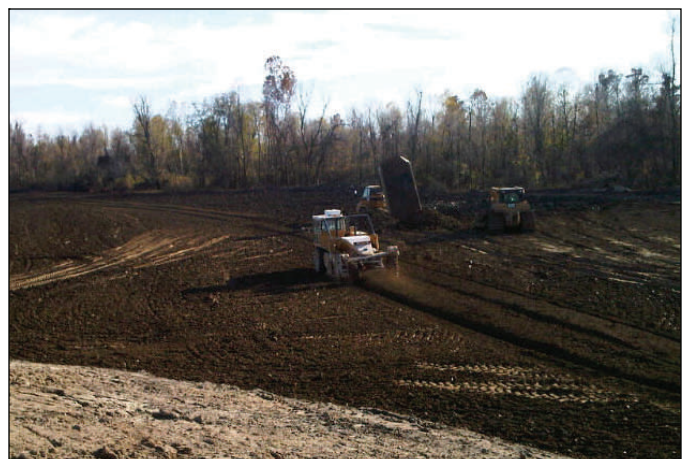
**Crews deliver and spread clay Nov. 18 at the center crevasse to begin levee reconstruction.**
