# OPERATION MAKE SAFE PROJECT UPDATE

Nov. 4, 2011

Birds Point - New Madrid Floodway  
Missouri

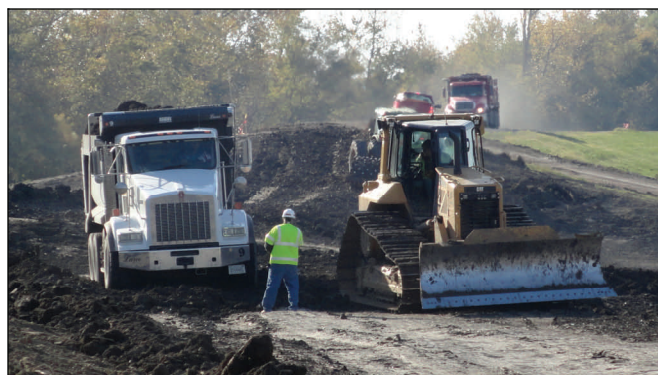
Crews spread clay landside of the levee at the upper crevasse Wednesday.

**Upper crevasse:** A Corps of Engineers crew consisting of 29 personnel and 24 pieces of heavy equipment is on site here, at two nearby borrow sites, and at a maintenance facility. Survey results indicate that the entire 9,000 feet of levee is at or above a (Cairo) gage elevation of 51 feet. Crews suspended earthwork because of oversaturated soil on site from the recent rain. The District, with assistance from Levee District No. 3 of Mississippi County, Missouri, acquired additional borrow material at Birds Point. The crew began utilizing this borrow site earlier this week, greatly increasing production.

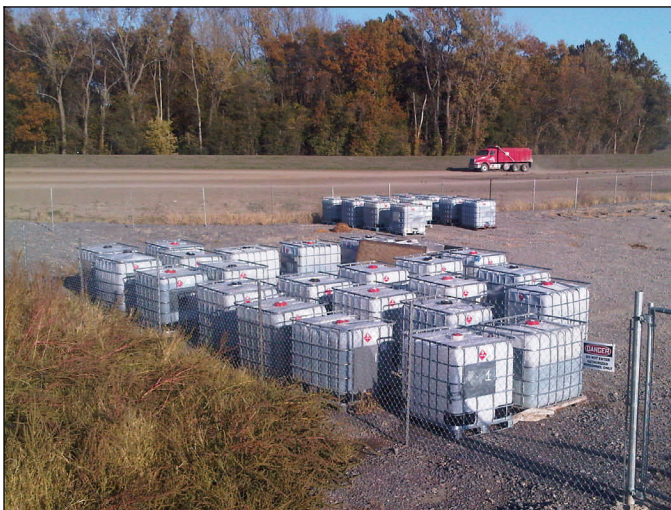
**Desensitized blasting agent awaits transport at the upper crevasse. The material will be transported to a disposal site in Illinois.**

**Blasting agent removal:** Desensitized blasting agent is packaged and awaiting shipment. A contractor is making final preparations for shipping before removing the material to a disposal site in central Illinois.

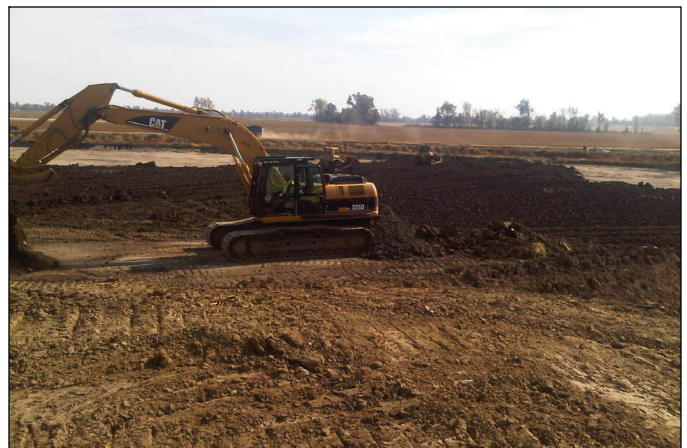
**Crews spread and compact clay at the center crevasse Wednesday. The excavator is removing asphalt.**

**Center crevasse:** A Corps of Engineers crew consisting of 14 personnel and 18 pieces of heavy equipment is on site here and at a nearby clay borrow site. The crew suspended clay placement until the ground has dried. The scour hole is filled with sand. The District acquired additional borrow material near Big Oak State Park. Use of this material will improve construction productivity greatly and reduce transportation costs. The crew is currently mobilizing to the borrow site.

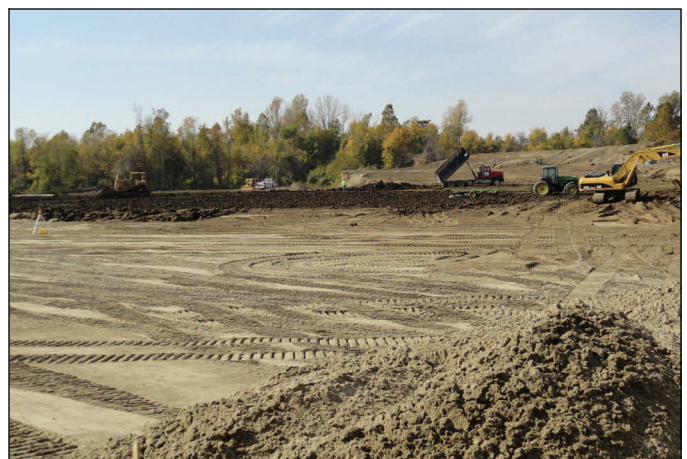
**The scour hole at the center crevasse is filled with sand. Dredging ended Monday morning.**

The center crevasse is located near Seven Island Conservation Area. Repairs are required for 800 feet of levee at this location. A scour hole developed here, connecting with the existing 1937 scour hole. Work here includes separating the two scour holes, filling the new scour hole using sand dredged from the river bottom, and repairing the levee to the interim grade.
