# OPERATION MAKE SAFE PROJECT UPDATE Nov. 9, 2011

Birds Point - New Madrid Floodway  
Missouri

**New Madrid Project Office**

**Memphis District**

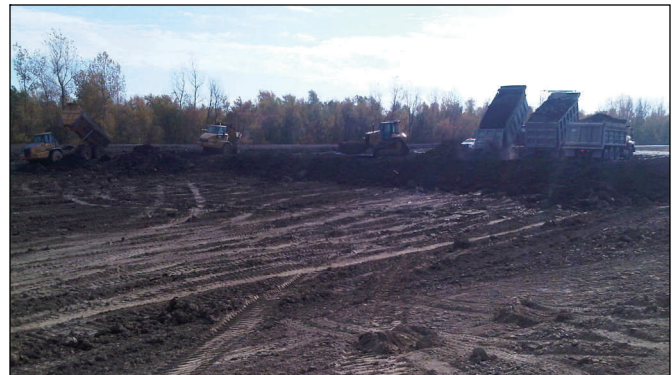
**Crews spread clay landside of the levee at the upper crevasse Tuesday.**

**Upper crevasse:** A Corps of Engineers crew consisting of 36 personnel and 30 pieces of heavy equipment is on site here, at two nearby borrow sites, and at a maintenance facility. Survey results indicate that the entire 9,000 feet of levee is at or above a (Cairo) gage elevation of 51 feet. The District began a night shift Saturday to maximize production when the weather is favorable. The addition of the night shift will allow the District to transport clay around the clock, reducing the risk of weather delays to completion of the 55-foot levee. Both day and night shifts will resume as the weather and ground conditions allow.

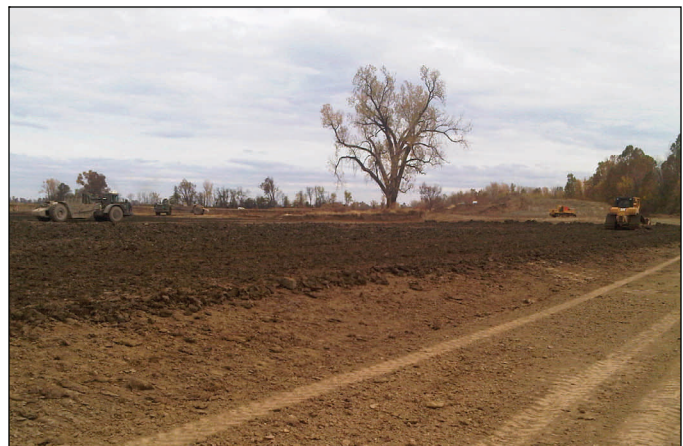
**Crews disk and compact clay after it is placed in the scour hole at the center crevasse Tuesday.**

**Center crevasse:** A Corps of Engineers crew consisting of 17 personnel and 16 pieces of heavy equipment is on site here and at a nearby clay borrow site. The crew opened a new borrow site near Big Oak State Park Sunday. Use of this material will improve construction productivity greatly and reduce transportation costs. Four additional 25-ton off-road dump trucks are scheduled for delivery later this week, bringing the total number of trucks to eight.

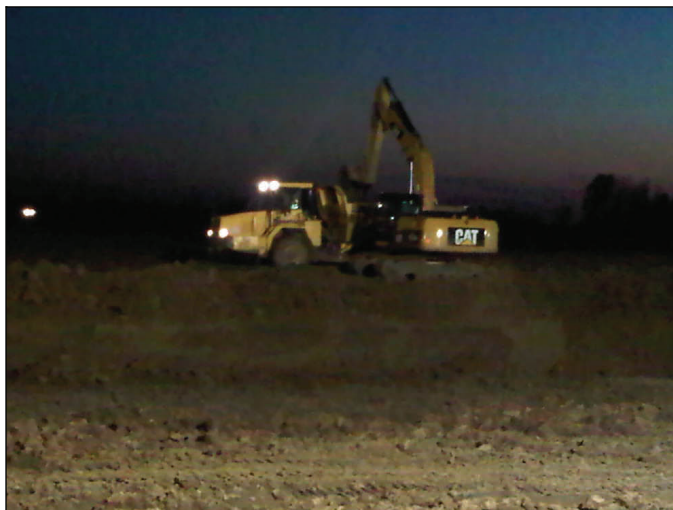
**An excavator operator loads an off-road dump truck Monday night with clay that will fill the land-side berm. Each off-road truck can carry up to 25 tons of clay. The District began night operations Saturday.**

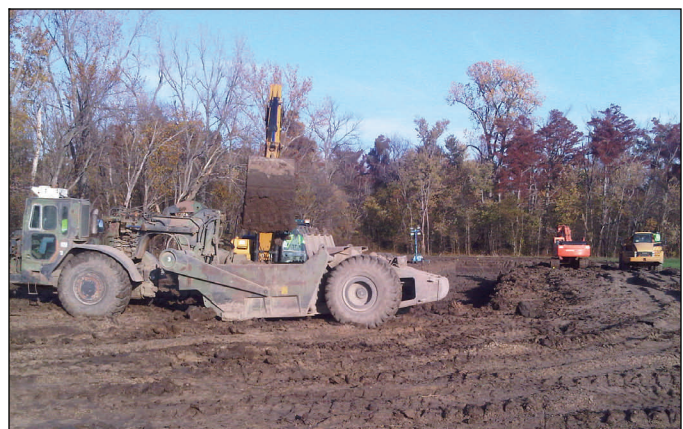
**Crews load clay at a newly-acquired borrow site Monday. The clay is bound for the scour hole at the center crevasse.**
